Building Information - Cuyahoga Falls City (43836) - Bolich Middle

Program Type	Classroom Facilities Assistance Program (CFAP) - Regular
Setting	Suburban
Assessment Name	Bolich_Middle_June_2009_Jan_2015_EEA_June_2018_Desktop_Update
Assessment Date (on-site; non-EEA)	2015-01-06
Kitchen Type	Full Kitchen
Cost Set:	2018
Building Name	Bolich Middle
Building IRN	3103
Building Address	2630 13th Street
Building City	Cuyahoga Falls
Building Zipcode	44223
Building Phone	(330) 926-3801
Acreage	35.00
Current Grades:	6-8
Teaching Stations	48
Number of Floors	2
Student Capacity	640
Current Enrollment	629
Enrollment Date	2009-05-19
Enrollment Date is the date in which the current enrollment was taken.	
Number of Classrooms	46
Historical Register	NO
Building's Principal	Mr. Michael Miller
Building Type	Middle

Harvey Bolich Middle School, which is not on the National Register of Historic Buildings, and originally constructed in 1953, is a 2 story, 96,768 square foot brick school building located in a suburban residential and commercial setting. The existing facility features a conventionally partitioned design, and does not utilize modular buildings. The structure of the overall facility contain

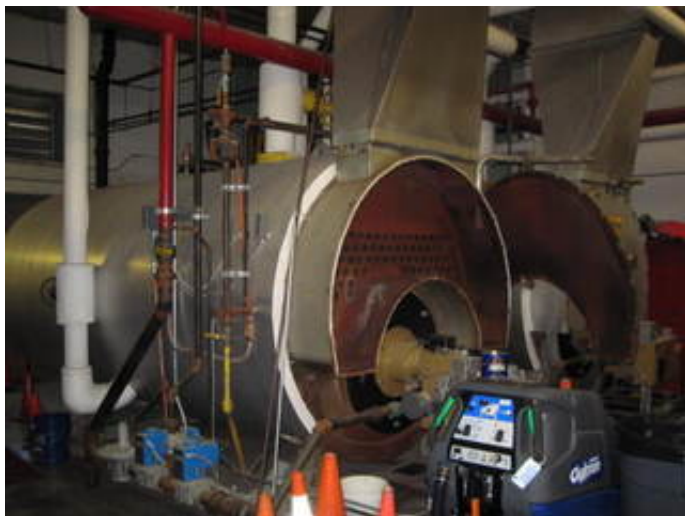
The existing system for the 1953 Original Construction is a natural gas fired heated water boiler type system, installed in 1953, and is in fair condition. The system in the 1963 Addition is an extension of that found in the 1953 Original Construction. 2-pipe vs. 4-pipe designations are not applicable in this facility, as no central air conditioning is provided. The two (2) water boilers, manufactured by Titusville, were installed in 1953 and are in fair to poor condition. Heating water is distributed to terminal units consisting of unit ventilators, unit heaters, air handlers, and heating fan convectors. The terminal equipment is original to each addition and is in fair to poor condition. The system does not comply with the 15 CFM per person fresh air requirements of the Ohio Building Code mechanical code and Ohio School Design Manual. The pneumatic type system temperature controls are original to each addition and are in fair condition. The system does not feature individual temperature controls in all spaces required by the OSDM. The overall system does not feature any central energy recovery systems. The facility is not equipped with louvered interior doors to facilitate Corridor utilization as return air plenums. The existing system is not ducted, and floor to structural deck heights will accommodate the installation of properly sized ductwork for a future Ohio School Design Manual approved system. The overall heating system is evaluated as not being in safe and efficient working order, and long term life expectancy of the existing system is not anticipated. The structure is not equipped with a central air conditioning system. The site does not contain underground fuel tanks.

Natural Gas Fired Heated Water Boilers

Provide new overall heating, ventilating, and air conditioning system to achieve compliance with Ohio Building Code and Ohio School Design Manual standards. Convert the overall facility to a ducted system to facilitate efficient exchange of conditioned air.

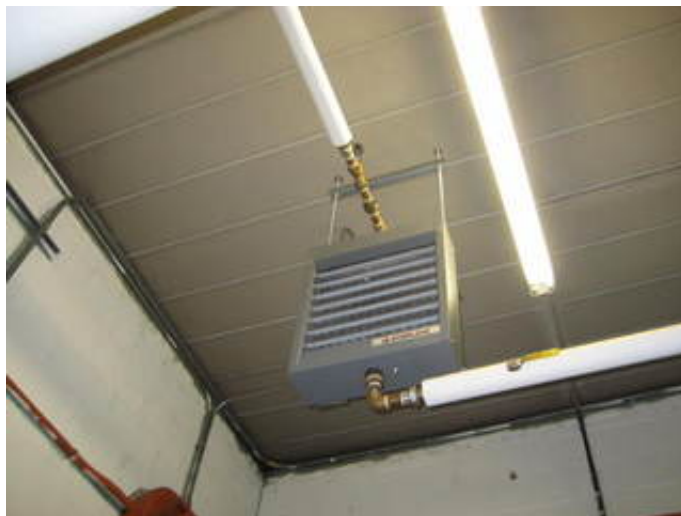
Heating Water Unit Heater

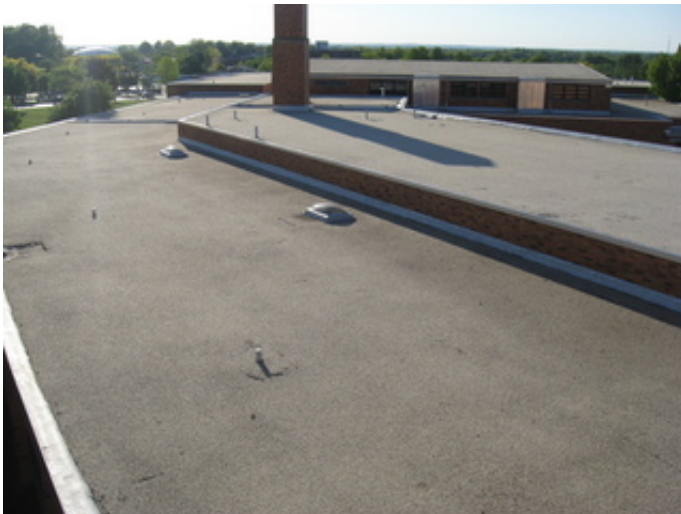
Description: The roof over the overall facility is an asphalt built-up roof with gravel wear coat that was installed in 1999, and is in fair condition. There are District reports of current leaking in the southeast classrooms of the second floor. The nature of the leaks is roofing asphalt is entering the building, except when the outdoor temperature is cold. Signs of past leaking were observed during the physical assessment. Access to the roof was gained by two interior roof access ladders that are in good condition and two access hatches in poor condition. Fall safety protection cages are not required and are not provided. There were no observations of standing water on the roof. Metal cap flashings are in good condition. Roof storm drainage is addressed through a system of gutters and downspouts with roof drains, which are properly located, and in good condition. The roof is not equipped with overflow roof drains though they are not required on this building. No problems requiring attention were encountered with any roof penetrations. There are not any covered walkways attached to this structure. 06-22-18 Assessment Update: It was reported by district personnel, and observed, the original roof area was not removed prior to installing the current roof system. Therefore, additional tear-off costs required. Additional roof insulation required to meet LEED energy efficiency requirements.

Rating: 3 Needs Replacement

Typical Roof Over The 1953 Original Construction

Recommendations: The roof over the overall facility requires replacement to meet Ohio School Design Manual guidelines due to condition. Replace 2 roof access hatches due to condition. 06-22-18 Assessment Update: Provide for additional roof tear-off due to recovery roof system installed over existing roof. Provide for additional roof insulation to meet LEED energy efficiency requirements.

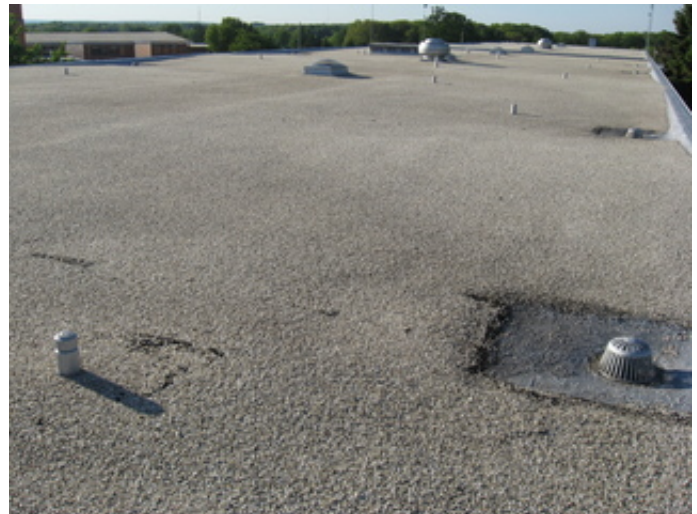
Typical Roof Over The Classroom Wing Of The 1953 Original Construction

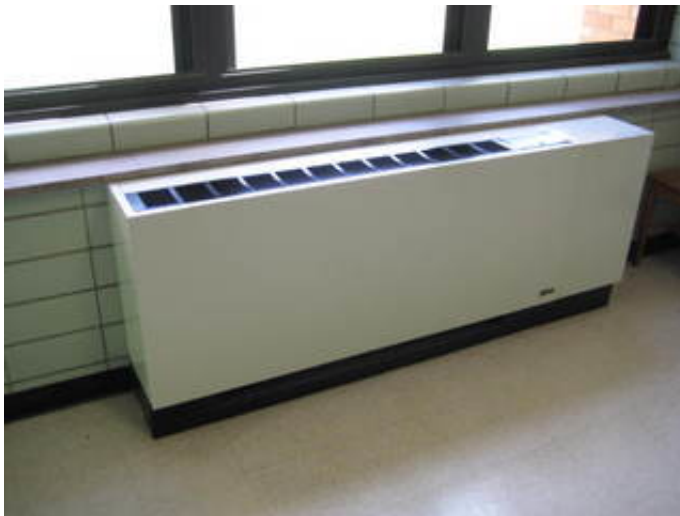
- Description:** The overall facility is not equipped with a central air conditioning system. Window units are provided in Classroom, Administrative Offices, Principal's Office, and Teacher's Lounge locations. The overall facility is not equipped with any isolated room systems. The ventilation system in the overall facility consists of unit ventilators and air handlers, original to each addition and in fair to poor condition, providing fresh air to Classrooms, and other miscellaneous spaces such as the Gymnasium, Student Dining, and Media Center. Relief air venting is provided by unit ventilators, air handlers, and central relief fans. The ventilation system does not meet the Ohio Building Code 15 CFM per occupant fresh air requirement. The overall system is not compliant with Ohio Building Code and Ohio School Design Manual requirements. Dust collection systems are not required in this facility. Exhaust systems for Restrooms, Storage Rooms, Custodial Closets, Locker Rooms, Maintenance Workrooms, Kitchen Dry Food Storage, P.E. Workroom & Storage, Art Rooms, Project Laboratories, and Loading & Receiving Areas are inadequately placed, and in fair condition. The Art Program is equipped with a kiln, and the existing kiln ventilation system is adequate. 06-22-18 Assessment Update: General building exhaust is included in Item A and should not be included in this line item. Kiln does not have proper exhaust.

Classroom Unit Ventilator

- Rating:** 1 Satisfactory
- Recommendations:** Provide an air conditioning system to meet with Ohio Building Code and Ohio School Design Manual requirements. Pricing included in Item A. Replace the existing general building exhaust system. 06-22-18 Assessment Update: Delete general building exhaust. Provide for proper exhaust system for kiln.

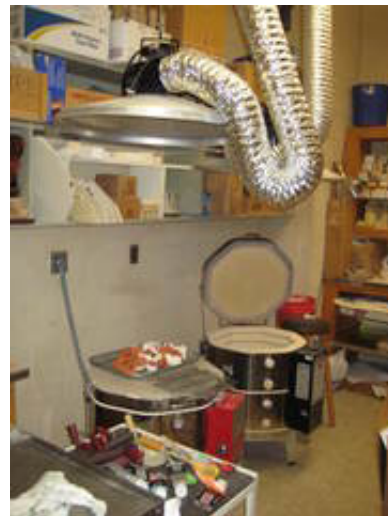
Art Program Kiln Ventilation Systems

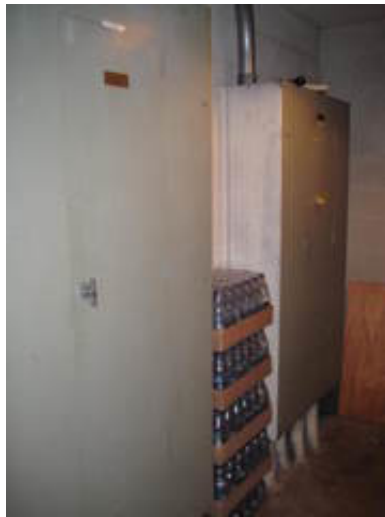
Description: The electrical system provided to the 1953 Original Construction is a 120/208 volts, 1000 amp, 3 phase and 4 wire system installed in 1953, and is in fair condition. The system in the 1963 Addition is an extension of that found in the 1953 Original Construction. Power is provided to the school by multiple City of Cuyahoga Falls owned, pad-mounted transformer located in a room outside the Mechanical Room, and in fair condition. The panel system, installed in 1953, is in fair condition, and cannot be expanded to add additional capacity. The Classrooms are not equipped with adequate electrical outlets. The typical Classroom contains four (4) general purpose outlets, zero (0) dedicated outlets for each Classroom computer, and one (1) dedicated outlet for each Classroom television. Some Classrooms are equipped with as many as six (6) general purpose outlets, while others are equipped with as few as three (3) general purpose outlets. There are not any spaces that have no electrical outlets. The Corridors are not equipped with adequate electrical outlets for servicing. Adequate GFI protected exterior outlets are not provided around the perimeter of the building. The facility is not equipped with an emergency generator. Adequate lightning protection safeguards are not provided. Stage lighting power system including control panel, breakers, and dimmers is inadequately provided, in fair condition and does not meet OSDM requirements. The overall electrical system does not meet Ohio School Design Manual requirements in supporting the current needs of the school, and will be inadequate to meet the facility's future needs.

Rating: 3 Needs Replacement

Main Electrical Distribution Panel

Recommendations: The entire electrical system requires replacement to meet Ohio School Design Manual guidelines for overall capacity and Classroom capacity due to age, condition, lack of OSDM-required features, and to accommodate the addition of an air conditioning system. Provide an emergency generator, with funding included in the electrical system replacement. Provide adequate lightning protection safeguards in the overall facility, including associated grounding system, with funding included in the electrical system replacement. Provide control panel, dimmers, and breakers to support the Stage lighting system, with funding included in the electrical system replacement.

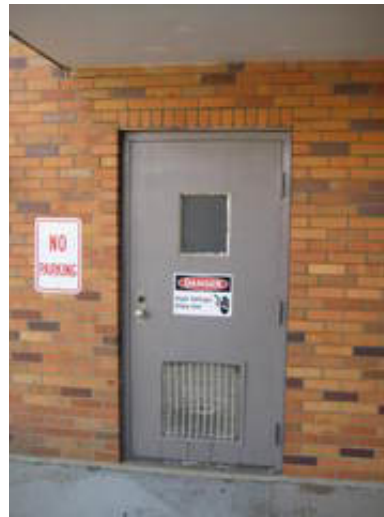
Pad Mounted Transformer Room

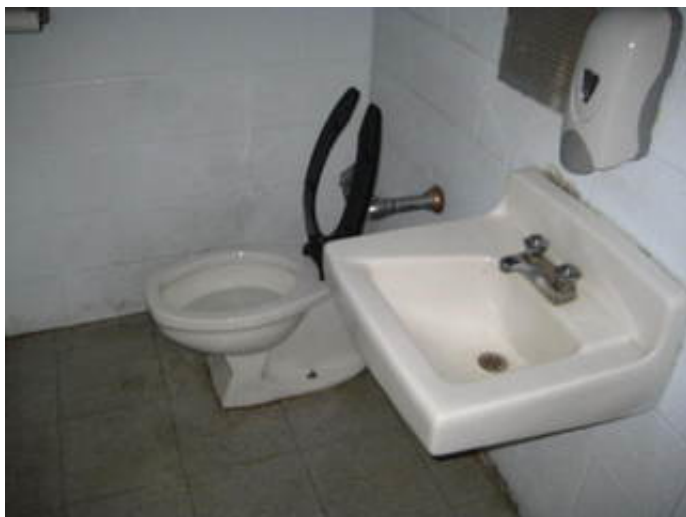
The service entrance is not equipped with a reduced pressure backflow preventer. A water treatment system is not provided, though none is needed. The domestic water supply piping in the overall facility is galvanized and copper, is original to each addition, and is in fair condition. The waste piping in the overall facility is cast iron and galvanized, is original to each addition, and is in fair condition. The facility is equipped with one (1) A.O. Smith natural gas water heater installed in 1999, and in good to fair condition, with one (1) separate 350 gallon storage tank in fair condition. The overall facility contains 3 Large Group Restrooms for boys, 3 Large Group Restrooms for girls, 1 Locker Room Restroom for boys, 1 Locker Room Restroom for girls, 0 Locker Room Restrooms for staff, 1 Kitchen Restroom, 1 Health Clinic Restroom, 0 Restrooms associated with Kindergarten / Pre-K Classrooms / Specialty Classrooms, and 3 Restrooms for staff. Boys' Large Group Restrooms contain 1 ADA and 9 non-ADA wall mounted flush valve toilets, 20 non-ADA floor mounted flush valve urinals, as well as 6 non-ADA wall mounted lavatories. Girls' Large Group Restrooms contain 1 ADA and 19 non-ADA floor mounted flush toilets, as well as 6 non-ADA wall mounted lavatories. Boys' Locker Room Restroom contains 2 non-ADA floor mounted flush valve toilets, 3 non-ADA floor mounted flush valve urinals, 2 non-ADA wall mounted lavatories, as well as 14 non-ADA showers. Girls' Locker Room Restroom contains 5 non-ADA floor mounted flush valve toilets, 2 non-ADA wall mounted lavatories, as well as 14 non-ADA showers. Staff Restrooms contain 3 non-ADA floor mounted flush valve toilets, as well as 3 non-ADA wall mounted lavatories. Condition of fixtures is fair. The facility is equipped with 3 non-ADA drinking fountains, as well as 5 ADA and 4 non-ADA electric water coolers, in fair condition. Due to existing grade configuration, there are no Elementary Classrooms. Special Education Classroom is not equipped with the required Restroom facilities. Kitchen is equipped with the required Restroom which contains 1 non-ADA floor mounted flush valve toilet, as well as 1 non-ADA wall mounted lavatory, and fixtures are in fair condition. Health Clinic is equipped with the required Restroom which contains 1 non-ADA floor mounted flush valve toilet, as well as 1 non-ADA wall mounted lavatory, and fixtures are in fair condition. Due to existing grade configuration, there are no Kindergarten / Pre-K Classrooms. Kitchen fixtures consist of one (1) dishwashing unit, one (1) disposal unit, and one (1) double-compartment sink, which are in fair condition. The Kitchen is equipped with an unsatisfactory grease interceptor due to age, condition, and insufficient capacity. The Kitchen is not provided the required 140 degree hot water supply. The school meets the OBC requirements for fixtures. Per OBC and OSDM requirements this facility should be equipped with 18 toilets, 8 urinals, 18 lavatories, and 7 electric water coolers, and at present it is equipped with 42 toilets, 23 urinals, 21 lavatories, and 9 electric water coolers. ADA requirements are not met for fixtures and drinking fountains (see Item O). Custodial Closets are properly located and are adequately provided with required service sink or floor drain sink, which is in fair condition. CONTINUED 06-22-18 Assessment Update: Shower/Eye Wash Stations required for Science Rooms. Locker room shower heads are old and worn and should be replaced.

Non-ADA Floor Mounted Flush Valve Toilet and Wall Mounted Lavatory

Replace galvanized water supply piping in the overall facility with copper piping due to age and condition. Replace sanitary waste piping in the overall facility due to age and condition. Due to age, condition, and OSFC standards, replace 23 faucets and valves, 21 lavatories, 42 toilets, and 4 electric water coolers. See Item O for replacement of fixtures related to ADA requirements. See Item J for provisions on Kitchen related equipment. Provide the service entrance with a reduced pressure back flow preventer. Replace the 350 gallon domestic hot water storage tank due to age and condition. Replace the Kitchen grease trap interceptor due to age, condition, and insufficient capacity. Provide the Kitchen with a water booster heater. Provide the Science Classrooms with the required compressed air connection. Provide the Science Classrooms with the required safety shower / eyewash station. Provide 3 additional exterior wall hydrants. Replace the existing Custodial Closet service sinks due to age and condition. 06-22-18 Assessment Update: Provide for shower/eye wash stations in Science Rooms. Replace locker room shower heads.

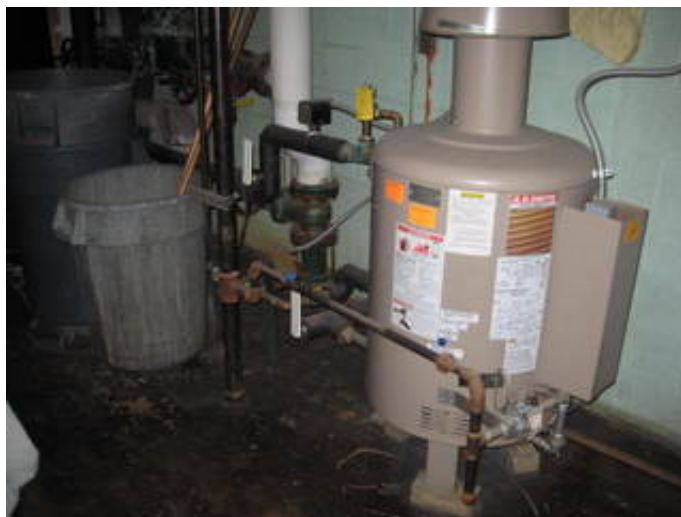
Natural Gas Fired Domestic Hot Water Heater

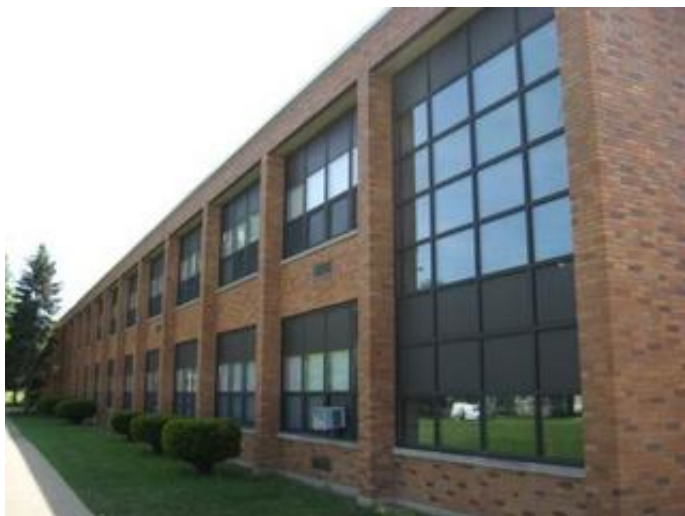
Description: The overall facility is equipped with thermally broken aluminum frame windows with double glazed insulated glazing type window system, which was installed in 2000, and is in good condition. Window system seals are in good condition, with no air and water infiltration being experienced. Window system hardware is in good condition. The window system features surface mounted shades and blinds, which are in good condition. The window system is equipped with insect screens on operable windows, which are in good condition. Aluminum frame curtain wall systems are found in two locations in the 1953 Original Construction Stairwells, in good condition. This facility does not feature any glass block windows. The exterior doors in the overall facility are equipped with thermally broken aluminum frame sidelights and transoms with double glazed insulated glazing, in good condition. The school does contain 16 acrylic bubble type skylights in fair condition. Window security grilles are not provided for ground floor windows. There is not a Greenhouse associated with this school.06-22-18 Assessment Update: There are missing and damaged insect screens. The surface mounted blinds are damaged and poor condition and should be replaced. Broken seals were observed and new glazing required.

Rating: 3 Needs Replacement

Typical Windows in the 1953 Original Construction

Recommendations: Replace skylights in the 1953 Original Construction. Replace single pane vision panels in exterior doors of the overall facility with approved insulating safety glass.06-22-18 Assessment Update: Replace insect screens. Replace surface mounted blinds. Replace units that have broken seal with new glazing.

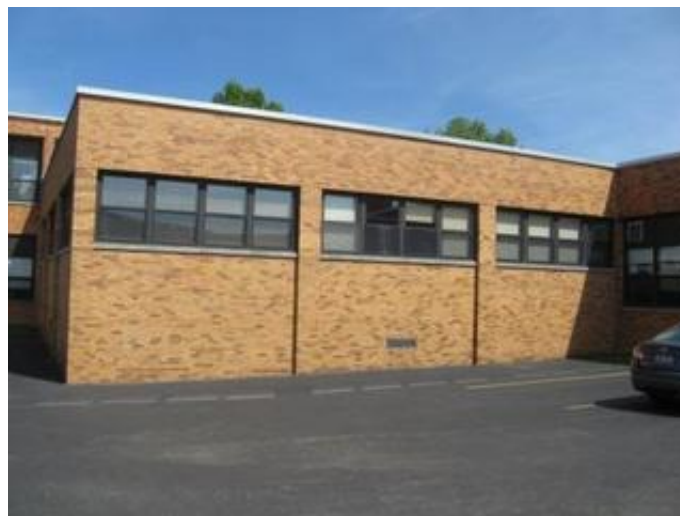
1963 Addition Windows

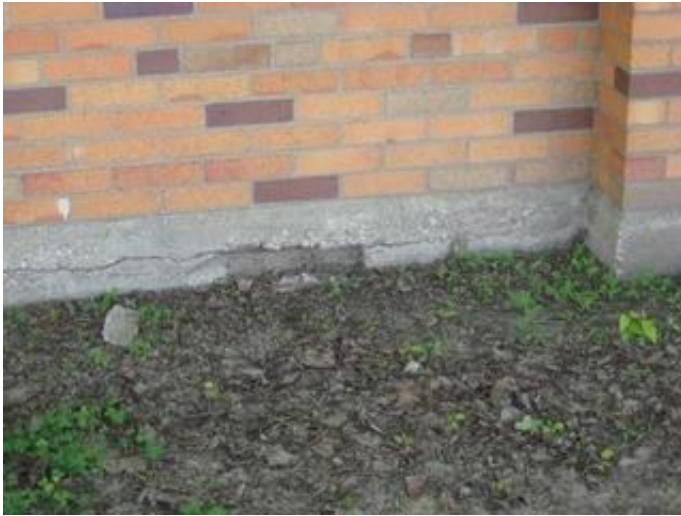
Description: The overall facility is equipped with concrete foundation walls on concrete footings which displayed locations of cracking and spalling and are in fair condition. The District reports that there has been no past leaking. No grading or site drainage deficiencies were noted around the perimeter of the structure that are contributing or could contribute to foundation / wall structural deterioration.

Rating: 2 Needs Repair

Location of Spalling in Exposed Concrete Foundation Wall

Recommendations: Repair locations of spalling and cracking in exposed concrete foundation walls through the overall facility.

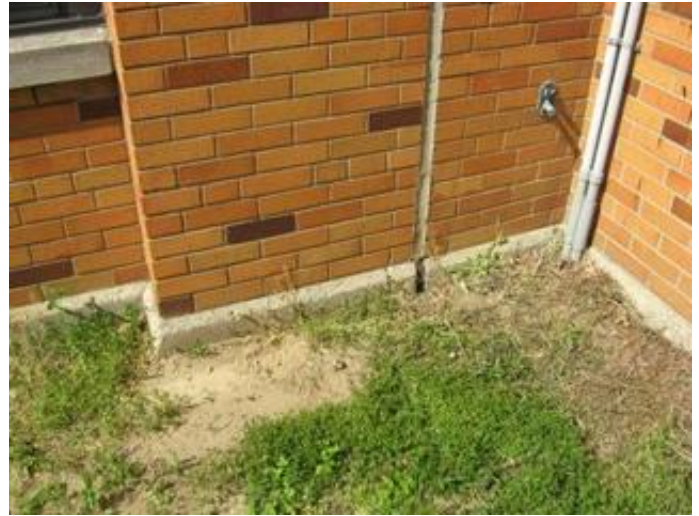
Condition of Exposed Concrete Foundation Wall at Exterior Expansion Joint

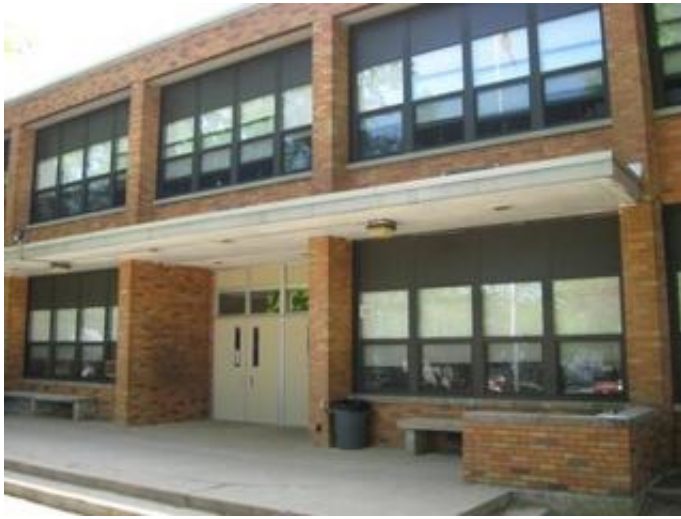
Description: The overall facility has a brick veneer on a masonry bearing wall system, which displayed locations of deterioration, and is in good to fair condition. The exterior masonry appears to have appropriately spaced and inadequately caulked control joints in fair to poor condition. Control joints are not provided at lintel locations at doors and windows. The school does have sufficient expansion joints, and they are in fair condition. The exterior masonry has not been cleaned and sealed in recent years, shows evidence of mortar deterioration and has locations of discoloration due to moisture and pollution. Architectural exterior accent material consists of stone, which is in fair condition. Interior walls are painted concrete masonry units and glazed block and are in good condition. Interior masonry appears to have adequately spaced and caulked control joints in good condition. Exterior painted concrete soffits are in fair condition. The window sills are stone, and are in fair condition. The exterior lintels are steel, are rusting and in fair condition. The chimney in the 1953 Original Construction is in fair condition requiring masonry repairs and tuckpointing. Canopies over entrances are painted concrete type construction, and are in fair condition. A loading dock has not been provided to facilitate unloading of trucks and receipt of product / supplies / foodstuffs.

Rating: 2 Needs Repair

Concrete Canopy at 1953 Original Construction Main Entry

Recommendations: Provide tuckpointing in all areas of mortar deterioration as required through the overall facility. Provide masonry cleaning, sealing and caulking as required through the overall facility. Recaulk existing control joints. Repoint stone window sills through the overall facility. Prep and paint exposed steel lintels through the overall facility. Provide masonry repairs as required through the overall facility. Provide masonry infill for existing unit ventilator openings in exterior walls. Repair and paint exterior soffits. Repair and paint entrance canopies. Repair chimney as required in the 1953 Original Construction. Repair minor cracks in interior masonry as required in the overall facility.

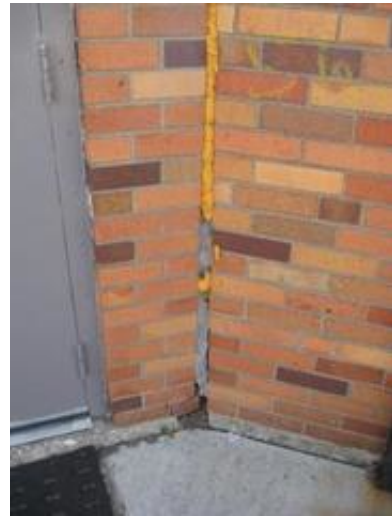
Condition of Expansion Joint in the 1953 Original Construction

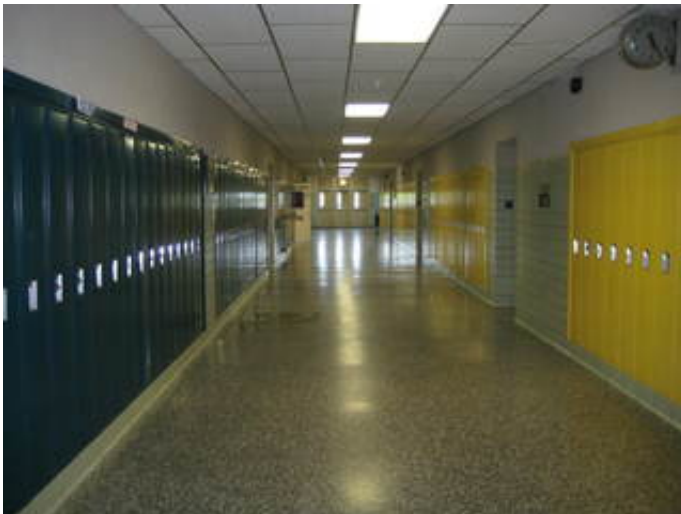
Description:	<p>The 1953 Original Construction features conventionally partitioned Classrooms with VAT and VCT flooring, acoustical tile ceilings, as well as glazed and painted block wall finishes, and they are in fair condition. The 1953 Original Construction has Corridors with terrazzo flooring, acoustical tile ceilings, as well as glazed and painted block wall finishes, and they are in fair condition. The 1953 Original Construction has Restrooms with ceramic tile flooring, acoustical tile ceilings, as well as glazed and painted block wall finishes, and they are in poor condition. Toilet partitions are marble, metal, plastic, and wood, and are in poor condition. Classroom casework in the 1953 Original Construction is metal type construction with metal tops, is inadequately provided, and in poor condition. The typical Classroom contains 12 lineal feet of casework, and Classroom casework provided ranges from 0 to 12 feet. Classrooms are provided adequate chalkboards, markerboards, and tackboards, which are in fair condition. The lockers, located in the Corridors, are adequately provided, and in good to fair condition. The Art program is equipped with a kiln in good condition, and existing kiln ventilation is adequate. The facility is equipped with metal non-louvered interior doors that are partially recessed without proper ADA hardware and clearances, and in fair to poor condition. The Gymnasium spaces have wood flooring, tectum ceilings, as well as glazed and painted block wall finishes, and they are in fair condition. Wood Gymnasium flooring has been well maintained, will accommodate no future sandings and refinishings, and is rated at an advanced stage of its product lifecycle. Gymnasium telescoping stands are wood type construction in fair condition. Gymnasium basketball backboards are fixed and manually operated type, and are in poor condition. The Media Center, located in the 1963 Addition, has carpet flooring, acoustical tile ceilings, as well as glazed and painted block wall finishes, and they are in fair condition. Student Dining, located in the 1953 Original Construction, has VCT flooring, acoustical tile ceilings, as well as glazed and painted block wall finishes, and they are in fair condition. OSDM-required fixed equipment for Stage is inadequately provided, and in poor condition. The existing Kitchen is full service, is undersized based on current enrollment, and the existing Kitchen equipment, installed in 1953 with incremental upgrades, is in fair condition. The Kitchen hood is in fair condition, and is equipped with the required UL 300 compliant wet chemical fire suppression system. The required 6" overhang on all three exposed sides of the cooking equipment is not provided by the hood. Kitchen hood exhaust ductwork is not of proper construction material and/or installed as required by the OSDM and OBMC. Walk-in / cooler and reach-in freezer are located within the Kitchen spaces, and are in fair condition. 06-22-18 Assessment Update: Provide budget for floor infill, patch, floor tile repair and wall tile repair for removal of floor mounted urinals. Provide for additional exterior wall insulation to meet LEED Energy Efficiency requirements. Repair locker room shower ceramic tile. Additional basketball backboards and goals required. Stage curtain should be replaced. Stage flooring is worn and should be replaced. Additional exterior wall insulation required to achieve LEED energy efficiency requirements.</p>

Corridor Finishes

Rating:	3 Needs Replacement
Recommendations:	<p>Provide complete replacement of finishes and casework due to installation of systems outlined in Items A, C, D, E, I, K, L, M, N, T, U, and condition. Provide for the replacement of interior doors due to condition. Provide for the replacement of Kitchen equipment due to age and condition. Provide for the replacement of the Kitchen exhaust hood due to age and condition. Provide for the replacement of walk-in cooler/freezer. Provide for the replacement of toilet partitions due to condition. Provide for the replacement of toilet accessories due to condition. Provide for the replacement of Gymnasium seating due to condition. Provide for the replacement of Gymnasium basketball goals due to condition. Provide for repairs to terrazzo flooring due to condition. Provide for the replacement of the Gymnasium wood floors due to product life cycle and condition. 06-22-18 Assessment Update: Provide budget for floor infill, patch, floor tile repair and wall tile repair for removal of floor mounted urinals. Provide for additional exterior wall insulation to meet LEED Energy Efficiency requirements. Repair locker room shower ceramic tile. Additional basketball backboards and goals required. Replace stage curtain. Replace wood stage floor. 06-22-18 Assessment Update: Provide budget for floor infill, patch, floor tile repair and wall tile repair for removal of floor mounted urinals. Provide for additional exterior wall insulation to meet LEED Energy Efficiency requirements. Repair locker room shower ceramic tile. Additional basketball backboards and goals required. Replace stage curtain. Provide for additional wall insulation. replace 8 doors in Media Center (increase quantity from 88 to 96).</p>

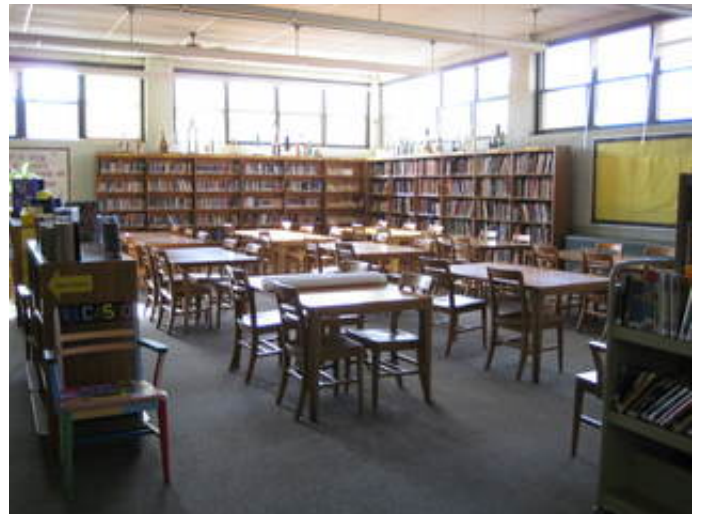
Media Center Finishes

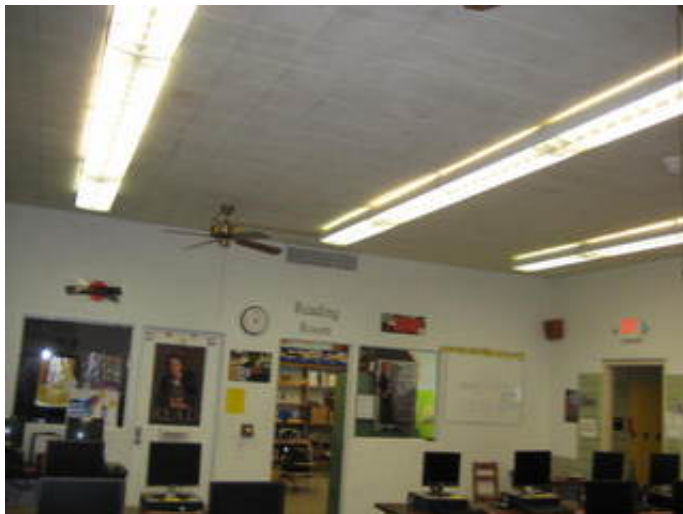
Description: The typical Classrooms in the overall facility are equipped with T-8 2x4 lay-in direct and T-8 1x4 surface mount fluorescent fixtures with single level switching. Classroom fixtures are in fair condition, providing an average illumination of 55 FC, thus complying with the 50 FC recommended by the OSDM. The typical Corridors in the overall facility are equipped with T-8 2x4 lay-in direct fluorescent fixtures with single level switching. Corridor fixtures are in fair to poor condition, providing an average illumination of 13 FC, which is less than the 20 FC recommended by the OSDM. The Gymnasium spaces are equipped with pendant metal halide type lighting, in fair condition, providing an average illumination of 37 FC, which is less than the 50 FC recommended by the OSDM. The Media Center is equipped with T-8 1x4 surface mount and suspended fluorescent fixture type lighting in fair condition, providing an average illumination of 48 FC, which is less than the 50 FC recommended by the OSDM. The Student Dining spaces are equipped with T-8 2x4 lay-in direct fluorescent fixture type lighting with single level switching. Student Dining fixtures are in good to fair condition, providing an average illumination of 58 FC, thus complying with the 50 FC recommended by the OSDM. The Kitchen spaces are equipped with T-12 1x4 suspended fluorescent fixture type lighting with single level switching. Kitchen fixtures are in fair to poor condition, providing an average illumination of 67 FC, which is less than the 75-80 FC recommended by the OSDM. The Service Areas in the overall facility are equipped with T-8 1x4 lay-in suspended /fluorescent fixture type lighting in fair condition, providing inadequate illumination. The typical Administrative spaces in the overall facility are equipped with T-8 1x4 suspended fluorescent fixture type lighting in fair condition, providing adequate illumination based on OSDM requirements. The overall lighting systems of the facility are not fully compliant with Ohio School Design Manual requirements due to age, condition, inadequate lighting levels, and lack of multi-level switching, and the utilization of T-12 fixtures.

Rating: 3 Needs Replacement

Media Center Fluorescent Light Fixtures

Recommendations: Provide complete replacement of lighting system due to age, condition, inadequate lighting levels, lack of multilevel switching, the utilization of T-12 fixtures, and installation of systems outlined in Items A, C, J, and U.

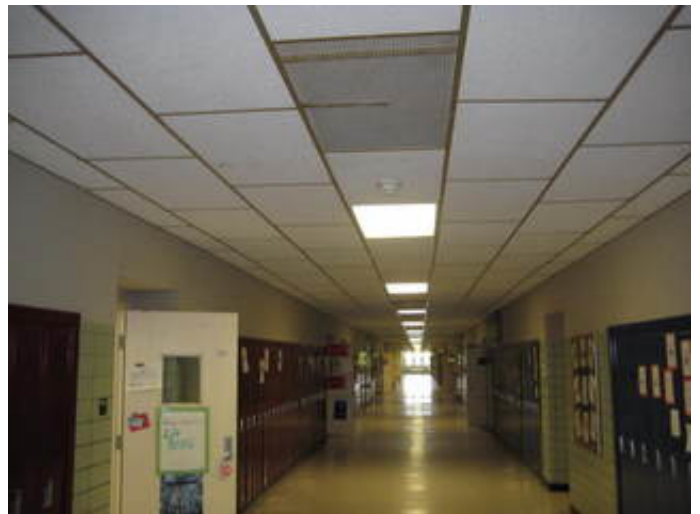
Corridor Fluorescent Light Fixtures

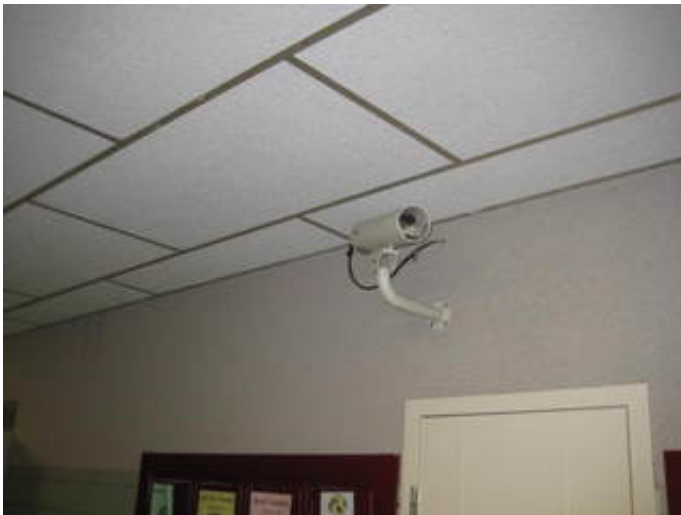
Description: The overall facility contains a Honeywell motion sensor and door contact type security system in fair to poor condition. Motion detectors are inadequately provided in main entries, central gathering areas, offices, main Corridors, and spaces where 6 or more computers are located. Exterior doors are inadequately equipped with door contacts. An automatic visitor control system is not provided. Compliant color CCTV cameras are not provided at main entry areas, parking lots, central gathering areas, and main Corridors. A compliant computer controlled access control system integrating alarms and video signals, with appropriate UPS backup, is not provided. The system is not equipped with card / biometric readers. The security system is inadequately provided throughout, and the system is not fully compliant with Ohio School Design Manual guidelines. Existing playground fencing is not fully compliant with Ohio School Design Manual guidelines. The exterior site lighting system is equipped with surface mounted HID high pressure sodium / mercury vapor entry lights in fair condition. Pedestrian walkways are not illuminated. Parking and bus pick-up / drop off areas are not illuminated. The exterior site lighting system provides inadequate coverage. 06-22-18 Assessment Update: The main entry is adjacent to the main entry but the entry does not provide for a secure entry. Modifications are required to achieve a secure main entrance into the building.

Rating: 3 Needs Replacement

Security System CCTV Camera

Recommendations: Provide complete replacement of security system to meet Ohio School Design Manual guidelines. Provide complete replacement of exterior site lighting system to meet Ohio School Design Manual guidelines. Provide additional playground fencing to meet Ohio School Design Manual guidelines, funding included in complete replacement of security system.06-22-18 Assessment Update: Provide for modifications on existing main entrance to provide for a security vestibule.

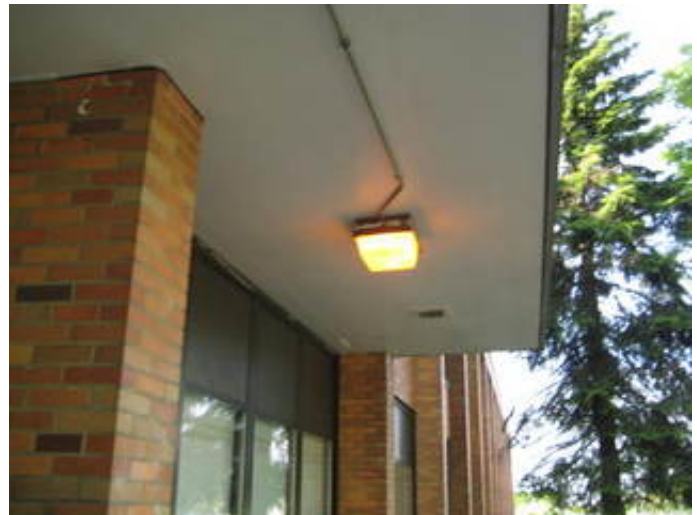
Surface Mounted HID High Pressure Sodium Entry Light Fixture

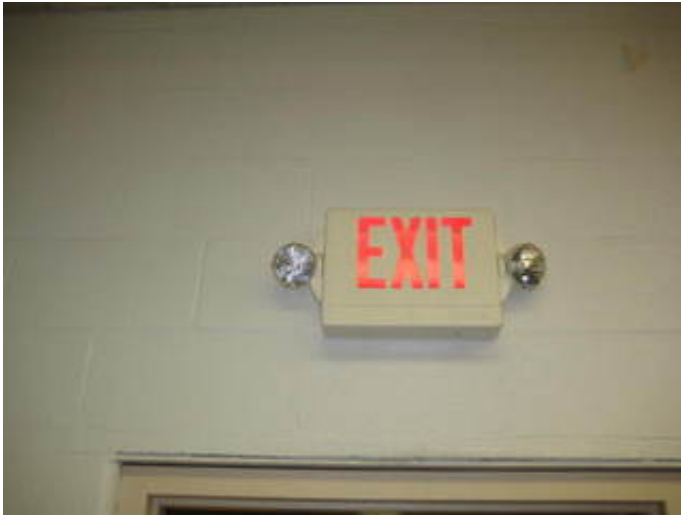
Description: The overall facility is equipped with an emergency egress lighting system consisting of non compliant plastic construction exit signs, as well as OSDM compliant red lettered, cast aluminum construction, and LED illuminated exit signs and the system is in fair condition. The facility is not adequately equipped with emergency egress floodlighting and the system is in fair to poor condition. The system is not provided with appropriate battery backup and emergency generator on separate circuits. The system is inadequately provided throughout, and does not meet Ohio School Design Manual and Ohio Building Code requirements.

Rating: 3 Needs Replacement

Compliant Illuminated Exit Sign

Recommendations: Provide complete replacement of emergency / egress lighting system to meet Ohio School Design Manual guidelines.

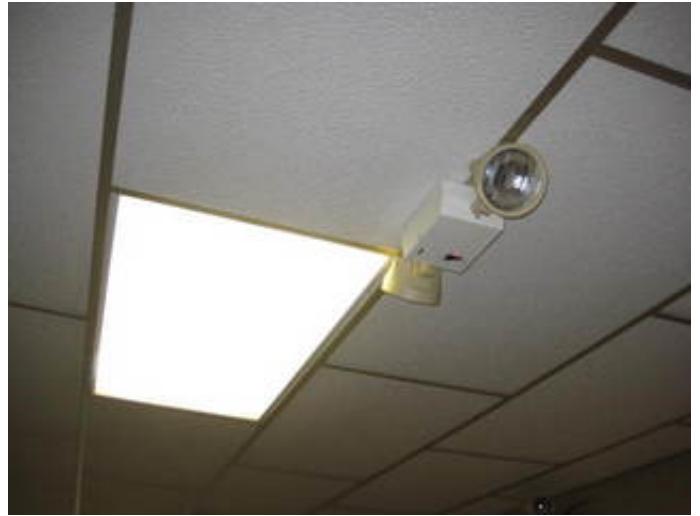
Emergency Egress Light Fixture

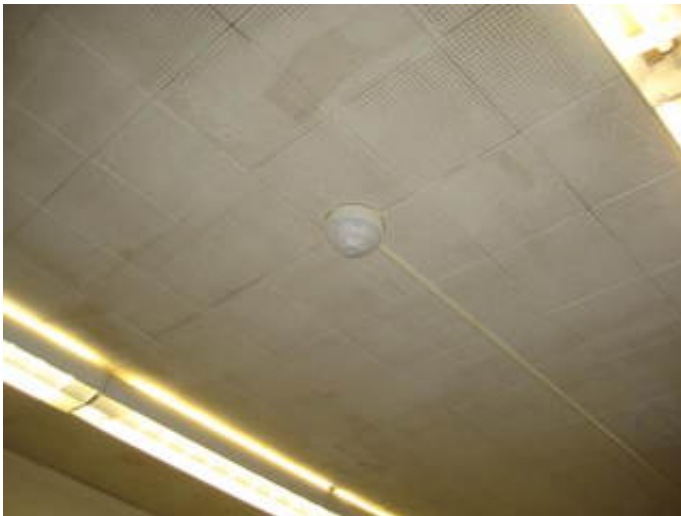
Rating: 3 Needs Replacement

Fire Alarm System Smoke Detection Device

Recommendations: Provide complete replacement of fire alarm system to meet OBC, NFPA, and Ohio School Design Manual guidelines.

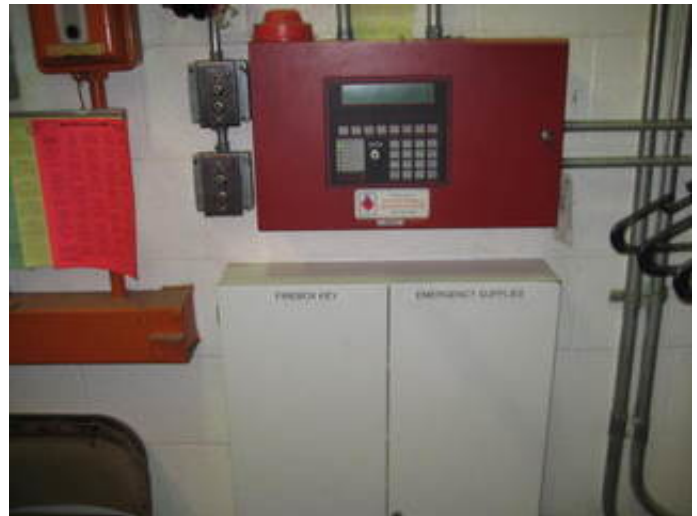
Fire Alarm System Control Panel

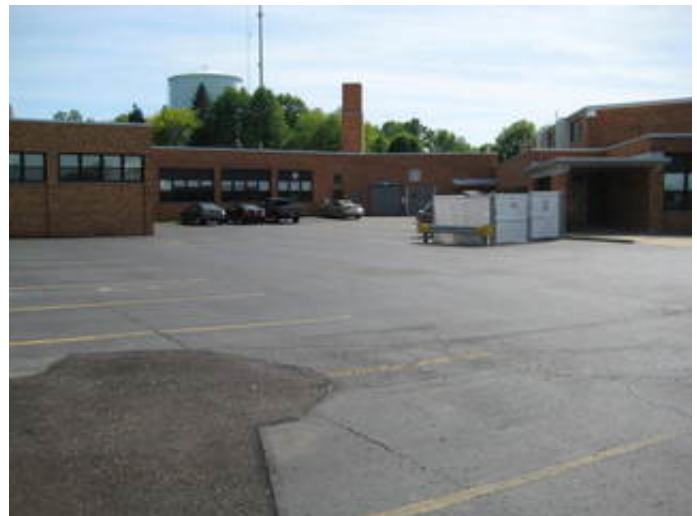
Asphalt Pavement Conditions

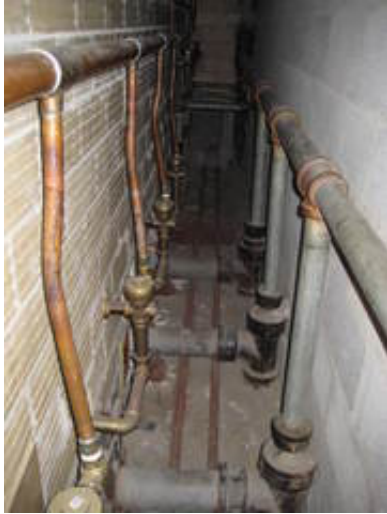
Rating: 2 Needs Repair

Sanitary Waste Piping

Recommendations: Existing conditions require no renovation or replacement at the present time. 06-22-18 Assessment Update: Replace underground storm sewer line from building to street.

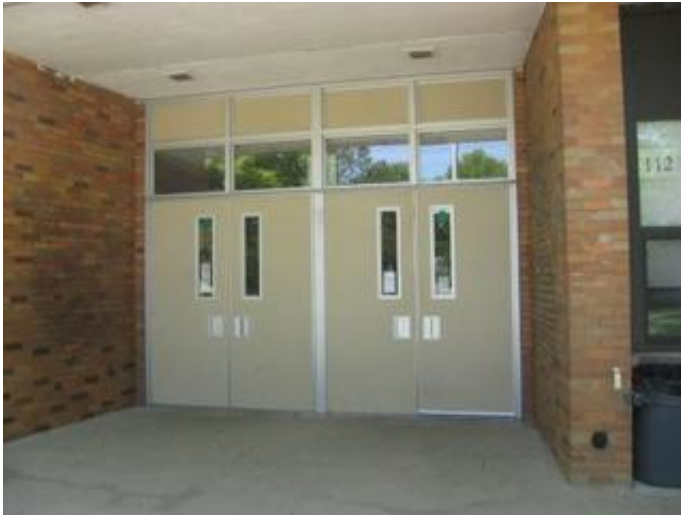
Rating: 3 Needs Replacement

Main Entry Doors in the 1953 Original Construction

Recommendations: Replace all hollow metal exterior doors and frames, due to poor condition. Replacement of single glazed door vision panels is addressed in Item F.

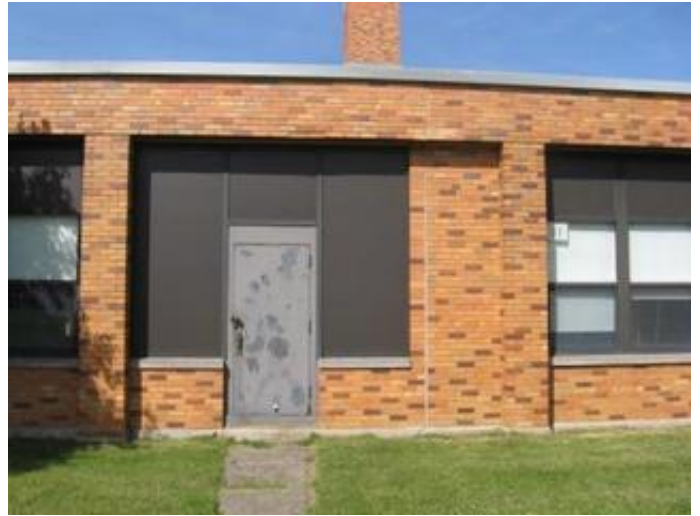
Hollow Metal Door and Frame in the 1953 Original Construction

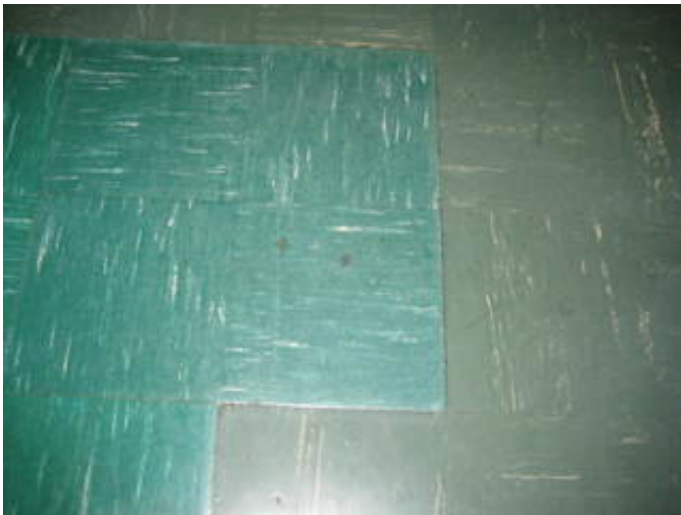
Rating: 3 Needs Replacement

VAT in Classrooms

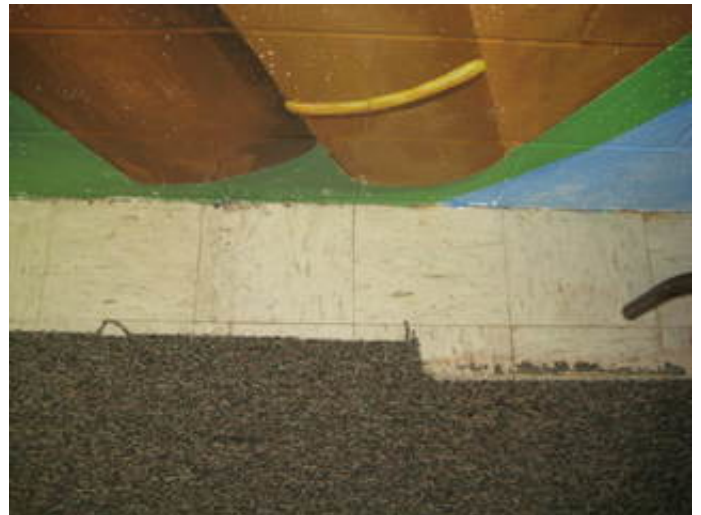
VAT in Media Center

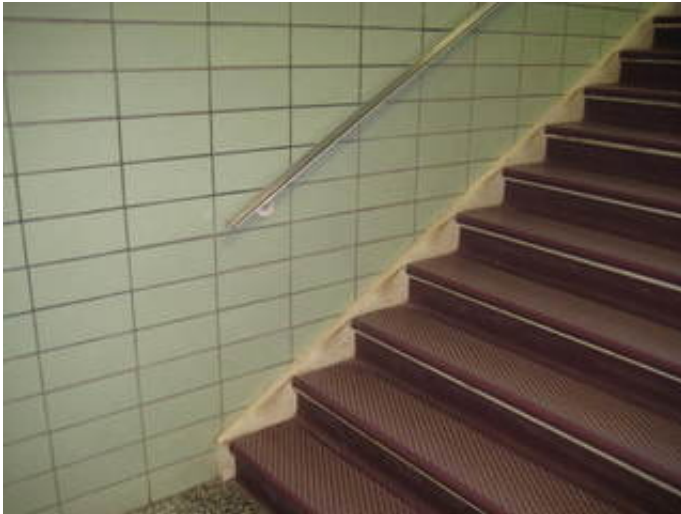
Non-Compliant Handrail

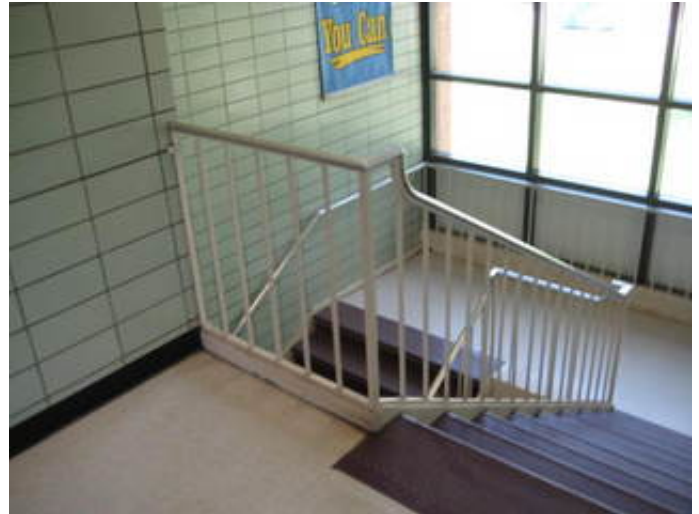
Non-Compliant Guardrail

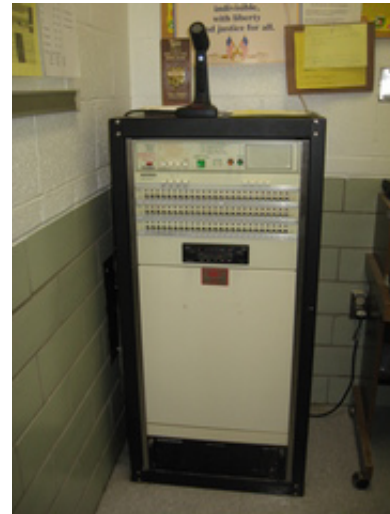
Typical Outdated Central PA System
