**Building Information - Cuyahoga Falls City (43836) - Cuyahoga Falls High**

Program Type	Classroom Facilities Assistance Program (CFAP) - Regular
Setting	Urban
Assessment Name	Cuyahoga_Falls_HS_June_2009_Jan_2015_EEA_June_2018_Desktop_Update
Assessment Date (on-site; non-EEA)	2015-01-07
Kitchen Type	Full Kitchen
Cost Set:	2018
Building Name	Cuyahoga Falls High
Building IRN	7930
Building Address	2300 4th Street
Building City	Cuyahoga Falls
Building Zipcode	44221
Building Phone	(330) 926-3808
Acreage	9.90
Current Grades:	9-12
Teaching Stations	89
Number of Floors	3
Student Capacity	1823
Current Enrollment	1662
Enrollment Date	2009-04-20
Enrollment Date is the date in which the current enrollment was taken.	
Number of Classrooms	103
Historical Register	<b>NO</b>
Building's Principal	Ms. Allison Bogdan
Building Type	High

Cuyahoga Falls High School, which is not on the National Register of Historic Buildings, and originally constructed in 1922, is a three story, 304,476 square foot brick and stone school building located in a suburban residential setting. The existing facility features a conventionally partitioned design, and does not utilize modular buildings. The structure of the o

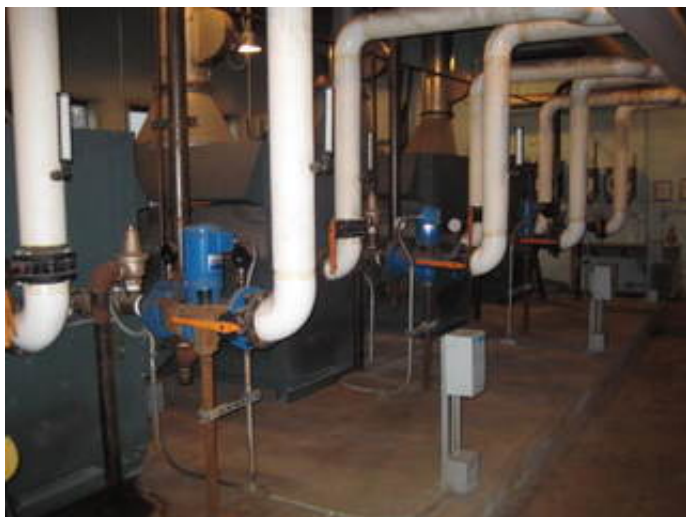
The existing system for the 1949 Addition is a natural gas fired heated water boiler type system, installed in 1949, and is in fair to poor condition. The systems in the 1922 Original Construction, 1922 and 1960 Auditorium Fixed Seating Areas, the 1927, 1960, and 1969 Additions, and the 1960 Board Offices are an extension of that found in the 1949 Addition. The heating and chilled water system for the 1960 Addition and the interior Classrooms of the 1922 Original Construction, is a 2-pipe system, without a capacity for simultaneous heating and cooling operation, which is not compliant with the OSDM requirements for basic system type. The heating system in the remainder of the overall facility is a 2-pipe system, with a capacity for only heating operation, which is not compliant with the OSDM requirements for basic system type. The four (4) heated water boilers, manufactured by Raypack, were installed in 1960 and are in fair to poor condition. Heating water is distributed to terminal units consisting of unit ventilators, cabinet heaters, unit heaters, air handlers, and heating fan convectors. The terminal equipment is original to each addition and is in fair condition. The system does not comply with the 15 CFM per person fresh air requirements of the Ohio Building Code mechanical code and Ohio School Design Manual. The pneumatic and electric type system temperature controls were installed in 1960 with incremental upgrades and are in fair condition. The system does feature individual temperature controls in all spaces required by the OSDM. The overall system does not feature any central energy recovery systems. The facility is not equipped with louvered interior doors to facilitate Corridor utilization as return air plenums. See Items J and O for replacement of doors. The existing systems in the 1922 and 1960 Auditorium Fixed Seating Areas, 1960 Addition and the interior Classrooms of the 1922 Original Construction are ducted, but the ductwork cannot be integrated into a possible future system due to arrangement, air volume, and routing of existing ductwork. The existing systems in the remainder of the overall facility are not ducted, and floor to structural deck heights will accommodate the installation of properly sized ductwork for a future Ohio School Design Manual approved system. The overall heating system is evaluated as being in safe and but inefficient working order, and long term life expectancy of the existing system is not anticipated. The structure is partially equipped with a central air conditioning system. The site does not contain underground fuel tanks.

Natrual Gas Fired Heated Water Boilers

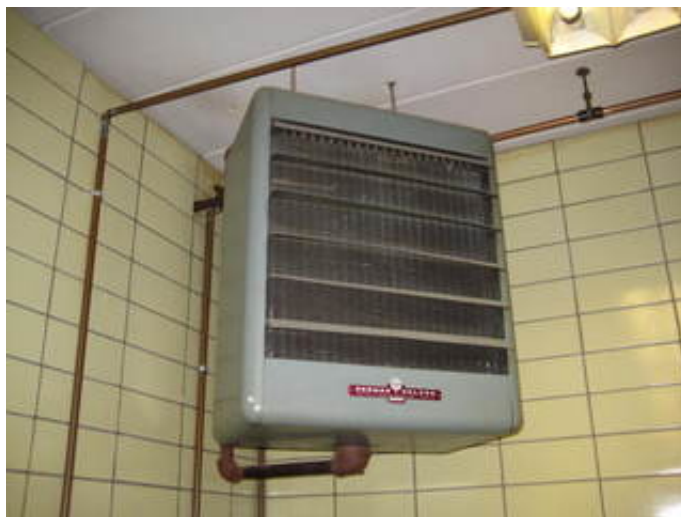
Heating Water Unit Heater

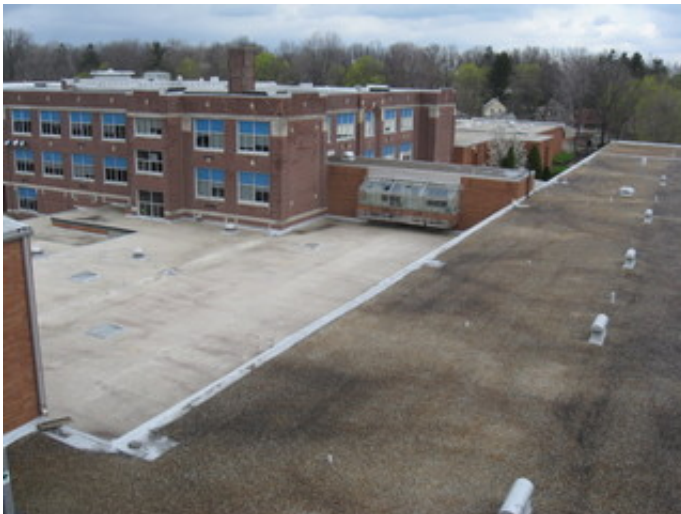
Roofs Over The 1960 Addition

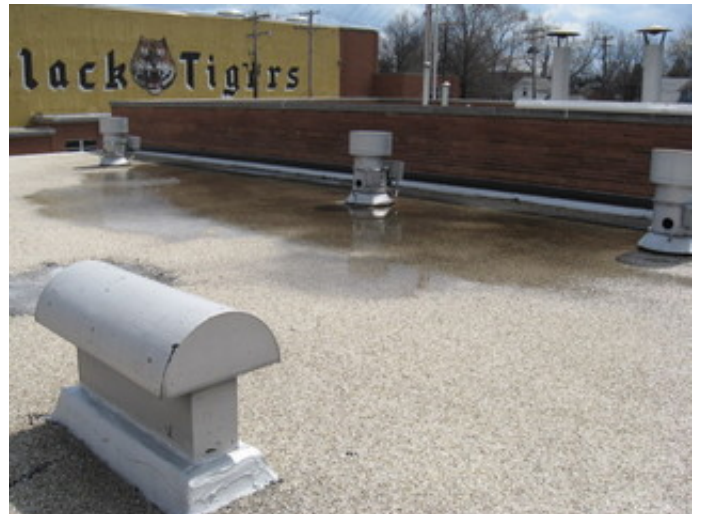
Ponding Water Over The 1927 Addition

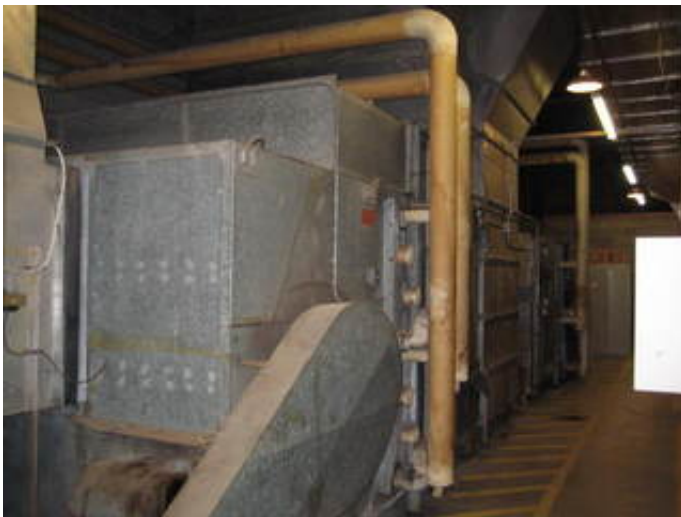
CAV Air Handler Unit

**Recommendations:** Provide an air conditioning system to meet with Ohio Building Code and Ohio School Design Manual requirements. Pricing included in Item A. Replace the existing general building exhaust system. Replace the existing Art Program kiln ventilation system due to age and condition. Replace the existing Wood Shop Program dust collection system due to age, condition, and insufficient capacity. Replace the existing Art Program paint hood exhaust system due to age, condition, and insufficient capacity. 06-22-18 Assessment Update: Delete general building exhaust. Provide for proper exhaust system for kiln.

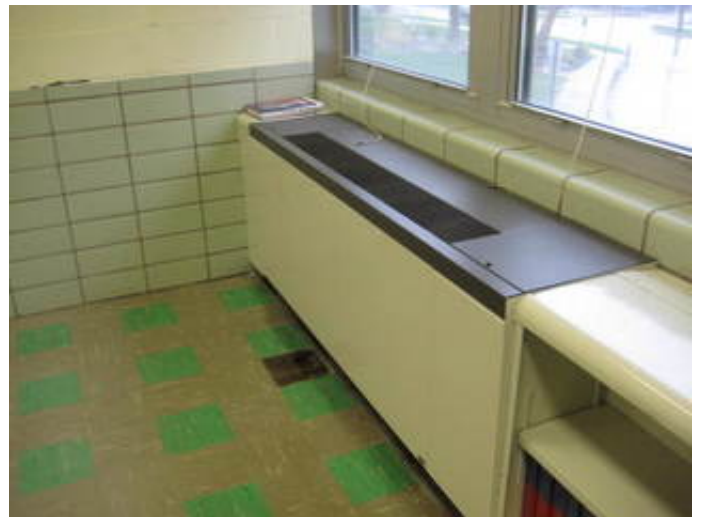
Unit Ventilator

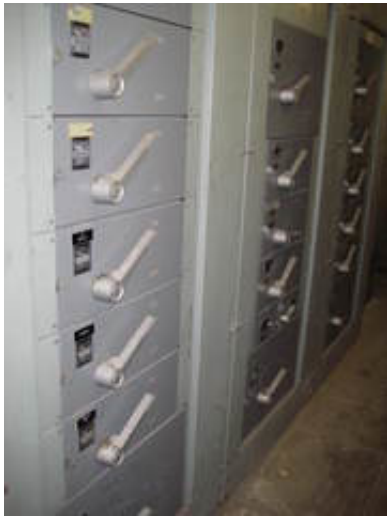
Main Electrical Distribution Panel

**Recommendations:** The entire electrical system requires replacement to meet Ohio School Design Manual guidelines for overall capacity and Classroom capacity due to age, condition, lack of OSDM-required features, and to accommodate the addition of an air conditioning system. Provide an emergency generator, with funding included in the electrical system replacement. Provide adequate lightning protection safeguards in the overall facility, including associated grounding system, with funding included in the electrical system replacement. Provide control panel, dimmers, and breakers to support the Stage lighting system, with funding included in the electrical system replacement.

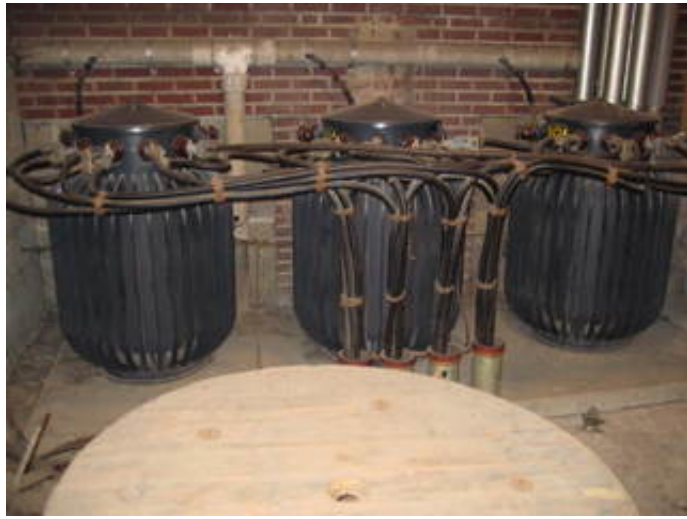
Pad Mounted Transformers

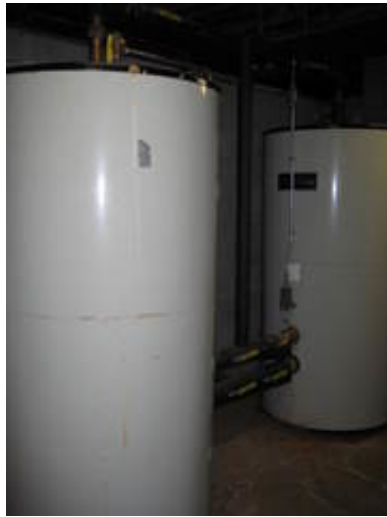
Domestic Hot Water Storage Tanks

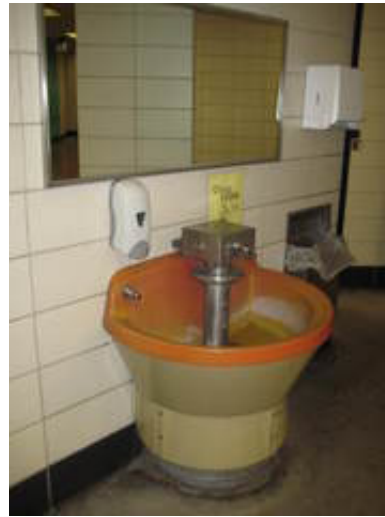
1922 Original Construction Restroom Lavatory

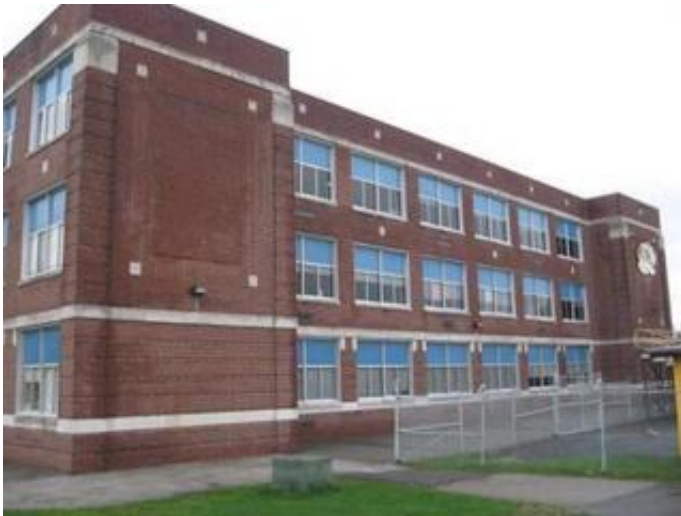
Typical Classroom Windows in the 1922 Original Construction

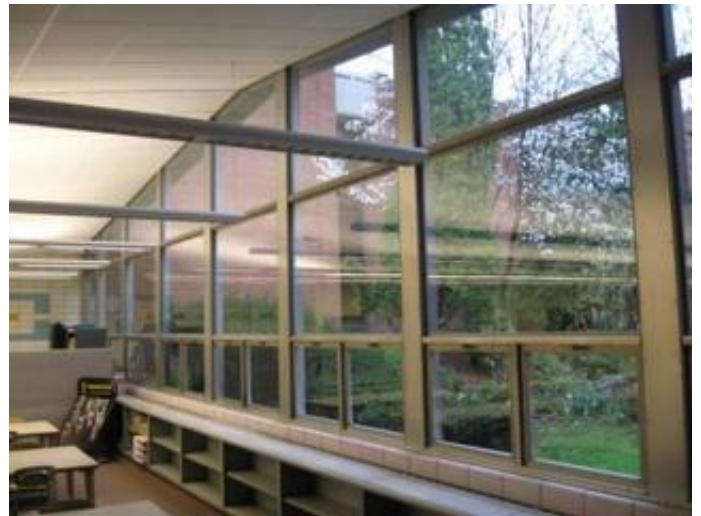
Media Center Window in the 1960 Addition

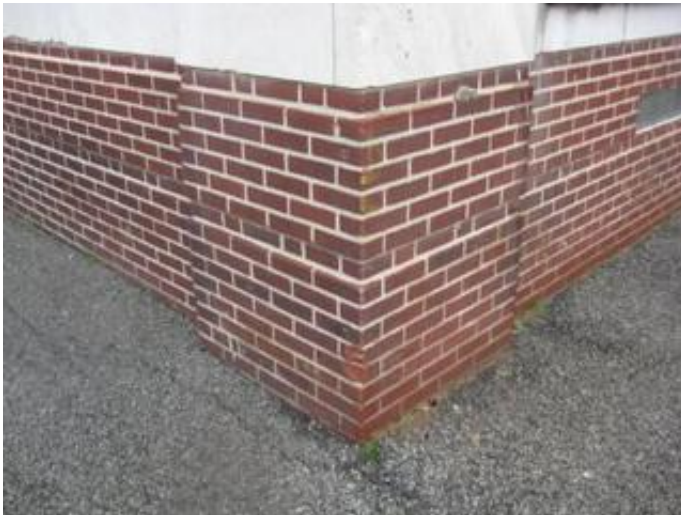
1922 Original Construction Exterior Wall at Grade

**Recommendations:** Address leaking issues in the 1922 Original Construction basement areas.

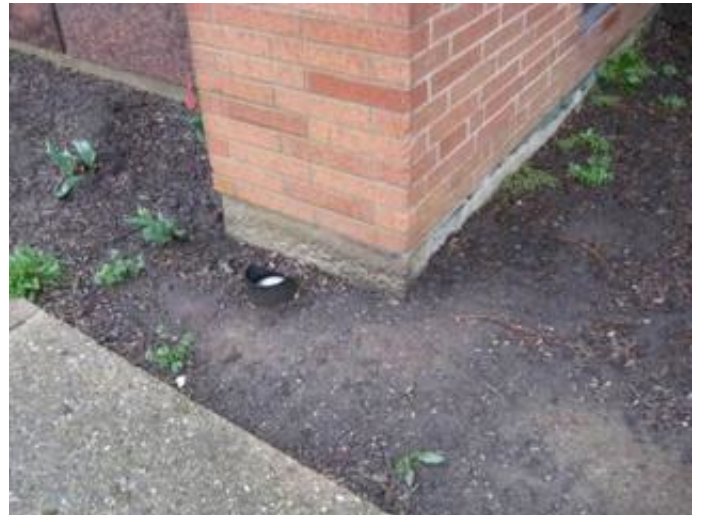
1960 Addition Exterior Wall at Grade

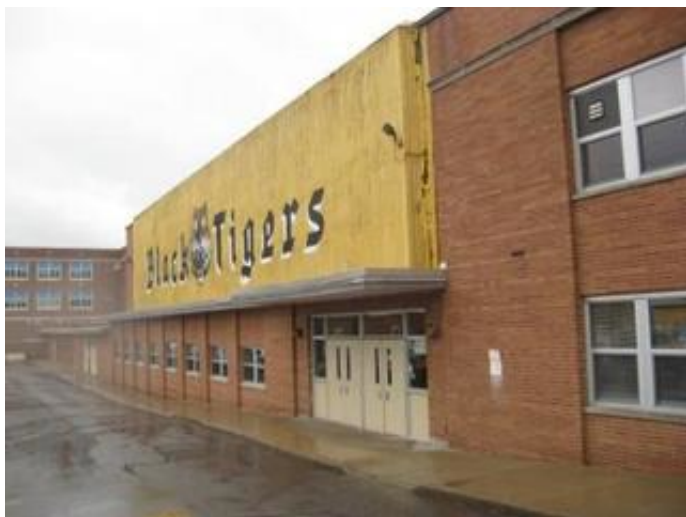
Exterior Wall of 1960 Addition Gymnasium Wall

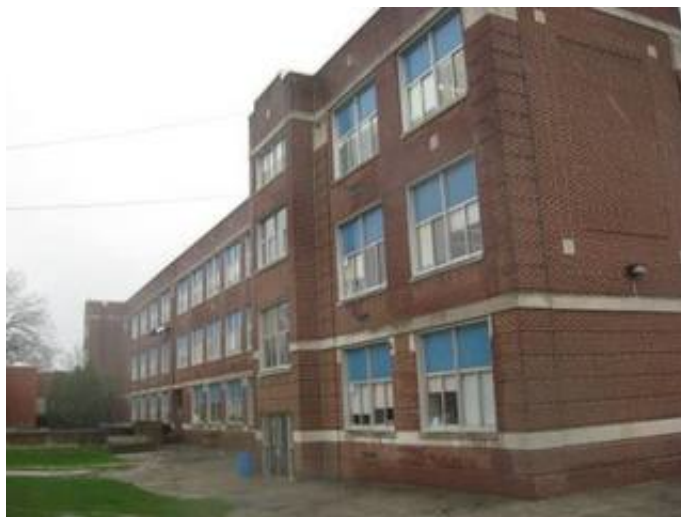
Exterior Walls of the 1922 Original Construction

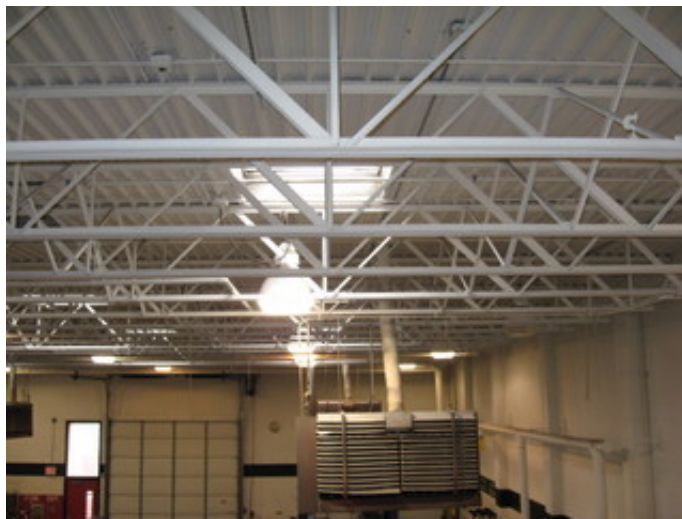
Roof Structure Of The 1969 Addition

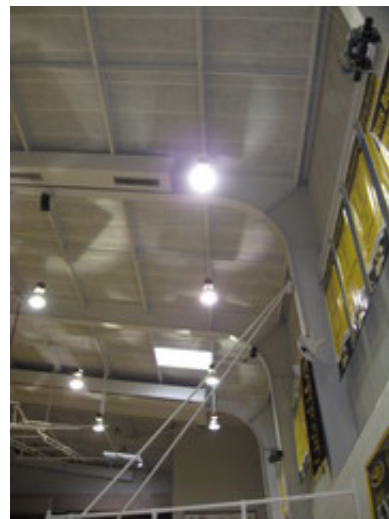
Roof Structure Of The Primary Gymnasium In The 1960 Addition

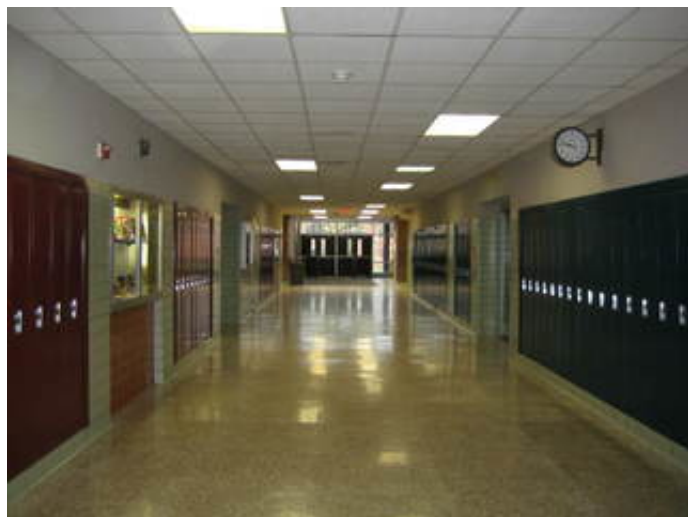
Corridor Finishes in the 1960 Addition

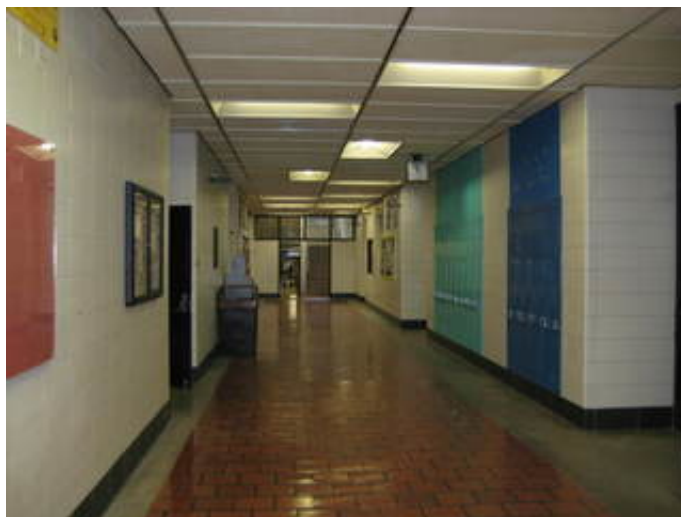
Corridor Finishes in the 1922 Original Construction

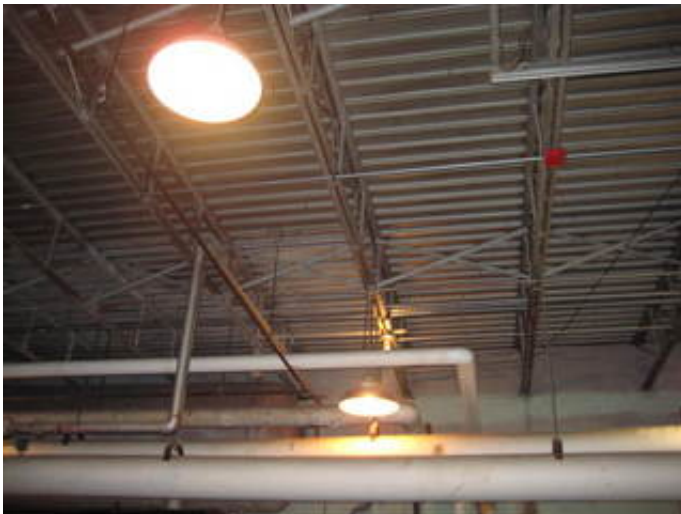
Service Area Pendant Incandescent Light Fixture

Provide complete replacement of lighting system due to age, condition, inadequate lighting levels, lack of multilevel switching, the utilization of incandescent fixtures, the utilization of T-12 fixtures, and installation of systems outlined in Items A, C, J, and U.

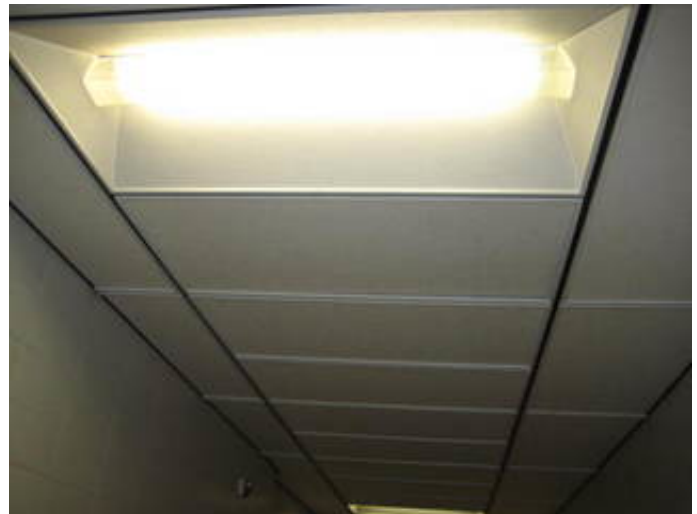
1922 Original Construction Corridor Fluorescent Light Fixture

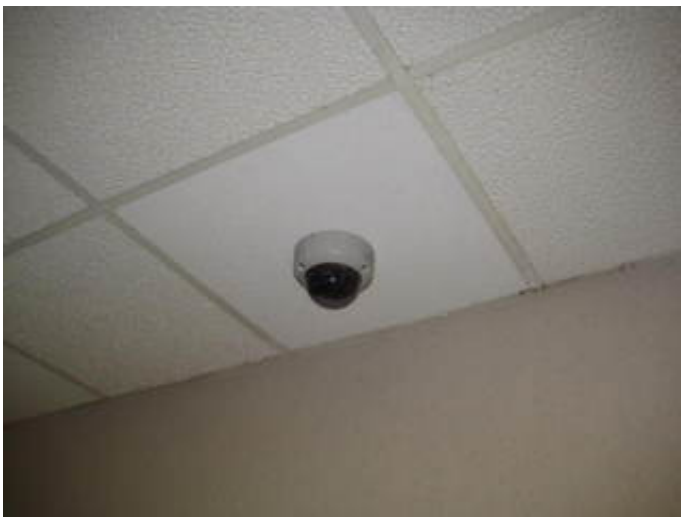
Security System CCTV Camera

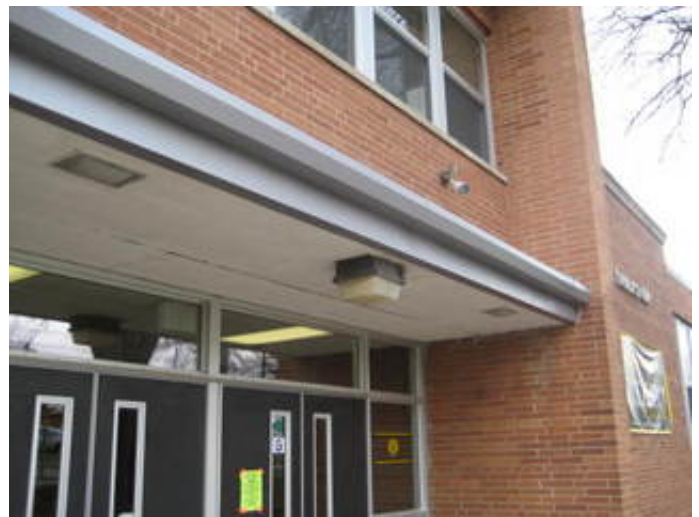
Surface Mounted HID High Pressure Sodium Entry Light Fixture

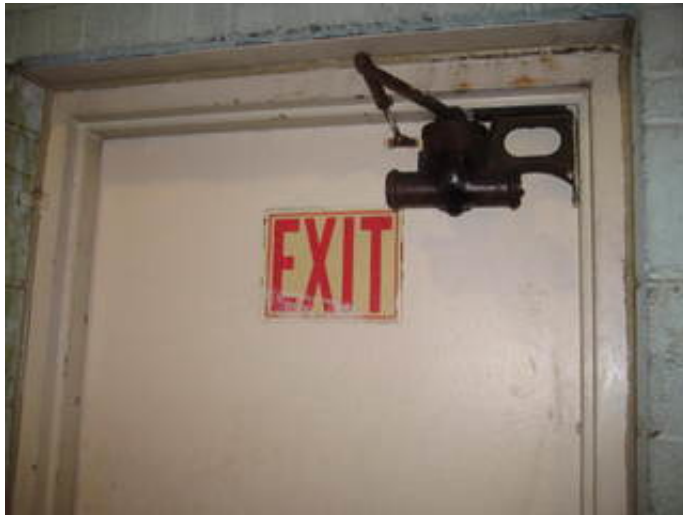
Non-compliant Exit Sign

**Recommendations:** Provide complete replacement of emergency / egress lighting system to meet Ohio School Design Manual guidelines.

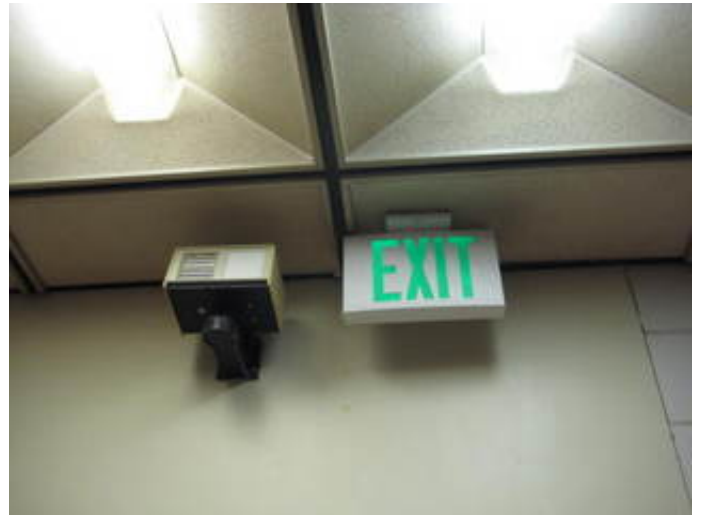
Non-compliant Green Lettered Illuminated Exit Sign

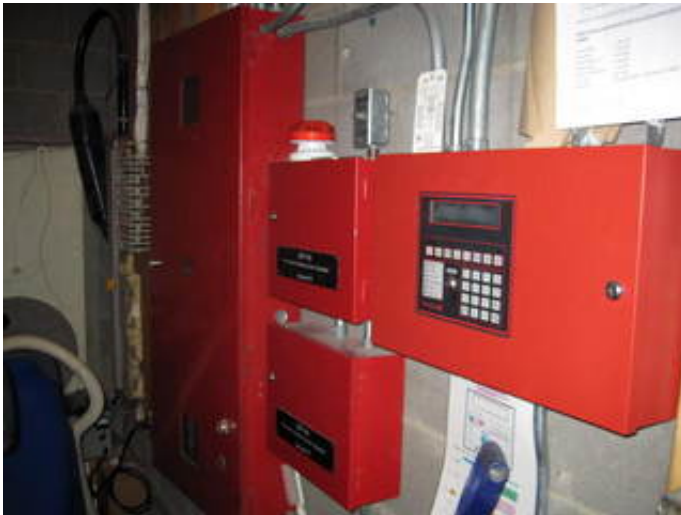
Fire Alarm, System Control Panels

**Recommendations:** Provide complete replacement of fire alarm system to meet OBC, NFPA, and Ohio School Design Manual guidelines.

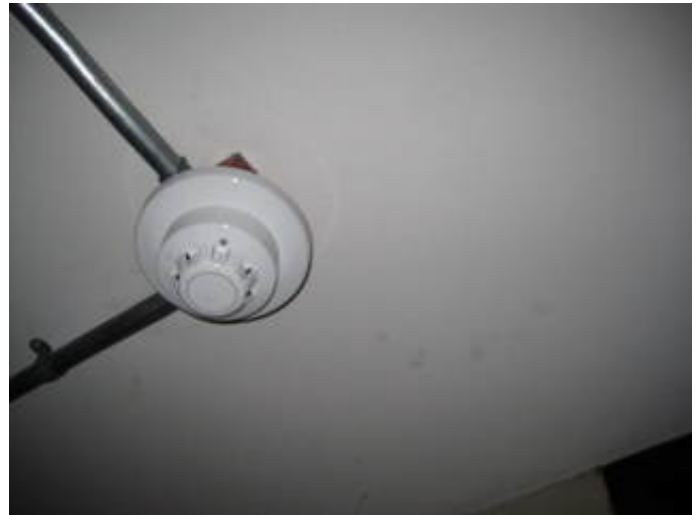
Fire Alarm System Smoke Detection Device

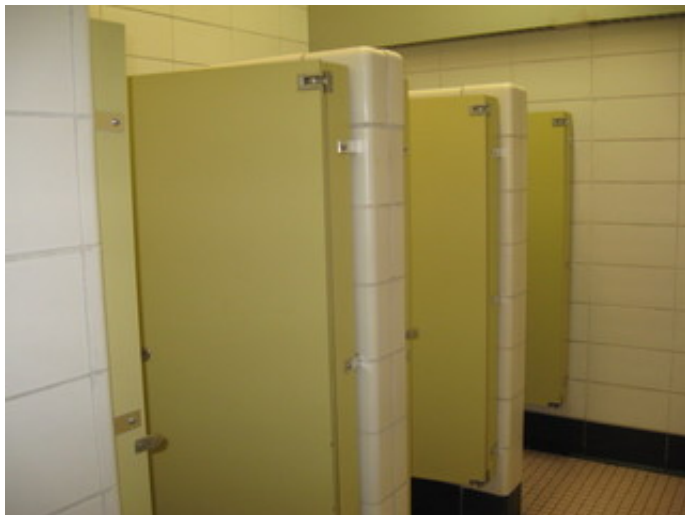
Typical Girl's Large Restroom In The 1922 Original Construction

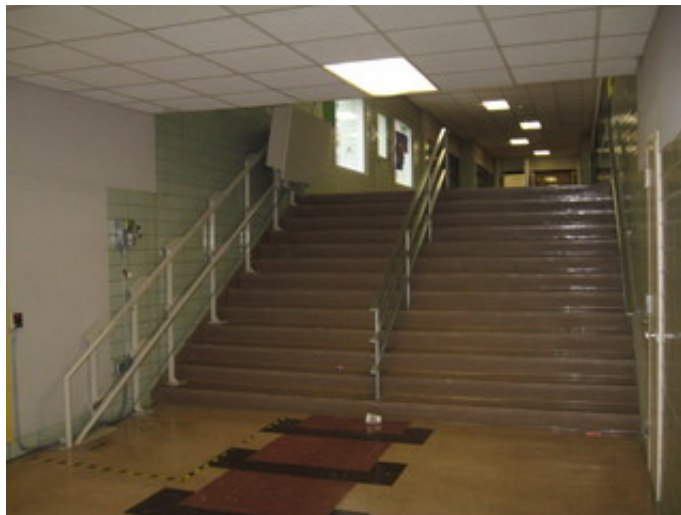
Chair Lift In The 1960 Addition

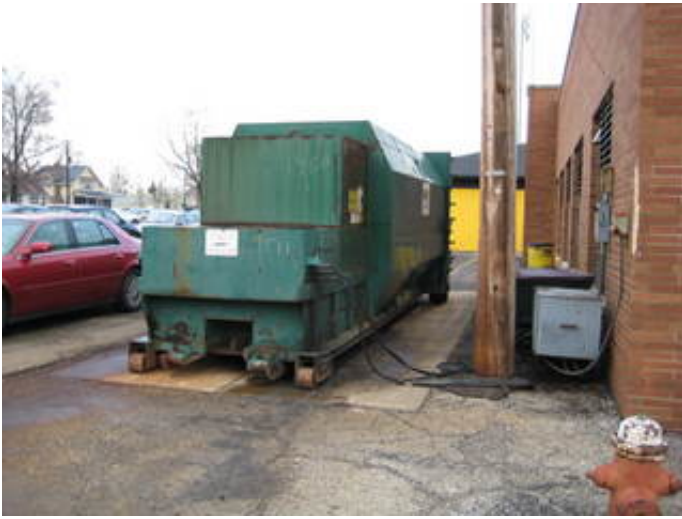
Concrete Dumpster Pad

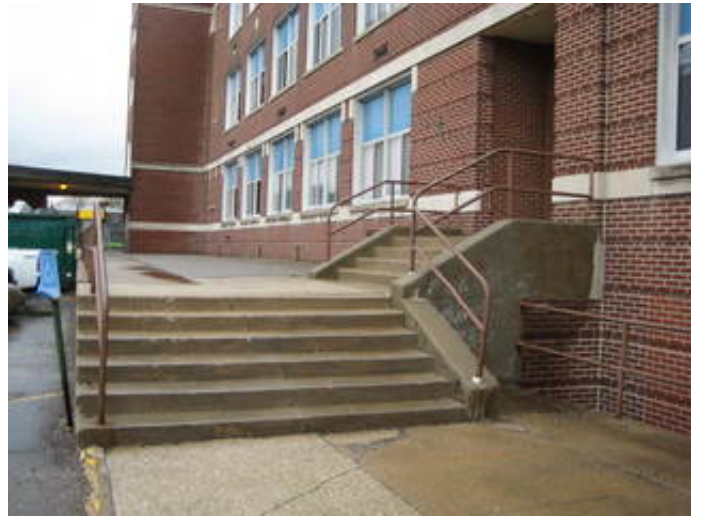
Exterior Stairs and Handrails

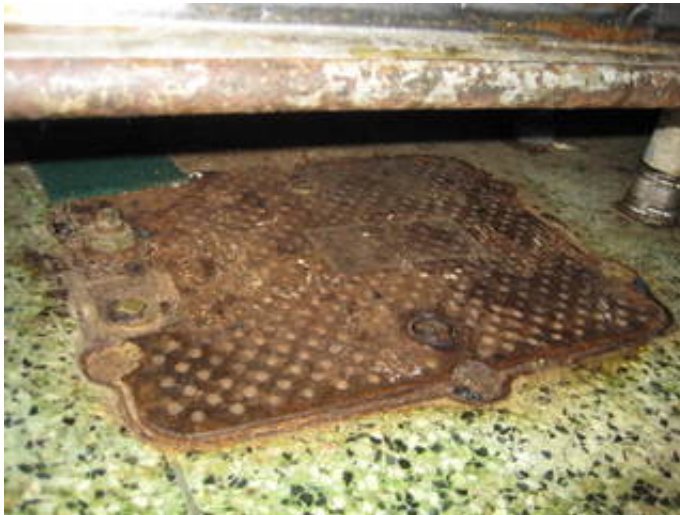
Kitchen Grease Trap Interceptor

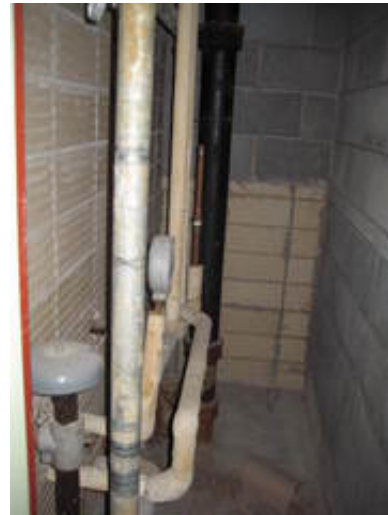
Sanitary Waste Piping

**Recommendations:** Existing conditions require no renovation or replacement at the present time. 06-22-18 Assessment Update: Replace main sanitary sewer lines from building to street to include new manholes.

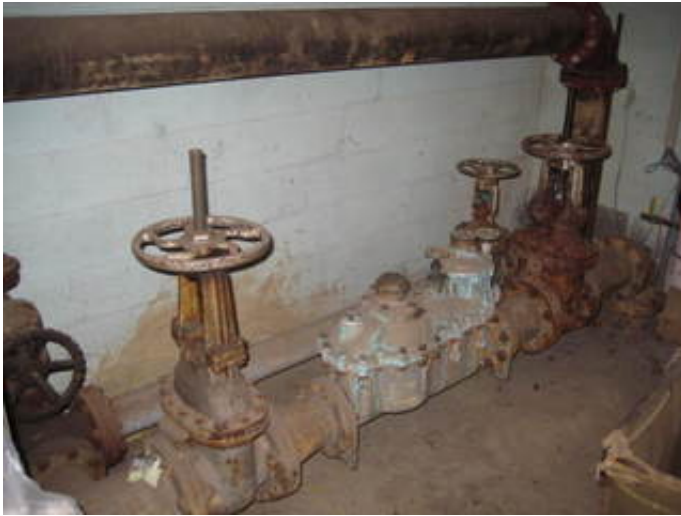
Incoming Domestic Water Service Line

**Recommendations:** Provide a new city water supply line of adequate capacity to support the existing needs of the facility, as well as a future automated fire suppression system. Funding provided in Item U.

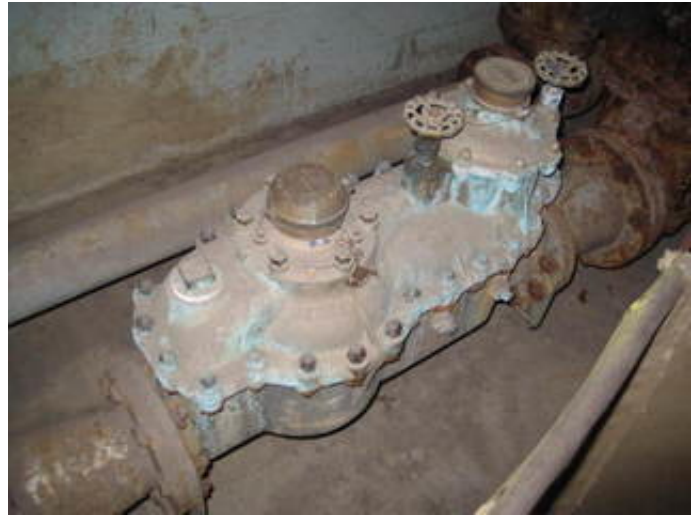
Incoming Domestic Water Service Meter

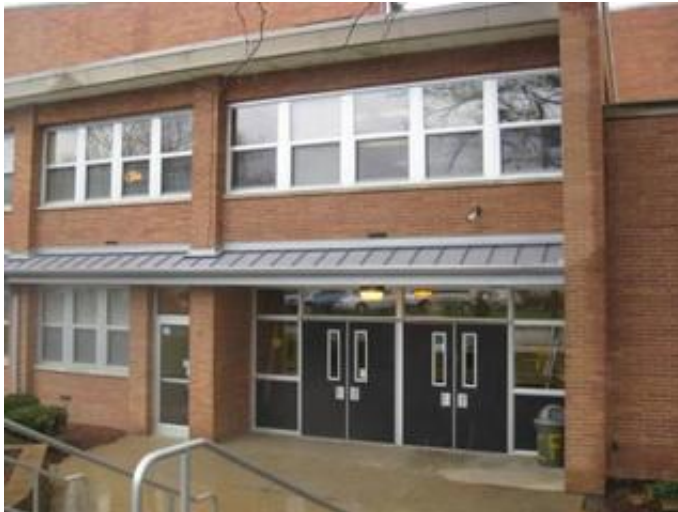
Typical Entrance Doors in the 1960 Addition

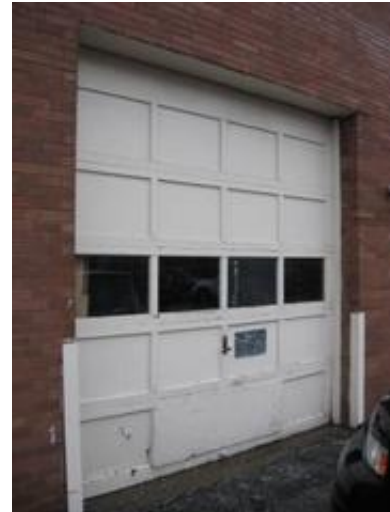
Overhead Door in the 1949 Addition

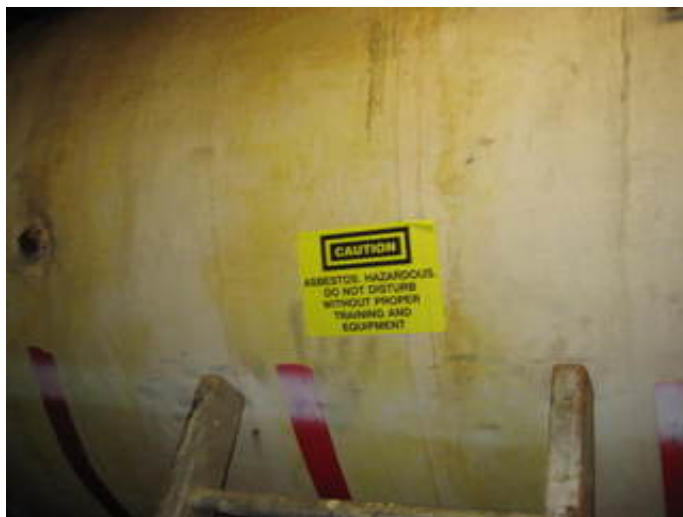
Tank Breaching

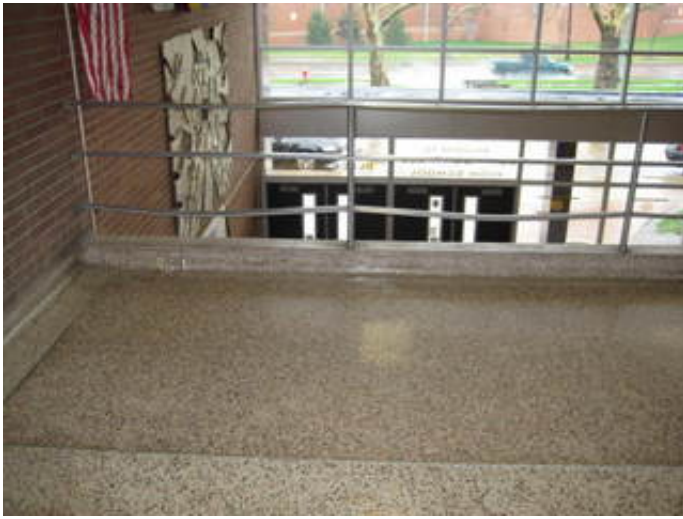
Non-compliant Guardrail

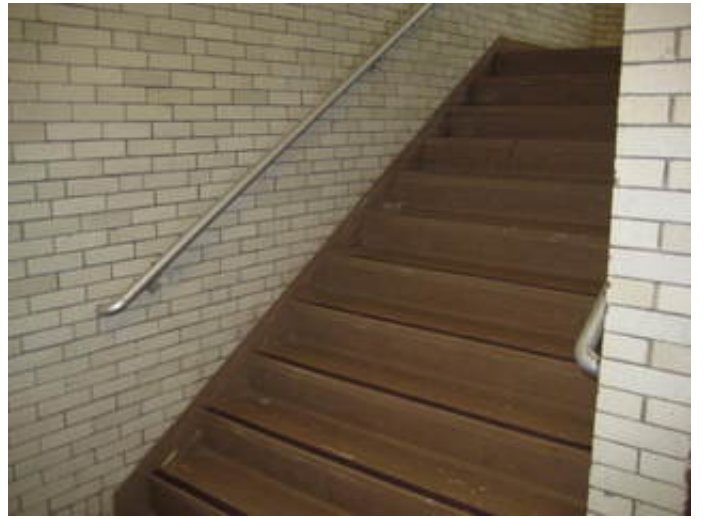
Non-compliant Handrail

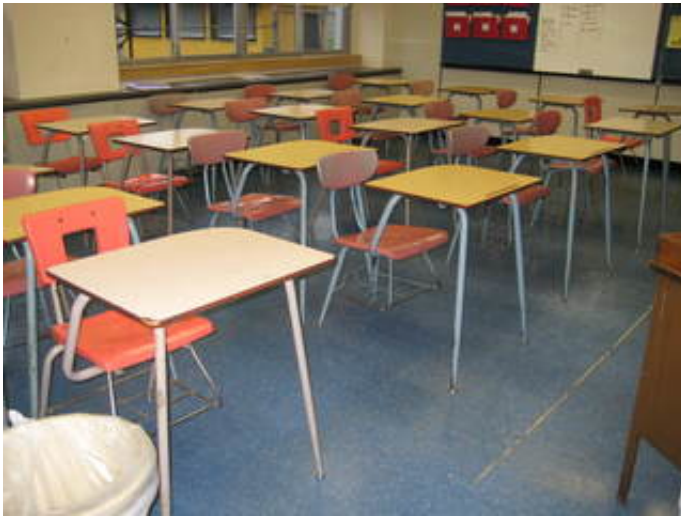
Typical Student Desks

**Recommendations:** Provide for replacement of outdated or inadequate furnishings.

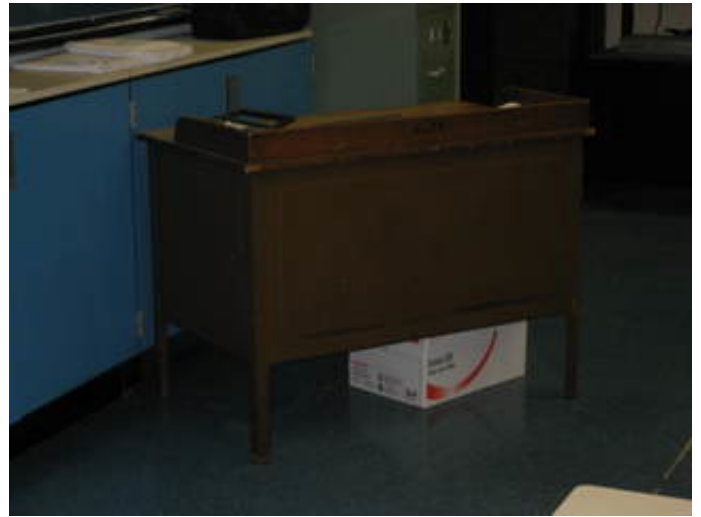
Typical Teacher's Desk

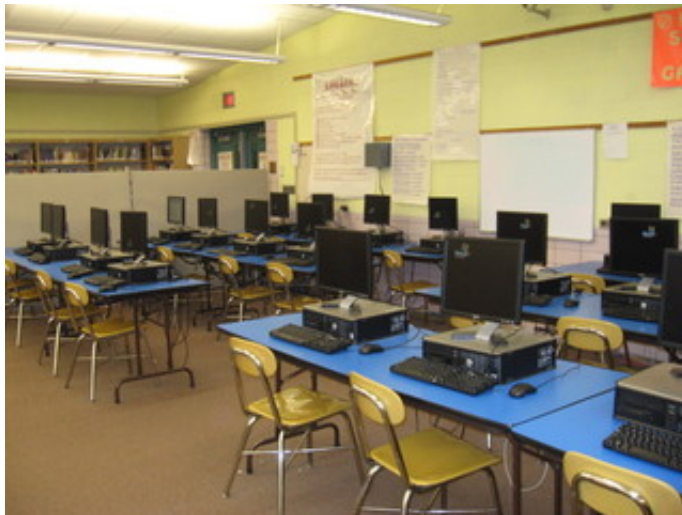
Student Computer Lab In The 1960 Addition

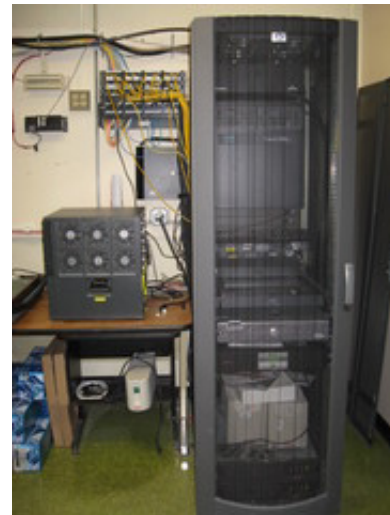
Non-Compliant Computer Network Infrastructure In The 1960 Addition
