Building Information - Cuyahoga Falls City (43836) - Dewitt Elementary

Gordon DeWitt Elementary School, which is not on the National Register of Historic Buildings, and originally constructed in 1968, is a 2 story, 50,520 square foot brick school building located in a suburban residential setting. The existing facility features a conventionally partitioned design, and does not utilize modular buildings. The structure of the overall facility contains brick veneer on a masonry bearing wall system type exterior wall construction, with concrete masonry units and operable partition walls type wall construction in the interior. The base floor system of the overall facility is concrete slab-on-grade type construction. The second floor system of the overall facility consists of precast concrete planks with concrete topping. The roof structure of the overall facility is precast concrete planks with concrete topping. The roofing system of the overall facility an asphalt built-up roof with gravel wear coat that was installed in 1999. The ventilation system of the building is inadequate to meet the needs of the users. The Classrooms are undersized in terms of the current standards established

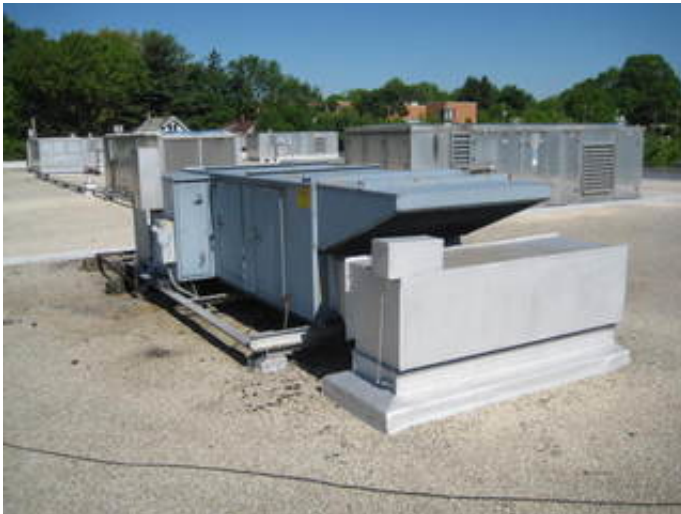
The existing system for the overall facility is a natural gas fired ducted packaged roof top HVAC unit type system, installed in 1968 with upgrades in 1999, and is in fair condition. 2-pipe vs. 4-pipe designations are not applicable in this facility, as no central air conditioning is provided. The overall facility is equipped with one (1) natural gas fired ducted heating & ventilating only roof top unit located on the Multi-Purpose Room (Student Dining / Gymnasium), installed in 1968 and in poor condition. Heated forced air is distributed to the Multi-Purpose Room (Student Dining / Gymnasium), Kitchen and Stage spaces via the ducted roof top unit. The remainder of the overall facility is equipped with four (4) natural gas fired ducted packaged HVAC roof top units, manufactured by Seasons-4, Inc., installed in 1999, and in good to fair condition. The overall facility is also equipped with other terminal units consisting of natural gas fired & electric unit heaters, installed in 1968, and in fair condition. The system does not comply with the 15 CFM per person fresh air requirements of the Ohio Building Code mechanical code and Ohio School Design Manual. The pneumatic type system temperature controls were installed in 1968 and are in fair condition. The system does not feature individual temperature controls in all spaces required by the OSDM. The overall system does not feature any central energy recovery systems. The facility is not equipped with louvered interior doors to facilitate Corridor utilization as return air plenums. The existing system is ducted, but the ductwork cannot be integrated into a possible future system due to arrangement, air volume, and routing of existing ductwork. The overall heating system is evaluated as being in safe but inefficient working order, and long term life expectancy of the existing system is not anticipated. The structure is equipped with a central air conditioning system, except for the Multi-Purpose Room (Student Dining / Gymnasium), Kitchen and Stage spaces. The site does not contain underground fuel tanks.

Natural Gas Fired Ducted Packaged HVAC Roof Top Unit

Provide new overall heating, ventilating, and air conditioning system to achieve compliance with Ohio Building Code and Ohio School Design Manual standards. Replace existing ductwork in the overall facility to facilitate efficient exchange of conditioned air with pricing included in conversion to ducted system replacement.

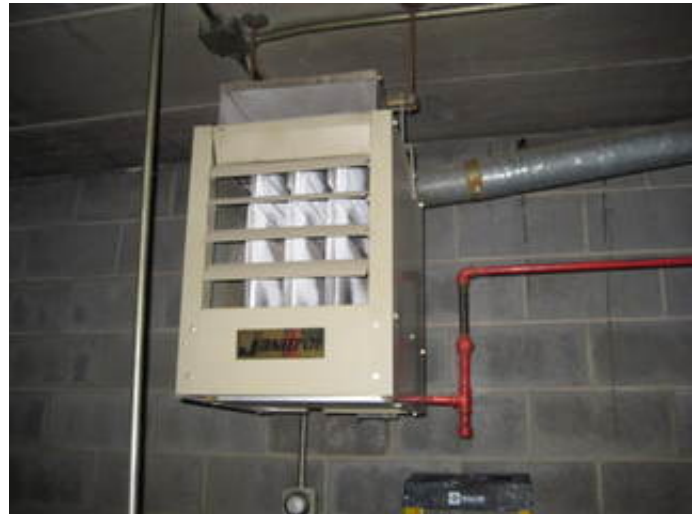
Heated Air Unit Heater

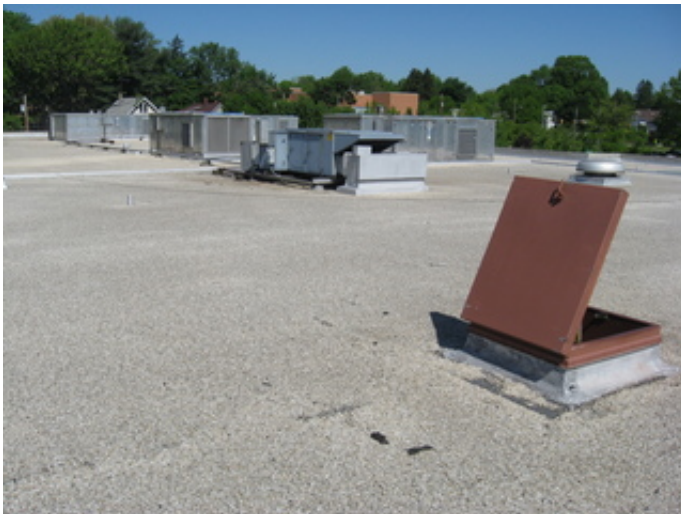
The roof over the overall facility is an asphalt built-up roof with gravel wear coat that was installed in 1999, and is in fair condition. There are no District reports of current leaking. Signs of past leaking were observed during the physical assessment. Access to the roof was gained by access roof hatch and interior access ladder that are in good condition. Fall safety protection cages are not required, and are not provided. There were observations of standing water on the roof. Metal cap flashings are in good condition. Roof storm drainage is addressed through a system of roof drains, which are improperly located, and in good condition. The roof is not equipped with overflow roof drains, though they are needed on this building except for the canopies and over the Multipurpose Room. No problems requiring attention were encountered with any roof penetrations. There are not any covered walkways attached to this structure. 06-22-18 Assessment Update: It was reported by district personnel, and observed, the original roof area was not removed prior to installing the current roof system. Therefore, additional tear-off costs required. Additional roof insulation required to meet LEED energy efficiency requirements. 2017 new roof membrane was installed over portions of the building (gym, media center, art classroom); however, due to these roofs also being a "recovery system" (i.e.; insulation and membrane installed over existing roof). Therefore, to meet energy efficiency requirements of LEED and provide for a better long term solution, those roof areas should receive complete tear-off and re-roofed, and as a result, there is no change to rood area to be replaced. Also, additional roof insulation should be provided to meet LEED energy efficiency requirements.

Typical Roof Over the Overall Facility

The roof over the overall facility requires replacement to meet Ohio School Design Manual guidelines for age of system and due to condition. 06-22-18 Assessment Update: Provide for additional roof tear-off due to recovery roof system installed over existing roof. Provide for additional roof insulation to meet LEED energy efficiency requirements.

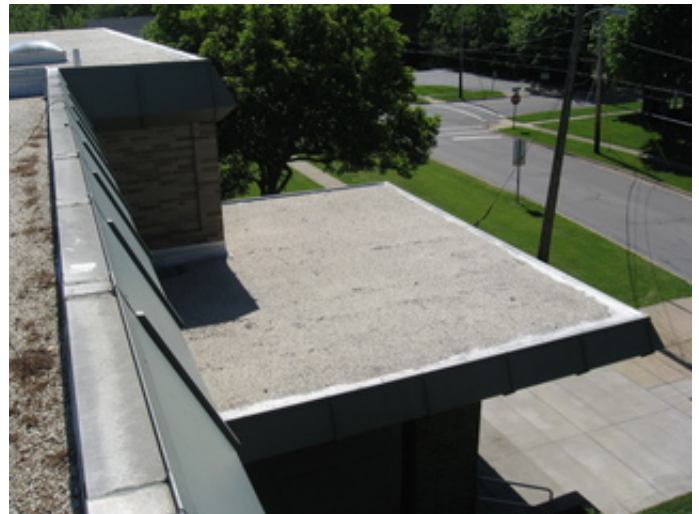
Typical Canopy and Fascia

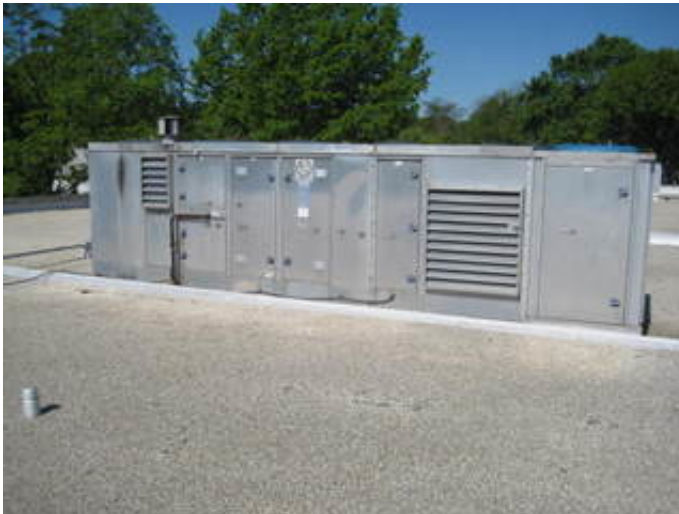
Description: The overall facility, except for the Multi-Purpose Room (Student Dining / Gymnasium), Kitchen and Stage spaces, is equipped with a ducted packaged roof top HVAC unit type central air conditioning system, which was installed in 1968 with upgrades in 1999, and is in good to fair condition. The four (4) packaged roof top HVAC units, manufactured by Seasons-4, Inc., were installed in 1999, and are in good to fair condition. The overall facility is not equipped with any window units or isolated room systems. The ventilation system in the overall facility consists of air handlers, installed in 1968 and in fair to poor condition, providing fresh air to Classrooms and other miscellaneous spaces such as the Multi-Purpose Room (Student Dining / Gymnasium) and Media Center. Relief air venting is provided by air handlers, ceiling plenums, the ducted heating & ventilating only roof top unit, the ducted packaged roof top HVAC units, and central relief fans. The ventilation system does not meet the Ohio Building Code 15 CFM per occupant fresh air requirement. The overall system is not compliant with Ohio Building Code and Ohio School Design Manual requirements. Dust collection systems are not required in this facility. Exhaust systems for Restrooms, Storage Rooms, Custodial Closets, Telecommunications Rooms, Maintenance Workrooms, Locker Rooms, Kitchen Dry Food Storage, P.E. Workroom & Storage, Art Material Storage, and Art Rooms are inadequately placed, and in fair condition. The Art Program is not equipped with a kiln. 06-22-18 Assessment Update: General building exhaust is included in Item A and should not be included in this line item.

Ducted Pakaged Roof Top HVAC Unit

Recommendations: Provide an air conditioning system to meet with Ohio Building Code and Ohio School Design Manual requirements. Pricing included in Item A. Replace the existing general building exhaust system. Provide the existing Art Program the required kiln ventilation system, with kiln pricing to be included in Item J. 06-22-18 Assessment Update: Delete general building exhaust.

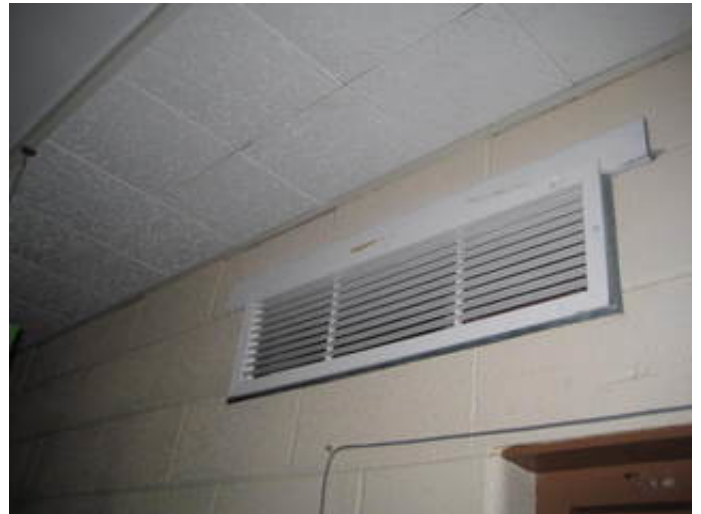
HVAC Wall Grille

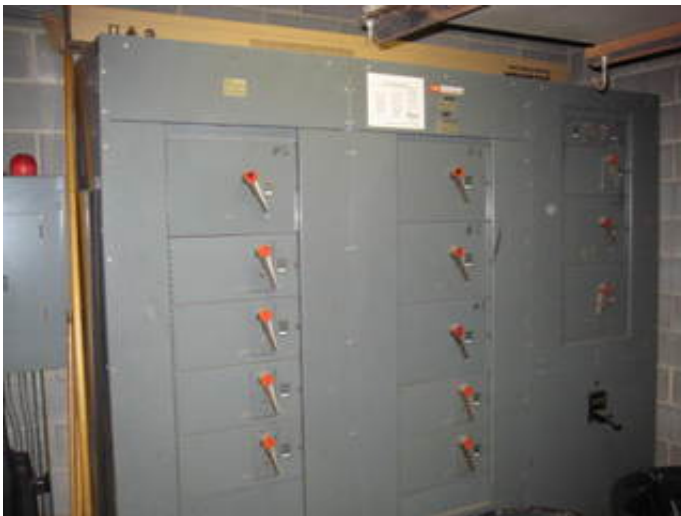
Description: The electrical system provided to the overall facility is a 120/208 volts, 1600 amp, 3 phase and 4 wire system installed in 1968, and is in fair condition. Power is provided to the school by multiple City of Cuyahoga Falls owned, pad-mounted transformers located in a Mechanical Room, and in fair condition. The panel system, installed in 1968, is in fair condition, and cannot be expanded to add additional capacity. The Classrooms are not equipped with adequate electrical outlets. The typical Classroom contains four (4) general purpose outlets, zero (0) dedicated outlets for each Classroom computer, and one (1) dedicated outlet for each Classroom television. Some Classrooms are equipped with as many as five (5) general purpose outlets, while others are equipped with as few as three (3) general purpose outlets. There are not any spaces that have no electrical outlets. The Corridors are not equipped with adequate electrical outlets for servicing. Adequate GFI protected exterior outlets are not provided around the perimeter of the building. The facility is not equipped with an emergency generator. Adequate lightning protection safeguards are not provided. Stage lighting power system including control panel, breakers, and dimmers is inadequately provided, in fair to poor condition and does not meet OSDM requirements. The overall electrical system does not meet Ohio School Design Manual requirements in supporting the current needs of the school, and will be inadequate to meet the facility's future needs.

Main Electrical Distribution Panel

Recommendations: The entire electrical system requires replacement to meet Ohio School Design Manual guidelines for overall capacity and Classroom capacity due to age, condition, lack of OSDM-required features, and to accommodate the addition of an air conditioning system. Provide an emergency generator, with funding included in the electrical system replacement. Provide adequate lightning protection safeguards in the overall facility, including associated grounding system, with funding included in the electrical system replacement. Provide control panel, dimmers, and breakers to support the Stage lighting system, with funding included in the electrical system replacement.

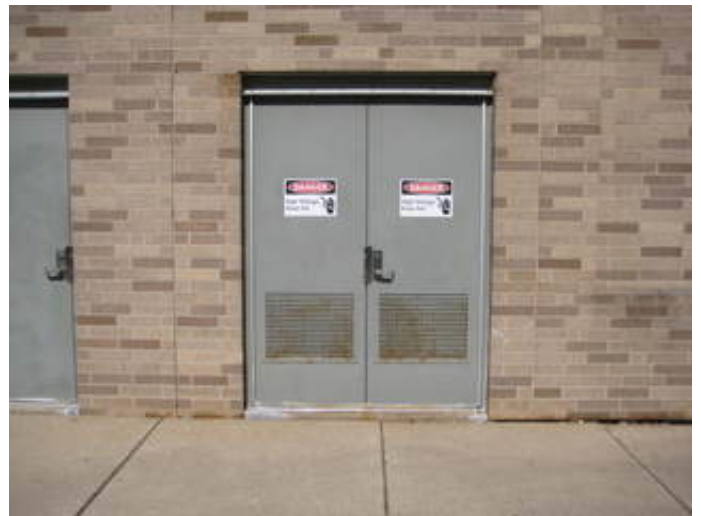
Pad Mounted Transformer Room

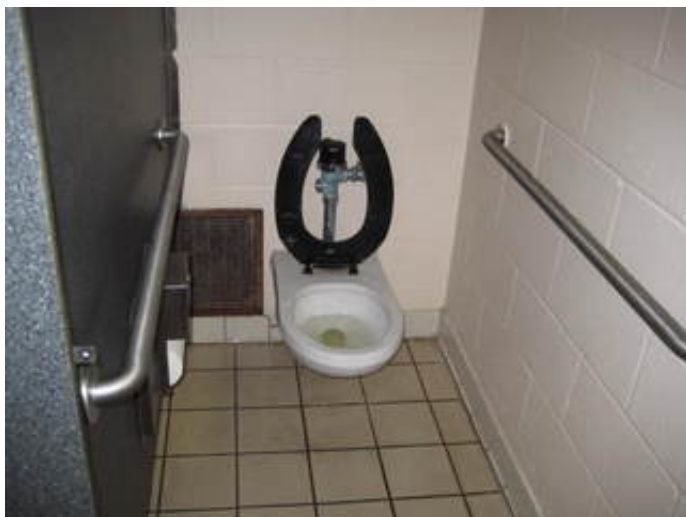
ADA Compliant Wall Hung Flush Valve Toilet

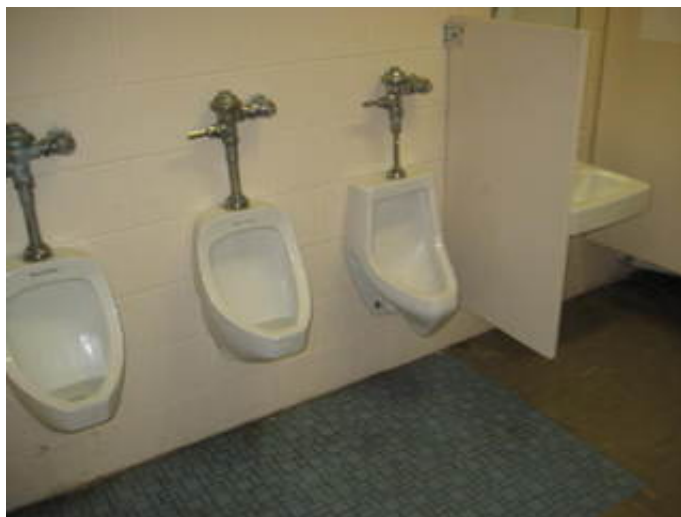
Wall Hung Flush Valve Urinals

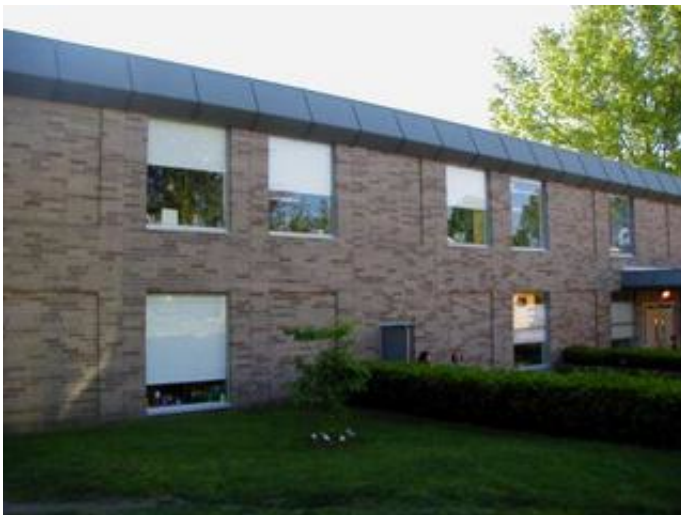
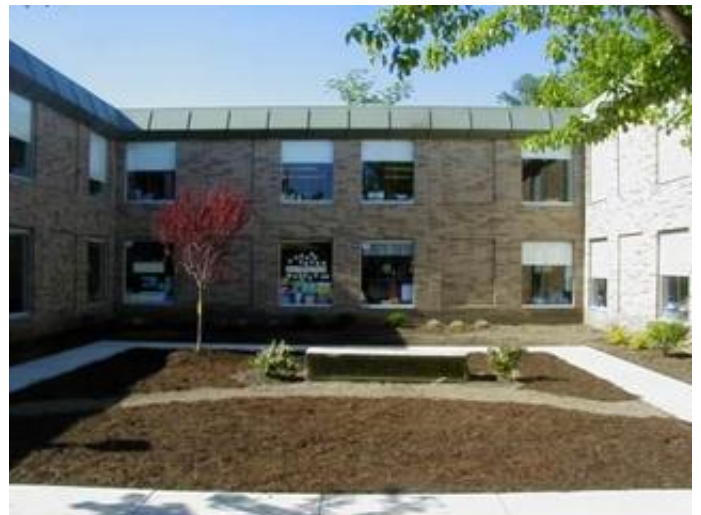
Description: The overall facility is equipped with non-thermally broken aluminum frame windows with single glazed type window system, which was installed in 1968, and is in fair condition. Window system seals are in fair condition, with minimal air and water infiltration being experienced. Window system for the overall facility is equipped with fixed units with no operable hardware. The window system features surface mounted shades and blinds, which are in good to fair condition. The window system is not equipped with insect screens. This facility is not equipped with any curtain wall systems. This facility does not feature any glass block windows. The exterior doors in the overall facility are equipped with thermally broken aluminum frame sidelights and transoms with single pane glazing, in good condition. The school does contain four acrylic bubble type skylights on aluminum frames which are in poor condition. Window security grilles are not provided for ground floor windows. There is not a Greenhouse associated with this school.

Typical Exterior Windows in the 1968 Original Construction

Recommendations: Provide a new insulated window system with integral blinds to meet with Ohio School Design Manual requirements. Replace single pane glazing in transoms, sidelights and vision panels in exterior doors of the overall facility with new insulated safety glass. Replace all skylights in the overall facility.

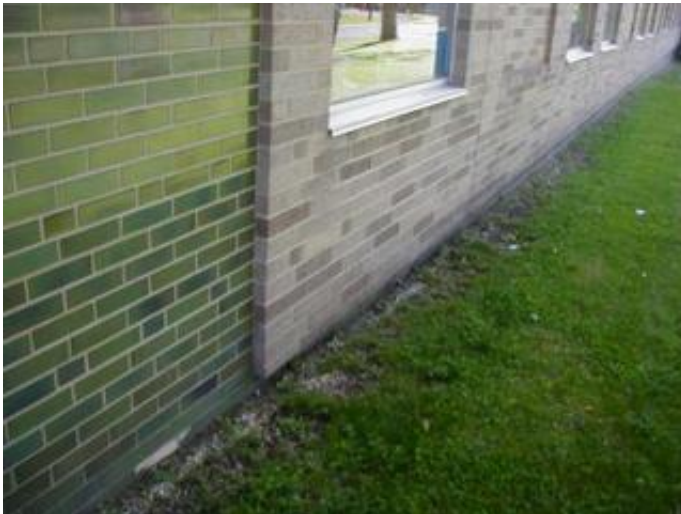
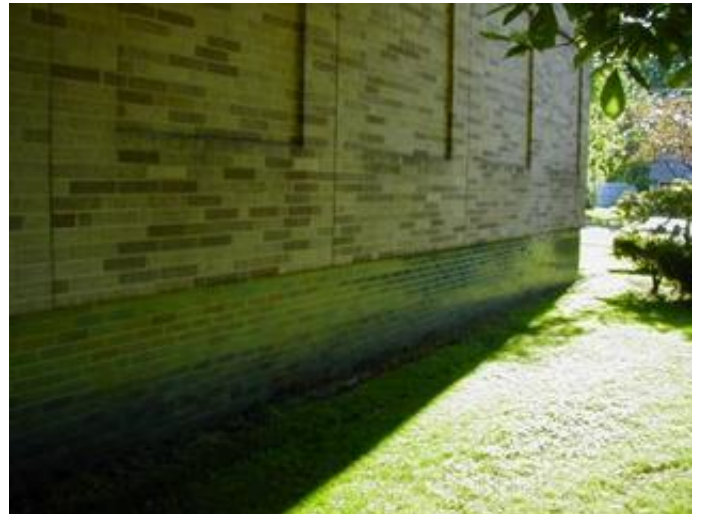
Description: The overall facility is equipped with concrete masonry unit concrete foundation walls on concrete footings, which displayed no location of significant differential settlement, cracking, or leaking on the exterior of the building, and are in good condition. Separation cracks were observed at junctures of two interior masonry walls and adjacent floor areas located in the Multi-Purpose Room. The District reports that there has been no past leaking. No grading or site drainage deficiencies were noted around the perimeter of the structure that are contributing or could contribute to foundation or wall structural deterioration.

Exterior Wall Condition at Grade

Recommendations: Existing conditions require no repairs to the exterior foundation walls of the building at the present time. Provide for a structural testing and study of interior masonry foundation issues in the Multi-Purpose Room. Address interior foundation issues.

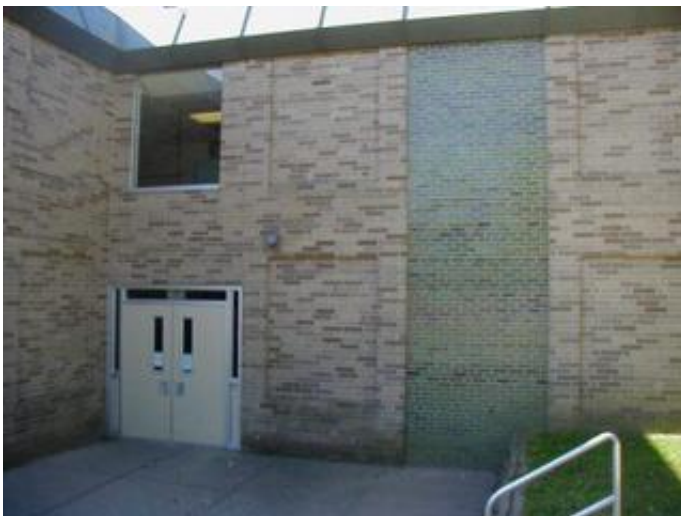
Description: The overall facility is brick veneer on a masonry bearing wall system, which displayed locations of deterioration at intersections of exterior masonry building walls and masonry retaining and planter walls. All exterior planter and retaining walls should be replaced. The exterior masonry appears to have appropriately spaced and inadequately caulked control joints in good to fair condition. Control joints are not provided at lintel locations at doors and windows. The exterior masonry has not been cleaned and sealed in recent years, and shows evidence of mortar deterioration at retaining and planter walls and has locations of discoloration due to moisture and pollution. Architectural exterior accent materials consist of glazed face brick in good condition. Interior walls are concrete masonry units and operable partition walls. Concrete masonry walls are in good to fair condition. Operable partition walls are in fair condition. Interior masonry appears to have adequately spaced and caulked control joints in good condition. There are no exterior soffits at the facility. The window sills are an element of the aluminum window system, and are in good to fair condition and will be replaced as part of the window replacement work included in Item F. The exterior lintels are steel, rusting and in good to fair condition. The chimney is in good condition. Canopies over entrances are masonry and plaster type construction, and in good condition. A loading dock has not been provided to facilitate unloading of trucks and receipt of product / supplies / foodstuffs. The school has sufficient expansion joints, and they are in good condition. 06-22-18 Assessment Update: Steel angle shelf above glazed brick watermark banding supporting face brick above is rusting and should be scraped, primed and painted. Steel lintels above infill reveal at South elevation are deteriorated and delaminating and should be replaced.

Typical Exterior Masonry Bearing Walls

Recommendations: Provide masonry cleaning, sealing and caulking as required through the overall facility. Recaulk existing control joints. Replace existing masonry retaining and planter walls through the overall facility. Repair interior masonry as required through the overall facility. Prep and paint exterior steel lintels through the overall facility. Replacement of operable partition walls is addressed in Item J. Re-caulk existing exterior control joints. H - Structures Walls and Chimneys: 10-02-14 Update: 4" glazed face brick watermark is below grade at NE corner of building (mechanical room) off 4th Street and glazed brick and lintel carrying corbel face brick wall panel is rusted and deteriorated. Provide allowance to excavate and repair below grade brick and replace lintel and rebuild corner. 06-22-18 Assessment Update: Scrape, prime and paint steel angle shelf above glazed brick watermark banding. Replace steel lintels above infill reveal at South elevation.

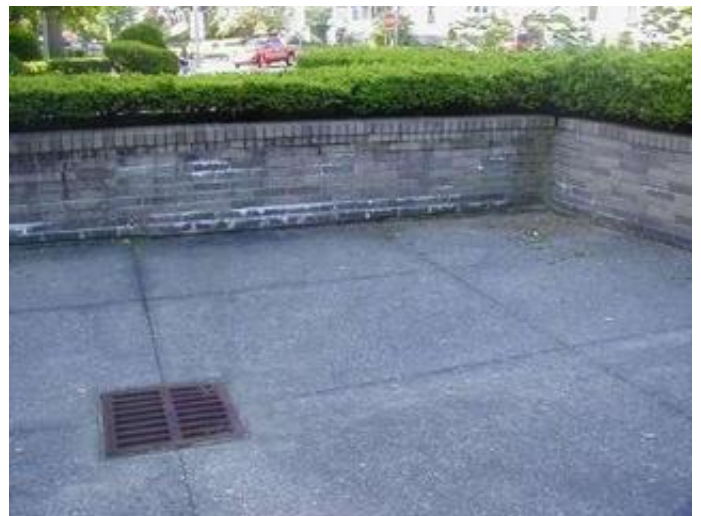
Typical Condition of Masonry Planter and Retaining Walls

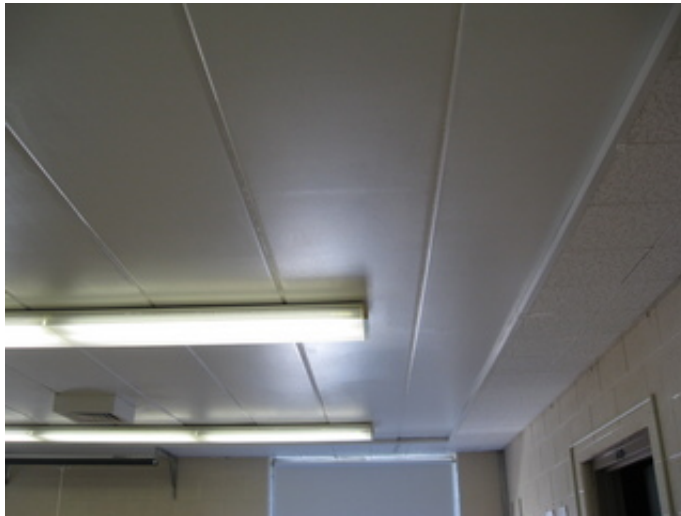
Description: The floor construction of the base floor of the overall facility is concrete slab-on-grade type construction, and is in good condition. There is no crawl space. The floor construction of the second floor of the overall facility is precast concrete planks with concrete topping type construction, and is in good condition, with only minor cracks telegraphing through the flooring in the Corridors that will be corrected in Item J. Ceiling to structural deck spaces are sufficient to accommodate HVAC, electrical, and plumbing scopes of work in required renovations. Existing floor to ceiling height will accommodate dropping the ceiling to provide room for new work. The roof construction of the overall facility is precast concrete planks with concrete topping type construction, and is in good condition.

Second Floor Precast Plank Structure

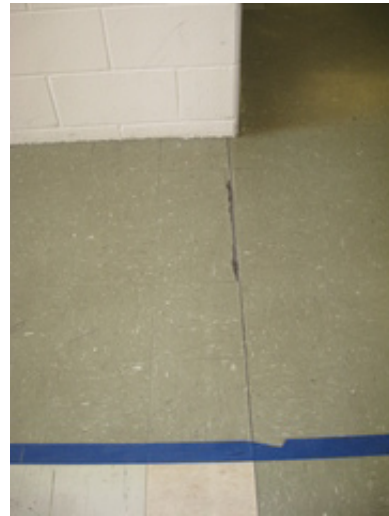
Minor Cracking Between Precast Planks On the Second Floor

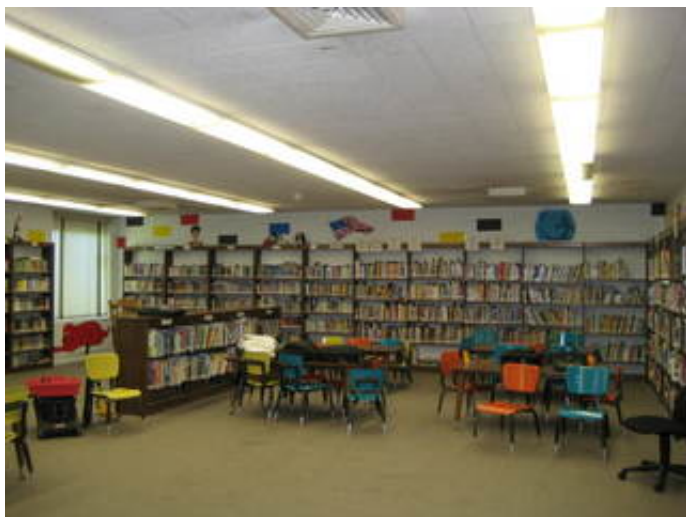
Media Center Finishes

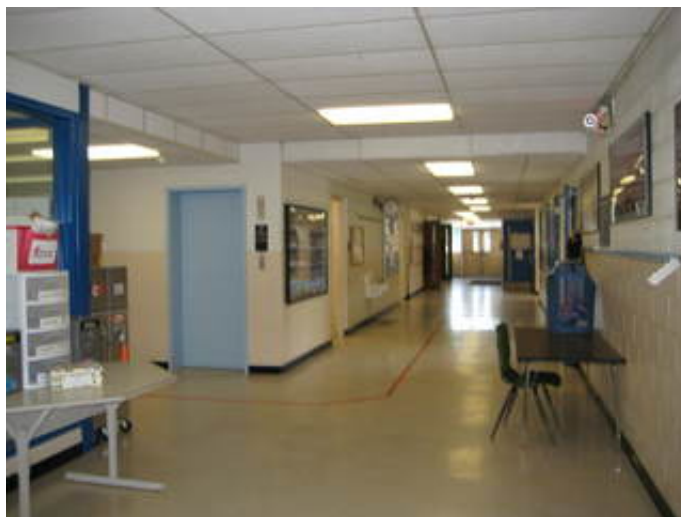
Typical Corridor Finishes

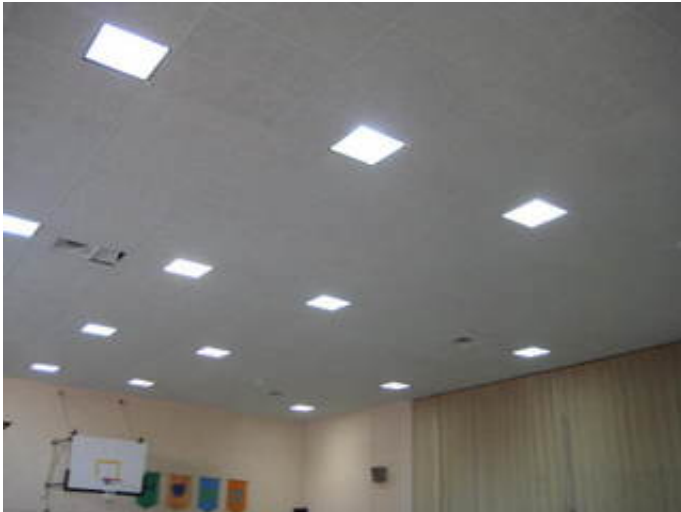
The typical Classrooms in the overall facility are equipped with T-8 1x4 surface mount fluorescent fixtures with single level switching. Classroom fixtures are in fair condition, providing an average illumination of 47 FC, which is less than the 50 FC recommended by the OSDM. The typical Corridors in the overall facility are equipped with T-8 2x4 lay-in direct fluorescent fixtures with single level switching. Corridor fixtures are in fair to poor condition, providing an average illumination of 15 FC, which is less than the 20 FC recommended by the OSDM. The Student Dining and Gymnasium spaces are combined in the Multi-Purpose Room (Student Dining and Gymnasium). The Media Center is equipped with T-8 1x4 surface mount fluorescent fixture type lighting in fair condition, providing an average illumination of 52 FC, thus complying with the 50 FC recommended by the OSDM. The Multi-Purpose Room (Student Dining and Gymnasium) spaces are equipped with recessed metal halide fixture type lighting with single level switching. Multi-Purpose Room (Student Dining and Gymnasium) fixtures are in fair condition, providing an average illumination of 41 FC, which is less than the 50 FC recommended by the OSDM. The Kitchen spaces are equipped with T-8 1x4 surface mount fluorescent fixture type lighting with single level switching. Kitchen fixtures are in fair condition, providing an average illumination of 63 FC, which is less than the 75-80 FC recommended by the OSDM. The Service Areas in the overall facility are equipped with T-8 1x4 suspended fluorescent fixture type lighting in fair condition, providing inadequate illumination. The typical Administrative spaces in the overall facility are equipped with T-8 2x4 lay-in direct fluorescent fixture type lighting in good to fair condition, providing adequate illumination based on OSDM requirements. The overall lighting systems of the facility are not fully compliant with Ohio School Design Manual requirements due to age, condition, inadequate lighting levels, lack of multi-level switching, and the utilization of incandescent fixtures.

Multi-Purpose Room (Student Dining and Gymnasium) Recessed Metal Halide Light Fixtures

Provide complete replacement of lighting system due to age, condition, inadequate lighting levels, lack of multilevel switching, the utilization of incandescent fixtures, and installation of systems outlined in Items A, C, J, and U.

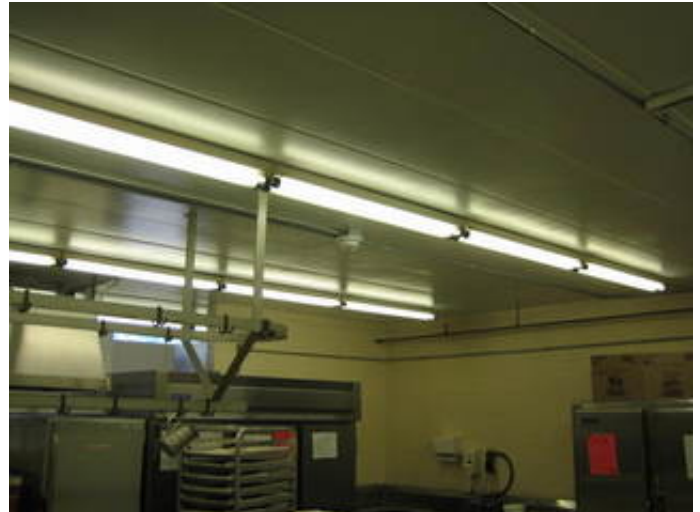
Kitchen Fluorescent Light Fixtures

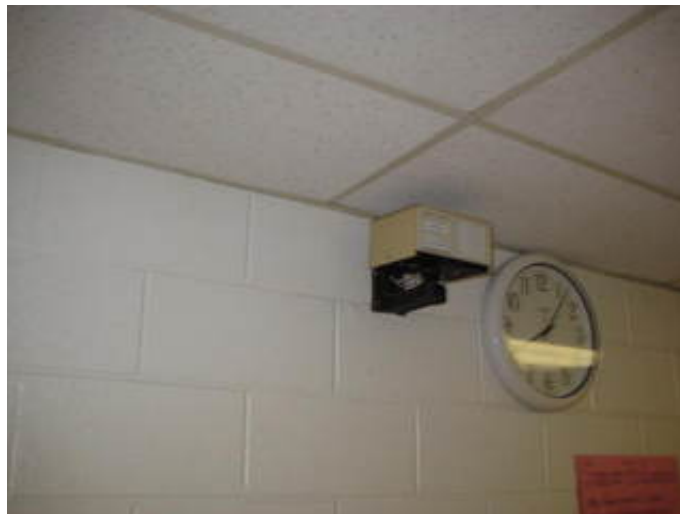
Description: The overall facility contains a Honeywell motion sensor and door contact type security system in fair to poor condition. Motion detectors are inadequately provided in main entries, central gathering areas, offices, main Corridors, and spaces where 6 or more computers are located. Exterior doors are not adequately equipped with door contacts. An automatic visitor control system is not provided. Compliant color CCTV cameras are not provided at main entry areas, parking lots, central gathering areas, and main Corridors. A compliant computer controlled access control system integrating alarms and video signals, with appropriate UPS backup, is not provided. The system is not equipped with card / biometric readers. The security system is inadequately provided throughout, and the system is not fully compliant with Ohio School Design Manual guidelines. Existing playground fencing is not fully compliant with Ohio School Design Manual guidelines. The exterior site lighting system is equipped with surface mounted HID high pressure sodium entry lights in fair condition. Pedestrian walkways are not illuminated. Parking and bus pick-up / drop off areas are illuminated by surface mounted HID mercury vapor light fixtures in fair condition. The exterior site lighting system provides inadequate coverage. 06-22-18 Assessment Update: There main entry into the building is not secured and a security vestibule is needed to limit direct access into the building. Modifications utilizing the adjacent main office required to achieve a more secure security entrance.

Security System Motion Detection Device

Recommendations: Provide complete replacement of security system to meet Ohio School Design Manual guidelines. Provide complete replacement of exterior site lighting system to meet Ohio School Design Manual guidelines. Provide additional playground fencing to meet Ohio School Design Manual guidelines, funding included in complete replacement of security system. 06-22-18 Assessment Update: Provide for modifications to main entry to provide for a security vestibule.

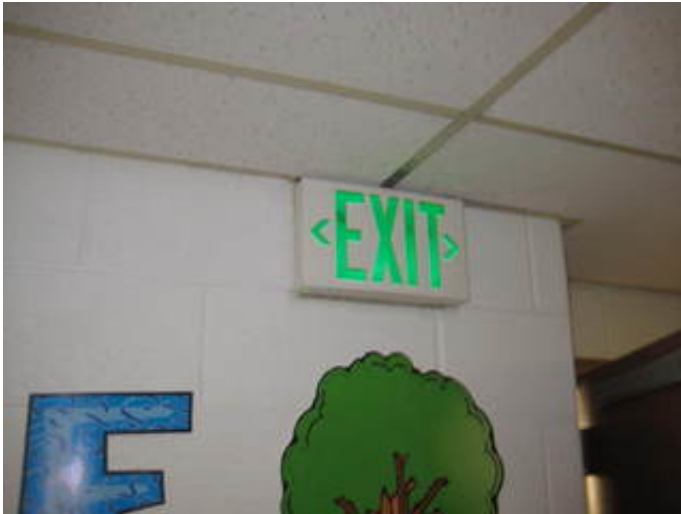
Description: The overall facility is equipped with an emergency egress lighting system consisting of non compliant green lettered and plastic construction exit signs, as well as OSDM compliant red lettered, cast aluminum construction, and LED illuminated exit signs and the system is in fair condition. The facility is not adequately equipped with emergency egress floodlighting, and the system is in fair to poor condition. The system is not provided with appropriate battery backup or emergency generator on separate circuits. The system is inadequately provided throughout, and does not meet Ohio School Design Manual and Ohio Building Code requirements.

Non-Compliant Green Lettered Illuminated Exit Sign

Recommendations: Provide complete replacement of emergency / egress lighting system to meet Ohio School Design Manual guidelines.

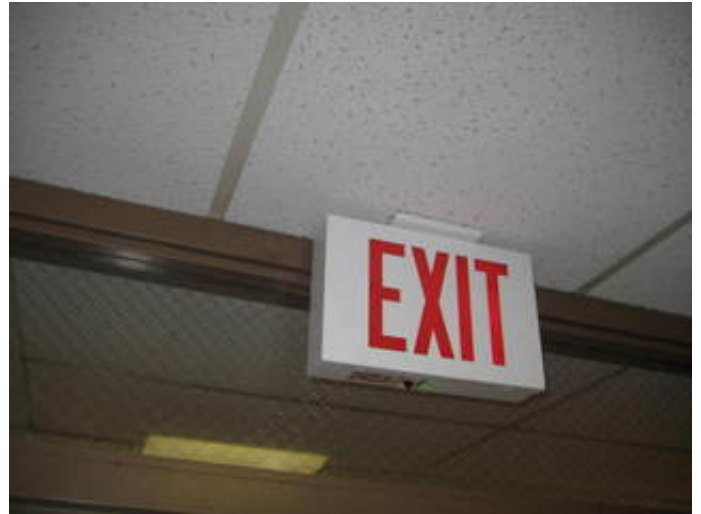
Compliant Illuminated Exit Sign

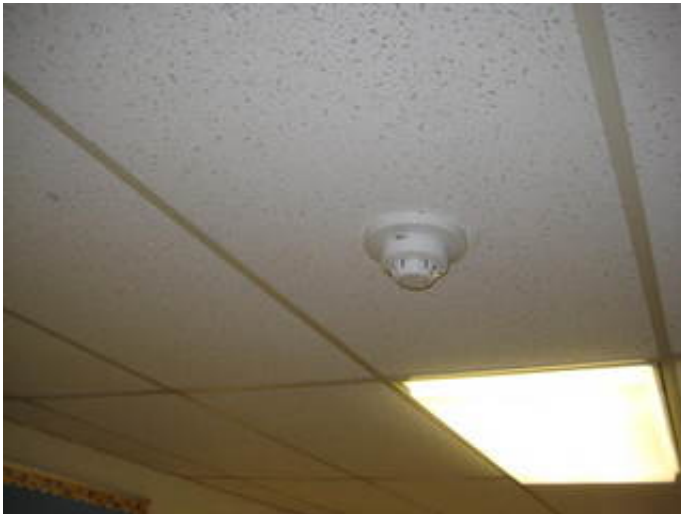
Description: The overall facility is equipped with an addressable Gamewell Flex 610 fire alarm system, installed in 1999, and in fair condition, consisting of manual pull stations, smoke detectors, and horn and strobe indicating devices. The system is automatic and is monitored by a third party. The system is not equipped with sufficient audible horns, strobe indicating devices, flow switches, tamper switches, and smoke detectors. The system is not equipped with any heat sensors. The system thus will not support future fire suppression systems. The system is not adequately provided throughout, and does not have additional zone capabilities. The system is not fully compliant with Ohio Building Code, NFPA, and Ohio School Design Manual requirements.

Fire Alarm System Smoke Detection Device

Recommendations: Provide complete replacement of fire alarm system to meet OBC, NFPA, and Ohio School Design Manual guidelines.

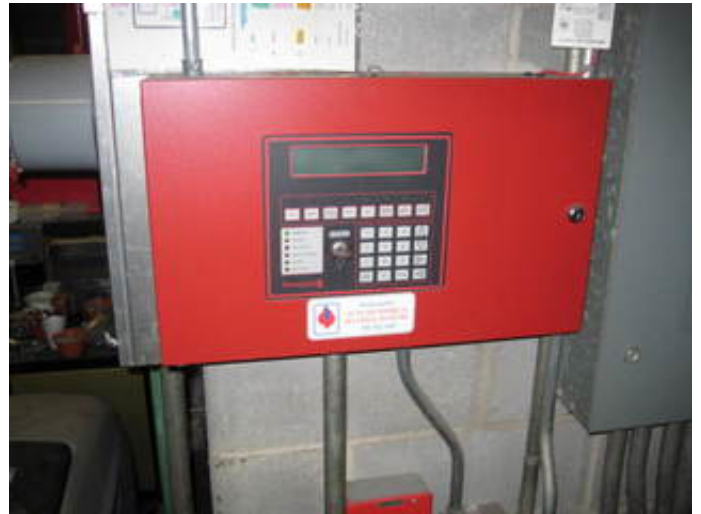
Fire Alarm System Control Panel

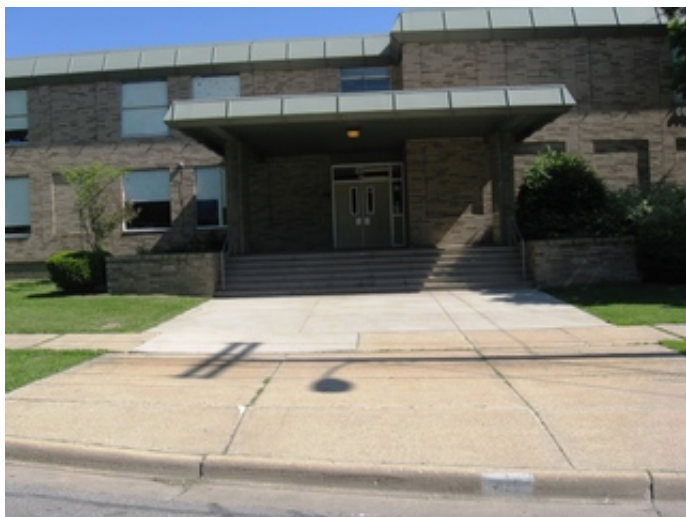
Non-Compliant ADA Access At The Main Entrance

Provide 2 ADA-compliant power assist door openers, 1 exterior ramp at the main entrance, 1 chair lift at the Stage, 2 electric water coolers, 5 toilets, 5 sinks, 2 toilet partitions with accessories, 3 toilet accessories, 36 doors and frames, and door hardware in the overall facility to facilitate the school's meeting of ADA requirements. Replace handrails at steps to the Stage with ADA compliant handrails. Remount 13 mirrors for ADA compliance. Enlarge and reconfigure new single ADA Toilet Rooms for 1 Health Clinic, 1 Kitchen, and 1 Kindergarten Toilet Room, including 3 toilets, 3 sinks and 3 sets of ADA accessories. ADA compliant sink base casework in the Classrooms is corrected in Item J. Voice call station in the elevator is corrected in Item W. Parking issues are corrected in Item P. For interior doors that are not being replaced under this Item, door hardware to be replaced with funding provided in Item J. Stairwells are corrected in Item U. 10-02-14 Update: Change handicapped restroom conversion allowance from \$10,000 for each restroom to \$16,761.00 for each restroom. Add Allowance of \$25,707.00 for converting space to handicapped accessible Family Restroom. 06-22-18 Assessment Update: Provide for complete replacement of ADA signage.

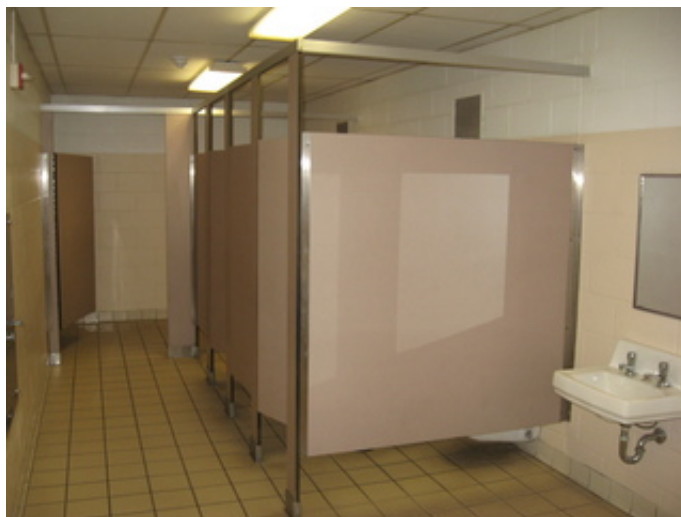
Typical Large Girl's Restroom

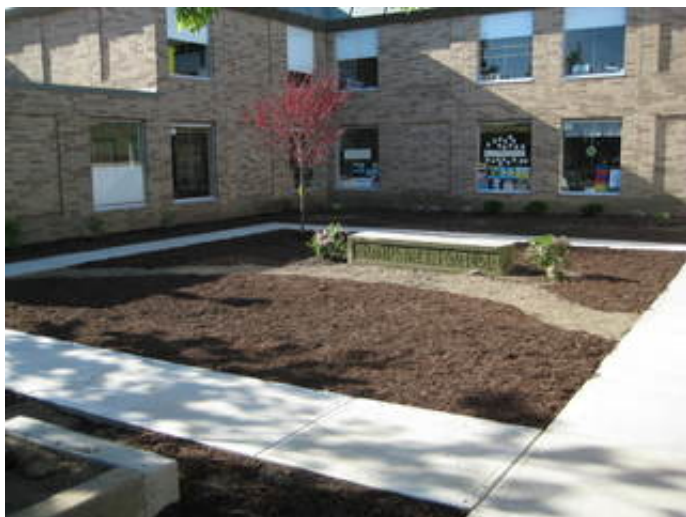
Garden Area

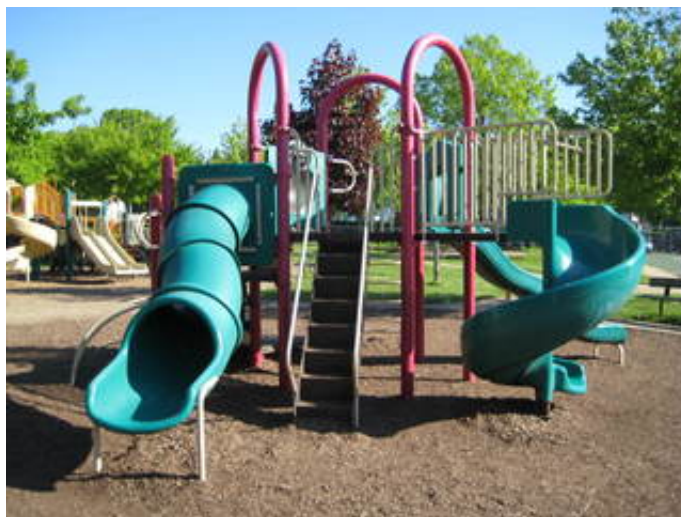
Playground Equipment

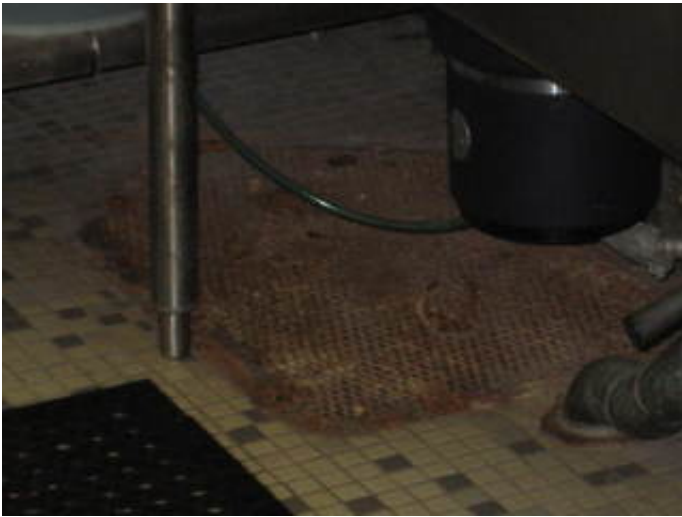
Kitchen Grease Trap Interceptor

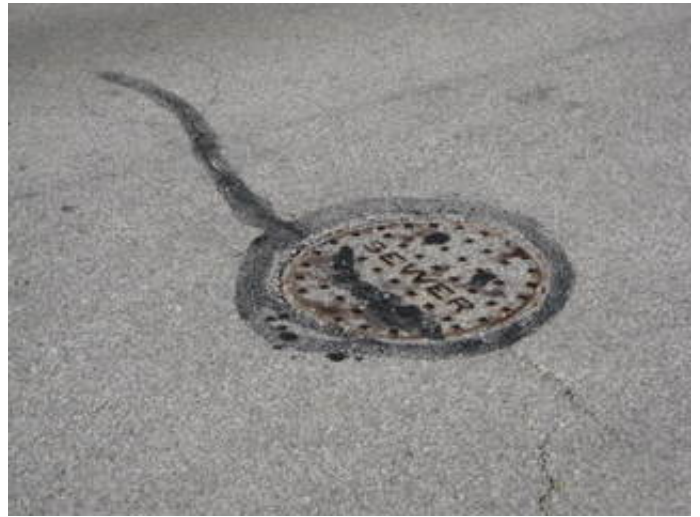
Description: The sanitary sewer system is tied in to the city system, and is in fair condition. No significant system deficiencies were reported by the school district or noted during the physical assessment.

Sanitary Manhole

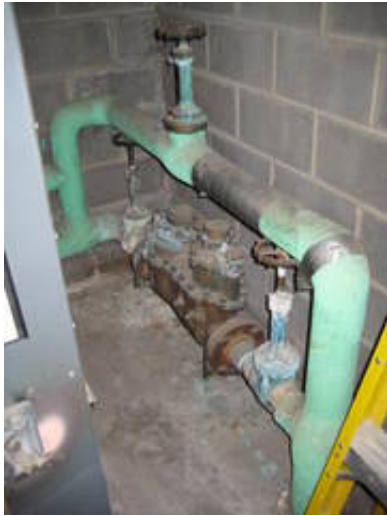
Incoming Domestic Water Service Line

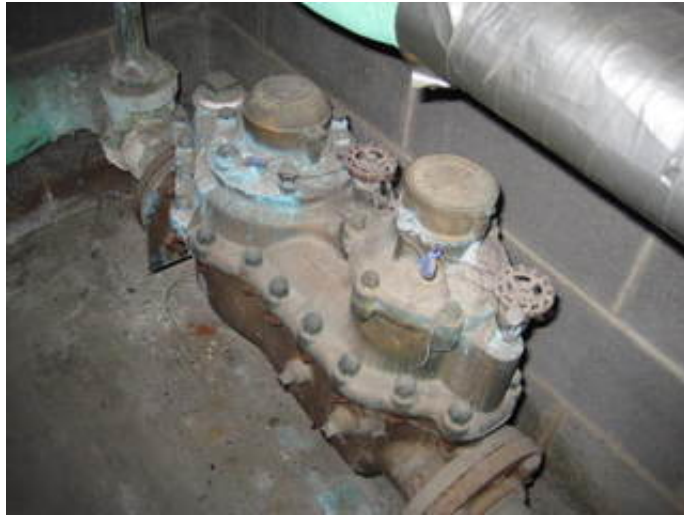
Description: The domestic water supply system is tied in to the city system, features 3" service and 3" water meter, and is in fair condition. The District was not able to provide water supply flow test data. The existing domestic water service appears to meet the facility's current needs. The facility is partially equipped with an automated fire suppression system in the Mechanical Room only, but the existing water supply will not provide adequate support for a future system. The domestic water service is not equipped with a water booster pump, and none is required. The system does not provide adequate pressure and capacity for the future needs of the school. 06-22-18 Assessment Update: The existing water meter is damaged and leaking and should be replaced.

Incoming Domestic Water Service Meter

Recommendations: Provide a new city water supply line of adequate capacity to support the existing needs of the facility, as well as a future automated fire suppression system. Funding provided in Item U. 06-22-18 Assessment Update: Replace existing water meter.

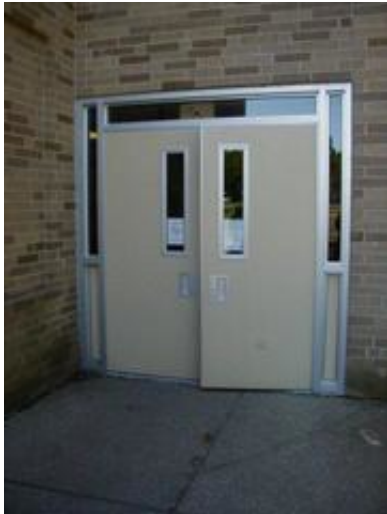
Typical Exterior FRP Entry Doors

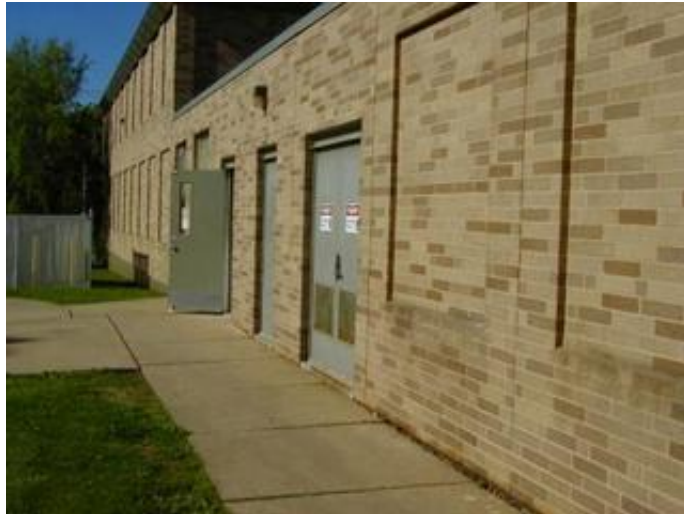
Description: Typical exterior doors in the overall facility are hollow metal type construction, installed on hollow metal frames, and in good to fair condition. Exterior hollow metal doors include single glazed vision panels, no vision panels or ventilation louvers. Entrance doors in the overall facility are FRP type construction, installed on aluminum frames, and in good condition. Entrance doors feature single glazed tempered glass vision panels. There are no overhead doors in the facility. 06-22-18 Assessment Update: The 8 exterior hollow metal frame doors were observed to be in a condition that required replacement in lieu of painting.

Typical Exterior Hollow Metal Doors

Recommendations: Replacement of single pane glazed transoms, sidelights and vision panels are addressed in Item F. Prep and paint all existing exterior hollow metal doors and frames. 06-22-18 Assessment Update: Delete scrape and paint 9 exterior metal doors. Provide for complete replacement of 8 exterior doors

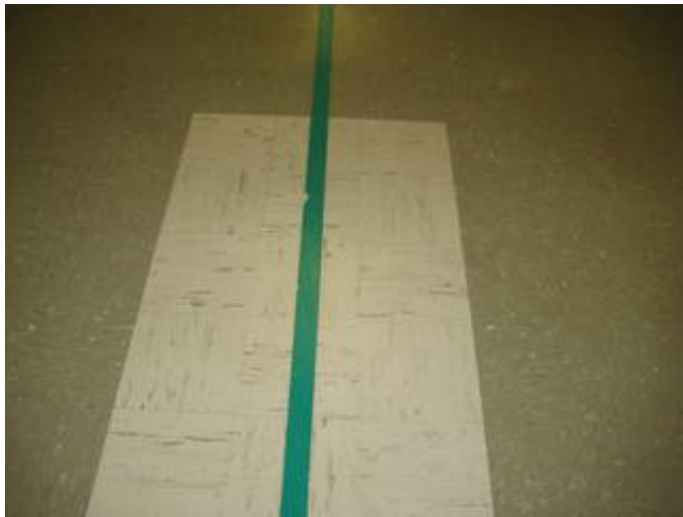
VAT in the Corridor

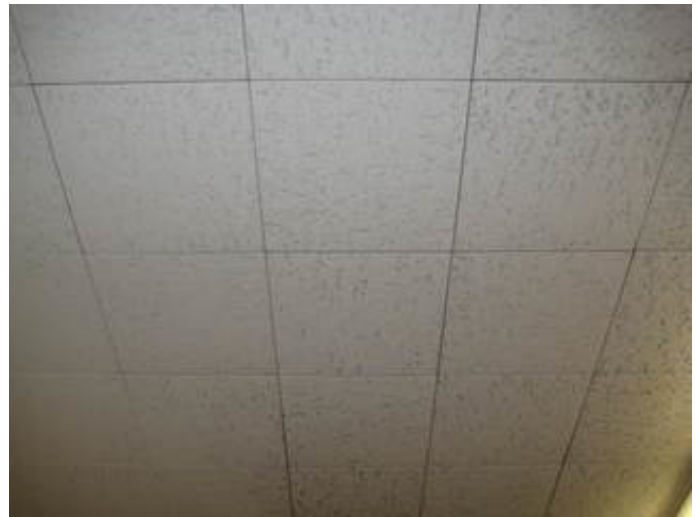
Acoustical Tile

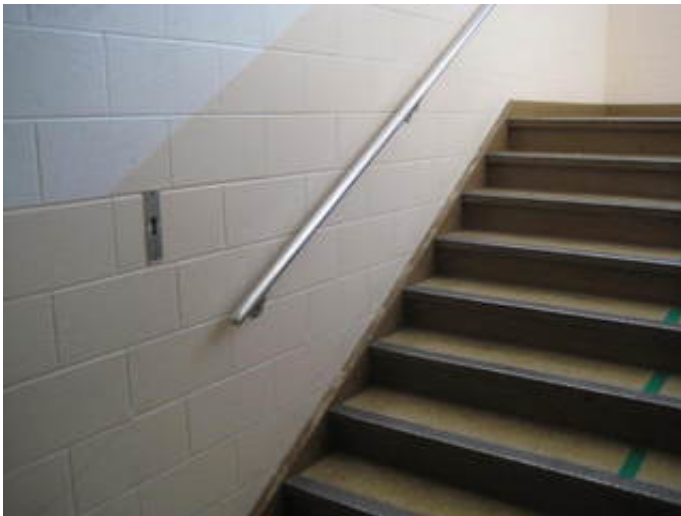
Non-Compliant Handrails

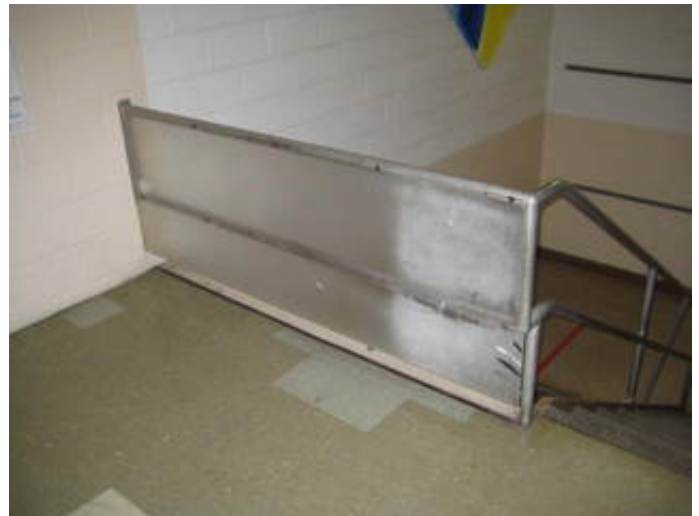
Non-Compliant Guardrail

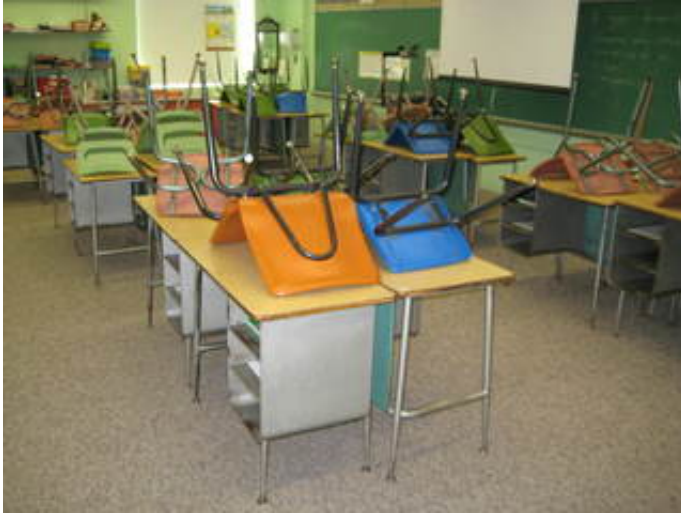
Typical Student Desks

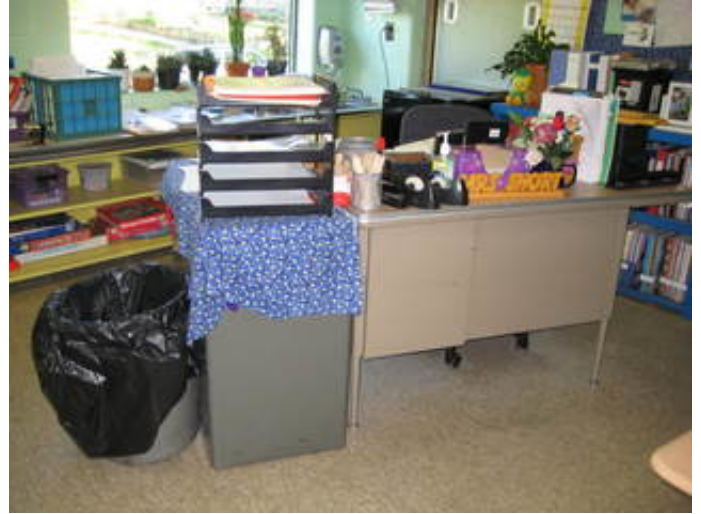
Typical Teacher's Desk

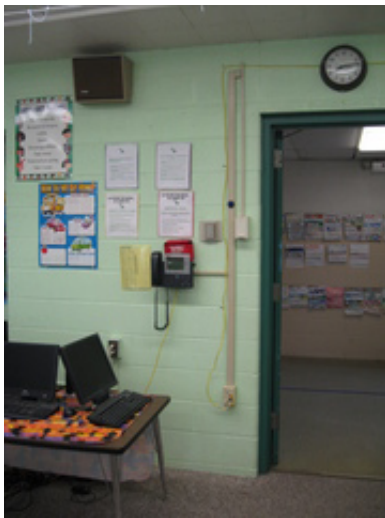
Typical Classroom Technology
