Building Information - Cuyahoga Falls City (43836) - Dewitt Elementary

Gordon DeWitt Elementary School, which is not on the National Register of Historic Buildings, and originally constructed in 1968, is a 2 story, 50,520 square foot brick school building located in a suburban residential setting. The existing facility features a conventionally partitioned design, and does not utilize modular buildings. The structure of the overall facility contains brick veneer on a masonry bearing wall system type exterior wall construction, with concrete masonry units and operable partition walls type wall construction in the interior. The base floor system of the overall facility is concrete slab-on-grade type construction. The second floor system of the overall facility consists of precast concrete planks with concrete topping. The roof structure of the overall facility is precast concrete planks with concrete topping. The roofing system of the overall facility an asphalt built-up roof with gravel wear coat that was installed in 1999. The ventilation system of the building is inadequate to meet the needs of the users. The Classrooms are undersized in terms of the current standards established

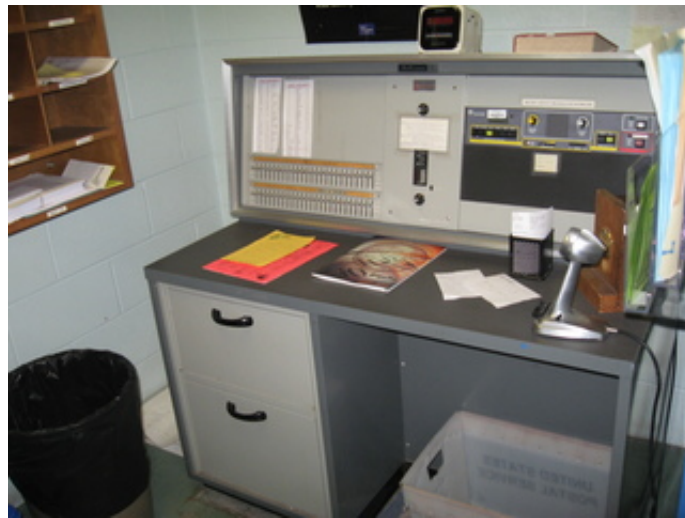
Outdated Non-Compliant Building PA System
