Building Information - Cuyahoga Falls City (43836) - Lincoln Elementary

Program Type	Classroom Facilities Assistance Program (CFAP) - Regular
Setting	Suburban
Assessment Name	Lincoln_ES_June_2009_Jan_2015_EEA_June_2018_Desktop_Update
Assessment Date (on-site; non-EEA)	2015-01-07
Kitchen Type	Full Kitchen
Cost Set:	2018
Building Name	Lincoln Elementary
Building IRN	20644
Building Address	3131 West Bailey Road
Building City	Cuyahoga Falls
Building Zipcode	44221
Building Phone	(330) 926-3803
Acreage	10.50
Current Grades:	K-5
Teaching Stations	28
Number of Floors	3
Student Capacity	538
Current Enrollment	476
Enrollment Date	2009-04-14
Enrollment Date is the date in which the current enrollment was taken.	
Number of Classrooms	26
Historical Register	NO
Building's Principal	Ms. Tracy Early
Building Type	Elementary

Building Construction Information - Cuyahoga Falls City (43836) - Lincoln Elementary (20644)

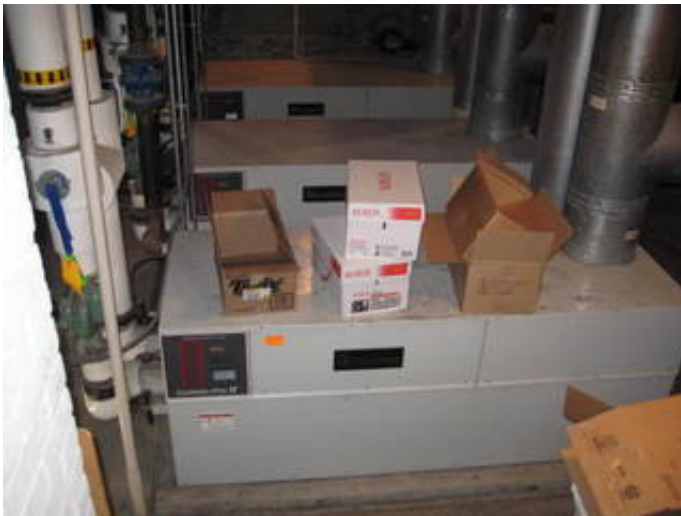
Description: The existing system for the 1930 Original Construction is a natural gas fired heated water boiler type system, installed in 1930, and is in fair to poor condition. The systems in the 1957 and 1959 Additions are an extension of that found in the 1930 Original Construction. 2-pipe vs. 4-pipe designations are not applicable in this facility, as no central air conditioning is provided. The three (3) Copper-Fin II boilers, manufactured by Lochinvar, were installed in the 1990's and are in fair condition. Heating water is distributed to terminal units consisting of unit ventilators, cabinet heaters, unit heaters, fin tubes, and air handlers. The terminal equipment is original to each addition and is in fair to poor condition. The system does not comply with the 15 CFM per person fresh air requirements of the Ohio Building Code mechanical code and Ohio School Design Manual. The pneumatic type system temperature controls are original to each addition and are in fair to poor condition. The system does not feature individual temperature controls in all spaces required by the OSDM. The overall system does not feature any central energy recovery systems. The facility is not equipped with louvered interior doors to facilitate Corridor utilization as return air plenums. The existing systems in a few Classrooms in the 1930 Original Construction and the Multi-Purpose Room (Student Dining / Gymnasium) in the 1959 Addition are ducted, but the ductwork in these areas cannot be integrated into a possible future system due to arrangement, air volume, and routing of existing ductwork. The existing system in the remainder of the overall facility is not ducted, but floor to structural deck heights will accommodate the installation of properly sized ductwork for a future Ohio School Design Manual approved system. The overall heating system is evaluated as not being in safe and efficient working order, and long term life expectancy of the existing system is not anticipated. The structure is not equipped with a central air conditioning system. The site does not contain underground fuel tanks.

Rating: 3 Needs Replacement

Natural Gas Fired Heated Water Boilers

Recommendations: Provide new overall heating, ventilating, and air conditioning system to achieve compliance with Ohio Building Code and Ohio School Design Manual standards. Convert the overall facility, except for a few Classrooms in the 1930 Original Construction and the Multi-Purpose Room (Student Dining / Gymnasium) in the 1959 Addition, to a ducted system to facilitate efficient exchange of conditioned air. Replace existing ductwork in a few Classrooms in the 1930 Original Construction and the Multi-Purpose Room (Student Dining / Gymnasium) in the 1959 Addition, to facilitate efficient exchange of conditioned air with pricing included in conversion to ducted system replacement.

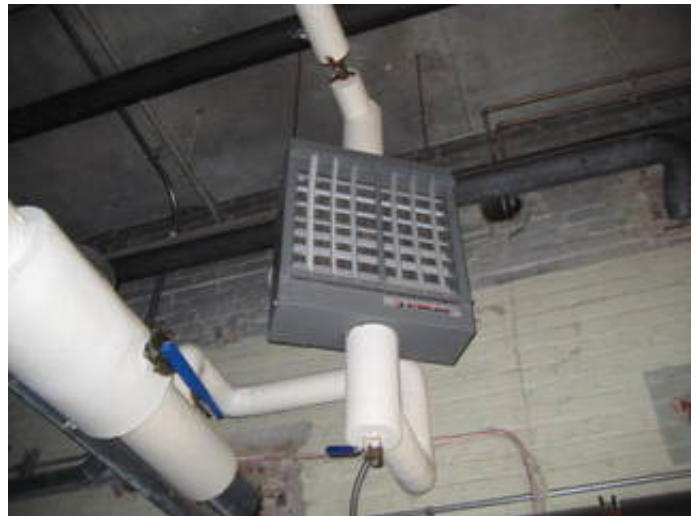
Heating Water Unit Heater

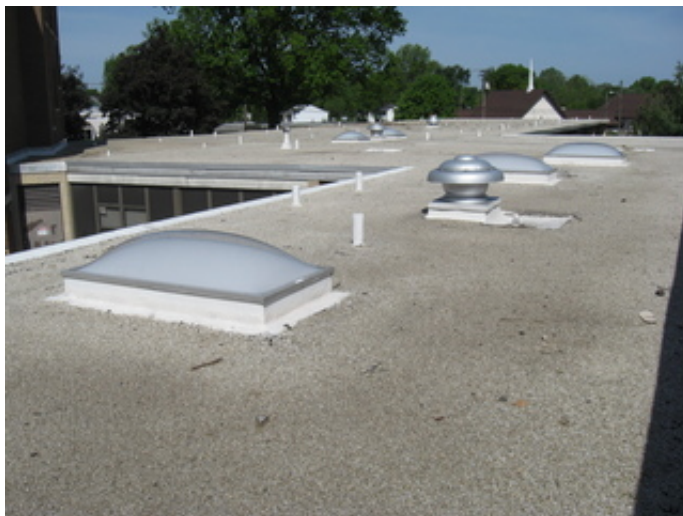
Description: The roof over the overall facility is a built-up asphalt with gravel ballast system, and is in fair condition; no installation date was available at time of assessment. There are no District reports of current leaking. Signs of past leaking were observed during the physical assessment. Access to the roof was gained by access hatch and interior access ladder that is in good condition, but is too close to the edge of the parapet. Fall safety protection cages are not required, and are not provided. There were no observations of standing water on the roof. Metal cap flashings are in good condition. Roof storm drainage is addressed through a system of roof drains, which are properly located, and in good condition. The roof over the 1930 Original Construction is equipped with overflow roof drains in sufficient quantity and in good condition. The roof over the 1957 and 1959 Additions is not equipped with overflow roof drains, though they are not required. No problems requiring attention were encountered with any roof penetrations. There are not any covered walkways attached to this structure. 06-22-18 Assessment Update: It was reported by district personnel, and observed, the original roof area was not removed prior to installing the current roof system. Therefore, additional tear-off costs required. Additional roof insulation required to meet LEED energy efficiency requirements.

Rating: 3 Needs Replacement

Typical Roof Over the 1959 Addition With Skylights

Recommendations: The roof over the overall facility requires replacement to meet Ohio School Design Manual guidelines due to condition. Replace roof hatch and provide fall protection on the 1930 Original Construction, add a new roof hatch to the 1957 Addition, and replace roof ladder to the 1959 Addition. 10-02-14 Update: Revise 1930 Original Construction from 33,454 sf to 11,151 sf 06-22-18 Assessment Update: Provide for additional roof tear-off due to recovery roof system installed over existing roof. Provide for additional roof insulation to meet LEED energy efficiency requirements.

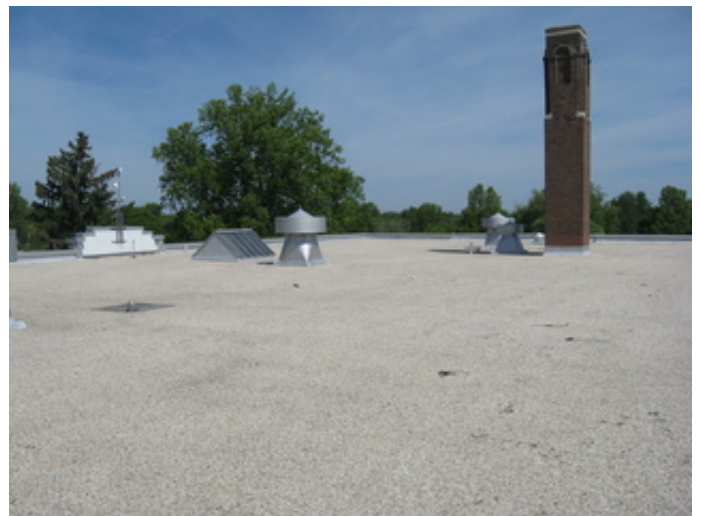
Typical Roof Over the 1930 Original Construction

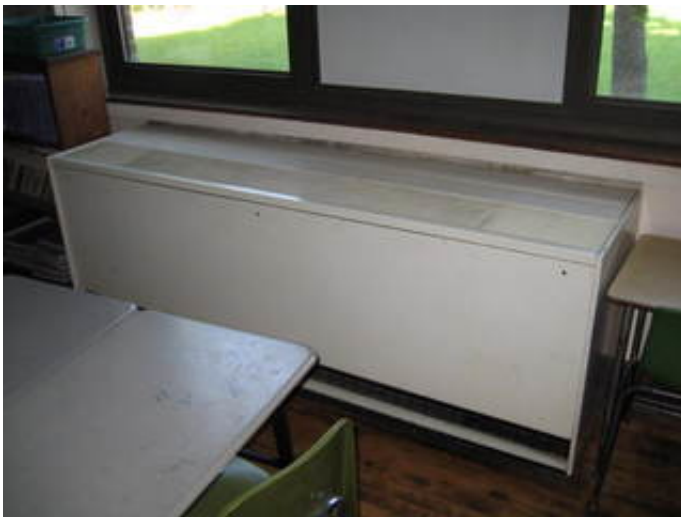
Description: The overall facility is not equipped with a central air conditioning system. Window units are provided in the Principal's Offices, Administrative Offices, Teacher's Lounge, Special Education Classroom, and other Classroom locations. The overall facility is not equipped with any isolated room systems. The ventilation system in the overall facility consists of unit ventilators and air handlers, original to each addition and in fair to poor condition, providing fresh air to Classrooms, and other miscellaneous spaces such as the Multi-Purpose Room (Student Dining / Gymnasium) and Media Center. Relief air venting is provided by unit ventilators, air handlers, ceiling plenums, and central relief fans. The ventilation system does not meet the Ohio Building Code 15 CFM per occupant fresh air requirement. The overall system is not compliant with Ohio Building Code and Ohio School Design Manual requirements. Dust collection systems are not required in this facility. Exhaust systems for Restrooms, Storage Rooms, Custodial Closets, Telecommunications Rooms, Maintenance Workrooms, Locker Rooms, Kitchen Dry Food Storage, P.E. Workroom & Storage, Art Material Storage, and Art Rooms are inadequately placed, and in fair to poor condition. The Art Program is equipped with a kiln, and the existing kiln ventilation system is adequate. 06-22-18 Assessment Update: General building exhaust is included in Item A and should not be included in this line item. Kiln does not have proper exhaust.

Rating: 2 Needs Repair

Classroom Unit Ventilator

Recommendations: Provide an air conditioning system to meet with Ohio Building Code and Ohio School Design Manual requirements. Pricing included in Item A. Replace the existing general building exhaust system. 06-22-18 Assessment Update: Delete general building exhaust. Provide for proper exhaust system for kiln.

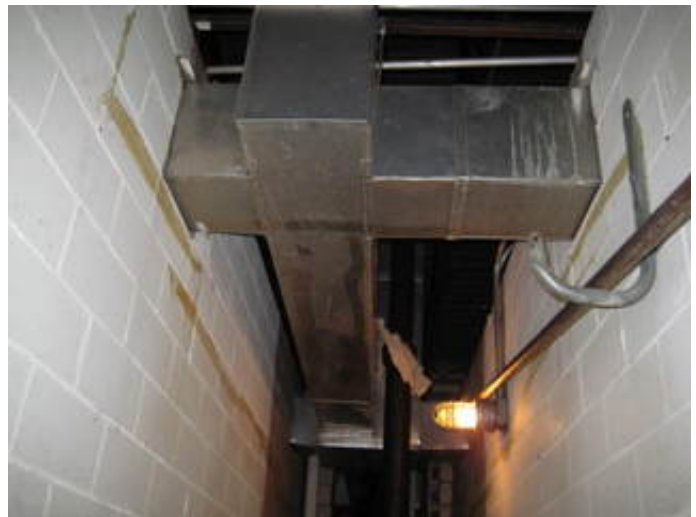
Restroom Exhaust Fan Ductwork

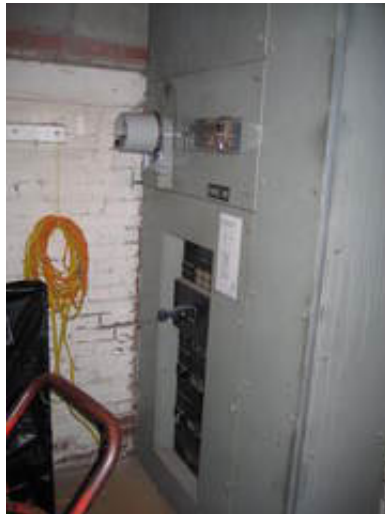
Description: The electrical system provided to the 1930 Original Construction is a 120/208 volts, 600 amp, 3 phase and 4 wire system installed in 1930, and is in poor condition. The systems in the 1957 and 1959 Additions are an extension of that found in the 1930 Original Construction. Power is provided to the school by multiple City of Cuyahoga Falls owned, pad-mounted transformer located in a Mechanical Room in the 1957 Addition, and in good to fair condition. The panel system, installed in 1930, is in poor condition, and cannot be expanded to add additional capacity. The Classrooms are not equipped with adequate electrical outlets. The typical Classroom contains three (3) general purpose outlets, zero (0) dedicated outlets for each Classroom computer, and one (1) dedicated outlet for each Classroom television. Some Classrooms are equipped with as many as five (5) general purpose outlets, while others are equipped with as few as two (2) general purpose outlets. There are not any spaces that have no electrical outlets. The Corridors are not equipped with adequate electrical outlets for servicing. GFI protected exterior outlets are not provided around the perimeter of the building. The facility is not equipped with an emergency generator. Adequate lightning protection safeguards are not provided. Stage lighting power system including control panel, breakers, and dimmers is inadequately provided, in poor condition and does not meet OSDM requirements. The overall electrical system does not meet Ohio School Design Manual requirements in supporting the current needs of the school, and will be inadequate to meet the facility's future needs.

Rating: 3 Needs Replacement

Main Electrical Distribution Panel

Recommendations: The entire electrical system requires replacement to meet Ohio School Design Manual guidelines for overall capacity and Classroom capacity due to age, condition, lack of OSDM-required features, and to accommodate the addition of an air conditioning system. Provide an emergency generator, with funding included in the electrical system replacement. Provide adequate lightning protection safeguards in the overall facility, including associated grounding system, with funding included in the electrical system replacement. Provide control panel, dimmers, and breakers to support the Stage lighting system, with funding included in the electrical system replacement.

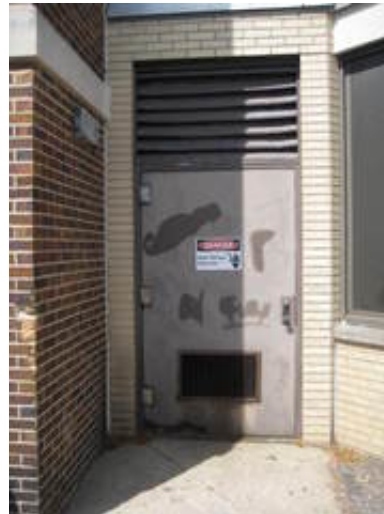
Pad Mounted Transformer Room

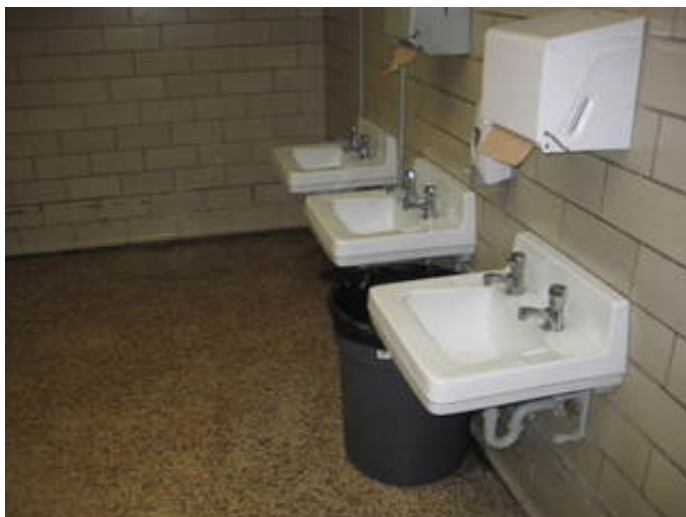
The service entrance is not equipped with a reduced pressure backflow preventer. A water treatment system is not provided, though none is needed. The domestic water supply piping in the overall facility is galvanized and copper, is original to each addition, and is in fair condition. The waste piping in the overall facility is cast iron and galvanized, is original to each addition, and is in fair condition. The facility is equipped with one (1) Rudd Multi-coil 500A natural gas water heater in poor condition, with one (1) separate 350 gallon storage tank in fair condition. The overall facility contains 4 Large Group Restrooms for boys, 4 Large Group Restrooms for girls, 1 Locker Room Restroom for boys, 1 Locker Room Restroom for girls, 0 Locker Room Restrooms for staff, 1 Kitchen Restroom, 0 Health Clinic Restroom, 0 Restrooms associated with Kindergarten / Pre-K Classrooms / Specialty Classrooms, and 4 Restrooms for staff. Boys' Large Group Restrooms contain 9 non-ADA wall mounted flush valve toilets, 18 non-ADA floor mounted flush valve urinals, as well as 13 non-ADA wall mounted lavatories. Girls' Large Group Restrooms contain 19 non-ADA wall mounted flush valve toilets, as well as 10 non-ADA wall mounted lavatories. Boys' Locker Room Restroom contains 1 non-ADA wall mounted flush valve toilet, 2 non-ADA floor mounted flush valve urinals, 1 non-ADA wall mounted lavatory, as well as 4 non-ADA showers. Girls' Locker Room Restroom contains 2 non-ADA wall mounted flush valve toilets, 1 non-ADA wall mounted lavatory, as well as 4 non-ADA showers. Staff Restrooms contain 4 non-ADA floor mounted tank type toilets, 1 non-ADA wall mounted flush valve urinal, as well as 4 non-ADA (1 countertop / 3 wall) mounted lavatories. Condition of fixtures is fair to poor. The facility is equipped with 2 non-ADA drinking fountains, as well as 1 ADA and 6 non-ADA electric water coolers, in fair to poor condition. Elementary Classrooms are not adequately equipped with required lavatory mounted type drinking fountains, which are not ADA compliant, and are in fair to poor condition. Special Education Classroom is not equipped with the required Restroom facilities. Kitchen is equipped with the required Restroom which contains 1 non-ADA wall mounted flush valve toilet, as well as 1 non-ADA wall mounted lavatory, and fixtures are in fair condition. Health Clinic is not equipped with the required Restroom facilities. Kindergarten / Pre-K Classrooms are not equipped with the required Restroom facilities. Kitchen fixtures consist of one (1) double-compartment sink, one (1) triple-compartment sink, one (1) dishwashing unit, and one (1) disposal unit, which are in fair condition. The Kitchen is equipped with two (2) unsatisfactory grease interceptors due to age, condition, and insufficient capacity. The Kitchen is not provided the required 140 degree hot water supply. The school meets the OBC requirements for fixtures. Per OBC and OSDM requirements this facility should be equipped with 14 toilets, 5 urinals, 14 lavatories, and 5 electric water coolers, and at present it is equipped with 30 toilets, 21 urinals, 36 lavatories, and 7 electric water coolers. ADA requirements are not met for fixtures and drinking fountains (see Item O). Custodial Closets are properly located and are adequately provided with required service sinks or floor drain sinks, which are in fair to poor condition. Science Classroom / Lab utility sinks, gas connections, compressed air connections, and safety shower / eyewash are not provided, but are not required due to existing grade configuration. Due to existing grade configuration, no Biology or Chemistry Classroom acid waste systems are required. Adequate exterior wall hydrants are not provided.

3 Needs Replacement

Non-ADA Wall Mounted Lavatories

Replace galvanized water supply piping in the overall facility with copper piping due to age and condition. Replace sanitary waste piping in the overall facility due to age and condition. Due to age, condition, and OSFC standards, replace 29 lavatory mounted type drinking fountains, 36 lavatories, 30 toilets, 21 urinals, and 5 electric water coolers. See Item O for replacement of fixtures related to ADA requirements. See Item J for provisions on Kitchen related equipment. Provide the service entrance with a reduced pressure back flow preventer. Replace the domestic hot water heater and 350 gallon storage tank due to age and condition. Replace the Kitchen grease trap interceptors due to age, condition, and insufficient capacity. Provide the Kitchen with a water booster heater. Provide 3 additional exterior wall hydrants. Replace the existing Custodial Closet service sinks due to age and condition.

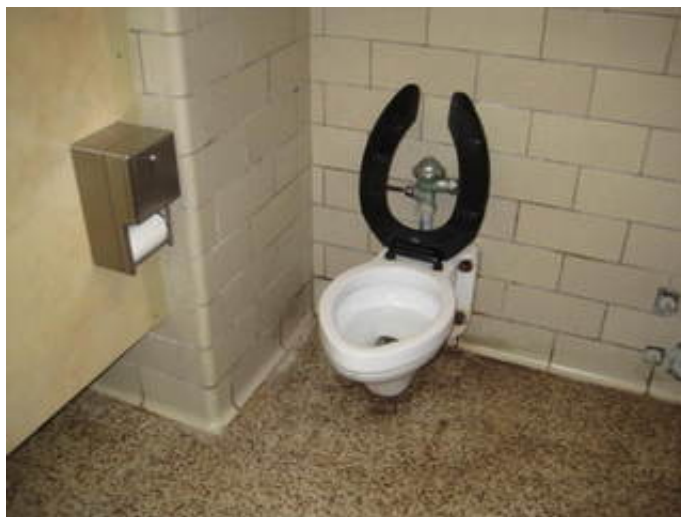
Non-ADA Wall Mounted Flush Valve Toilet

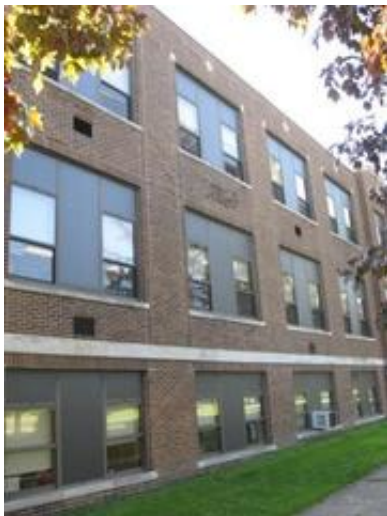
Description: The overall facility is equipped with thermally broken aluminum frame windows with double glazed insulated glazing type window system, which was installed in 1982, and is in fair condition. Window system seals are in fair condition, with minimal air and water infiltration being experienced. Window system hardware is in fair condition. The window system features surface mounted curtains, shades and blinds, which are in fair condition. The window system is partially equipped with insect screens on operable windows, which are in good to fair condition. This facility is not equipped with any curtain wall systems. This facility does not feature any glass block windows. The exterior doors in the overall facility are equipped with thermally broken aluminum frame sidelights with double glazed insulated glazing, which are in good condition. Transoms in the exterior doors are equipped with thermally broken aluminum frames with insulated FRP panels, which are in good condition. The school does contain skylights in fair to poor condition. The 1930 Original Construction contains one steel and single pane wire glass skylight in poor condition. The 1957 and 1959 Additions contain five acrylic bubble with aluminum frame type skylights in fair condition. Window security grilles are provided for some ground floor windows in the 1930 Original construction, and are in fair condition. There is not a Greenhouse associated with this school.

Rating: 3 Needs Replacement

Typical Classroom Windows in the 1930 Original Construction

Recommendations: Provide a new insulated window system with integral blinds to meet with Ohio School Design Manual requirements. Replace skylights in the overall facility. Replace vision panel in exterior doors of the overall facility with approved insulating safety glass.

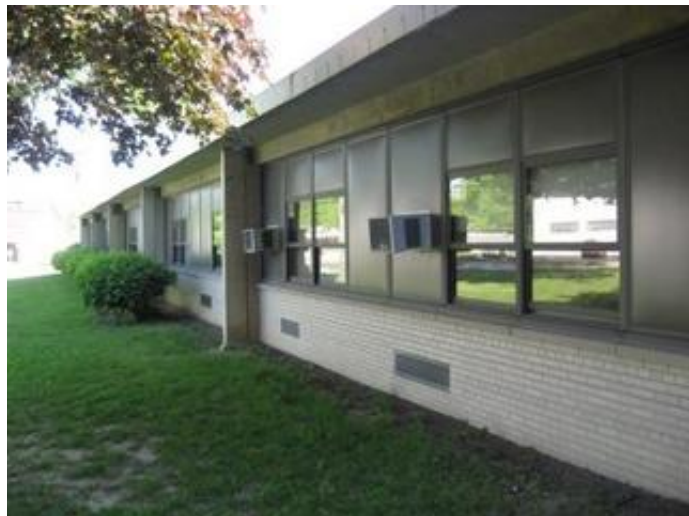
Typical Classroom Windows in the 1957 Addition

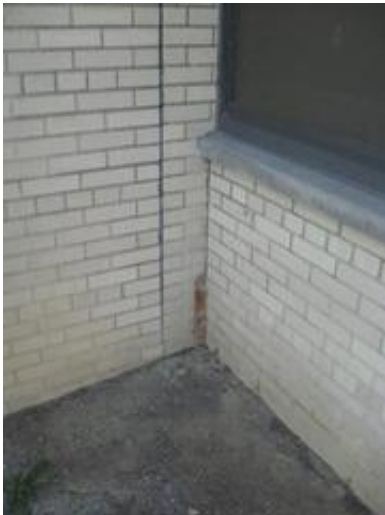
Description: The overall facility is equipped with concrete and concrete masonry unit foundation walls on concrete footings, which displayed no locations of significant differential settlement, cracking, or leaking, and are in good condition. The District reports that there has been no past leaking. No grading or site drainage deficiencies were noted around the perimeter of the structure that are contributing or could contribute to foundation / wall structural deterioration.

Exterior Foundation Condition at Juncture of 1957 and 1959 Additions

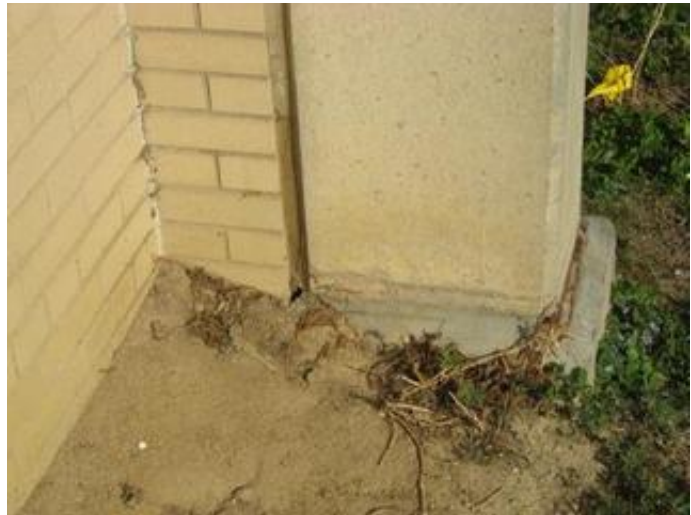
Typical Exterior Foundation Condition at Exposed Concrete Columns in the 1957 Addition

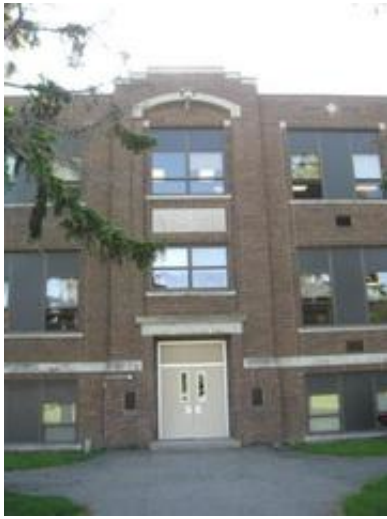
Description: The overall facility has a brick veneer on a masonry bearing wall system, which displayed locations of deterioration, and is in fair condition. The exterior masonry in the 1930 Original Construction does not have control joints and none are required as no cracking is apparent. Control joints are not provided at lintel locations at doors and windows. The exterior masonry in the 1957 and 1959 Additions appears to have appropriately spaced and inadequately caulked control joints in fair to poor condition. Control joints are provided at some door and window lintel locations and are in fair to poor condition. The exterior masonry has not been cleaned and sealed in recent years; shows evidence of mortar deterioration and has locations of discoloration due to pollution and moisture. Architectural exterior accent material consists of stone, which is in fair condition. Interior walls are concrete masonry units, glazed block, brick, plaster and metal stud with gypsum board and are in good to fair condition. Interior masonry appears to have adequately spaced and inadequately caulked control joints in fair condition. Exterior soffits are exposed concrete and insulated panels in fair condition. The window sills are stone, and are in fair condition. The exterior lintels are precast concrete and steel, and are in fair condition. Steel lintels are rusting and exposed concrete lintels have locations of spalling and minor cracking. Chimneys in the 1930 Original Construction are in fair to poor condition and require tuckpointing and masonry repairs. There are no canopies in the overall facility. A loading dock has not been provided to facilitate the unloading of trucks and receipt of product / supplies / foodstuffs. The school does have sufficient expansion joints, and they are in fair condition.

Rating: 2 Needs Repair

Typical 1930 Original Construction Exterior Wall Condition

Recommendations: Provide tuckpointing in all areas of mortar deterioration as required through the overall facility. Provide masonry cleaning, sealing and caulking as required through the overall facility. Recaulk existing exterior control joints. Recaulk existing interior control joints. Provide masonry repairs as required in the overall facility. Repair chimney masonry as required in the 1930 Original Construction. Provide masonry infill for existing unit ventilator openings in the exterior walls of the overall facility. Recaulk existing exterior expansion joints. Prep and paint all exposed steel lintels in the overall facility. Repair exposed concrete lintels as required in the 1957 Addition. Repair exterior concrete soffits and columns. Repoint stone window sills. Repoint stone trim in the 1930 Original Construction.

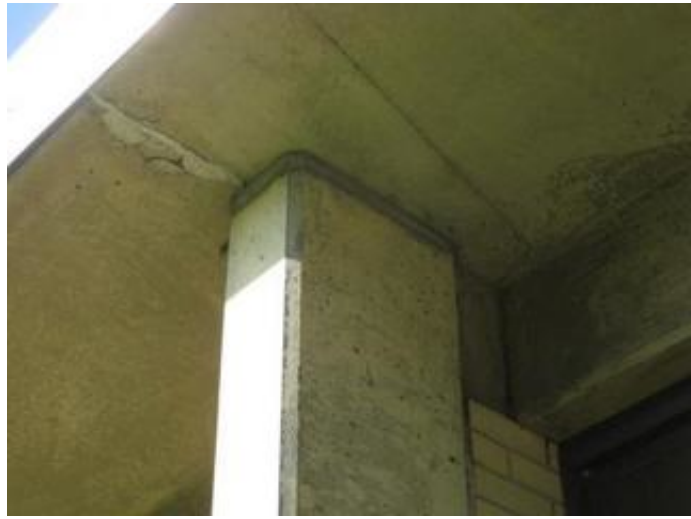
Typical Condition of Exposed Concrete Soffit and Column on the 1957 Addition

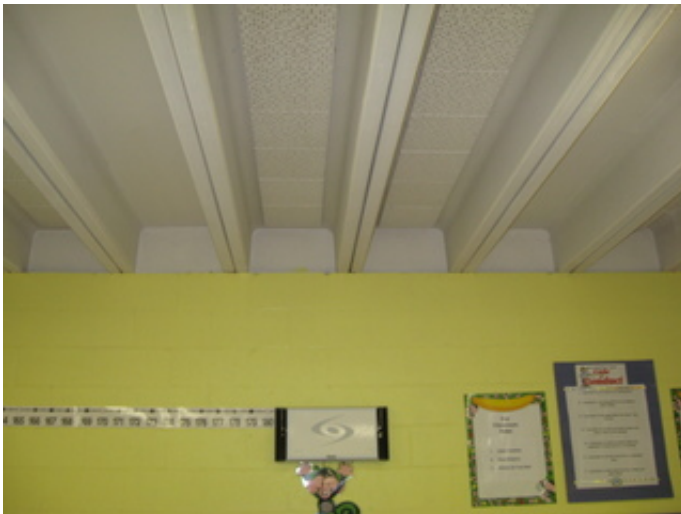
Description: The floor construction of the base floor of the overall facility is concrete slab-on-grade type construction, and is in good condition. There is no crawl space. The floor construction of the second and third floors of the 1930 Original Construction is metal lath reinforced concrete deck on steel beam type construction, and is in good condition. There are no intermediate floors in single story structure of the 1957 Addition. The floor construction of the intermediate floors on either side of the stage in the 1959 Addition is precast concrete planks with concrete topping type construction, and is in good condition. Ceiling to structural deck spaces are sufficient to accommodate HVAC, electrical, and plumbing scopes of work in required renovations. Existing floor to ceiling height will accommodate dropping the ceiling to provide room for new work. The roof construction of the 1930 Original Construction is metal lath reinforced concrete deck on steel beam type construction, and is in good condition. The roof construction of the 1957 Addition is precast reinforced concrete plank type construction, and is in good condition. The roof construction of the 1959 Addition is metal form deck on steel joist type construction, and is in good condition. The roof construction of the 1959 Addition over the Multi-Purpose Room is metal form deck on steel truss type construction, and is in good condition.

Typical Roof Structure Of the 1957 Addition

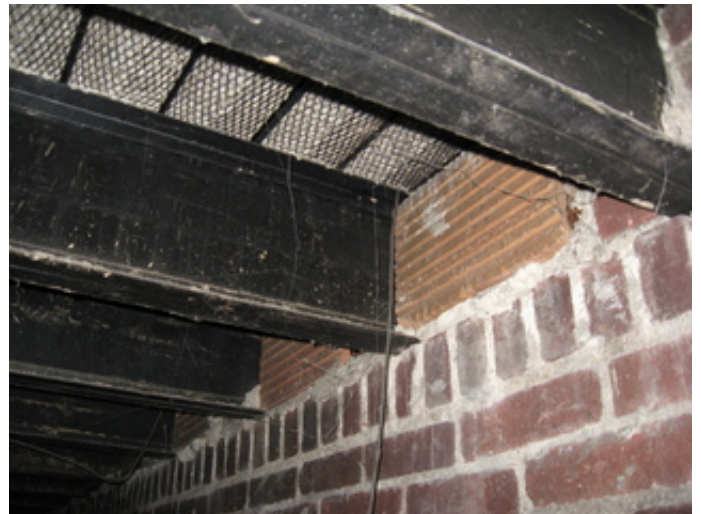
Typical Floor Structure Of the 1930 Original Construction

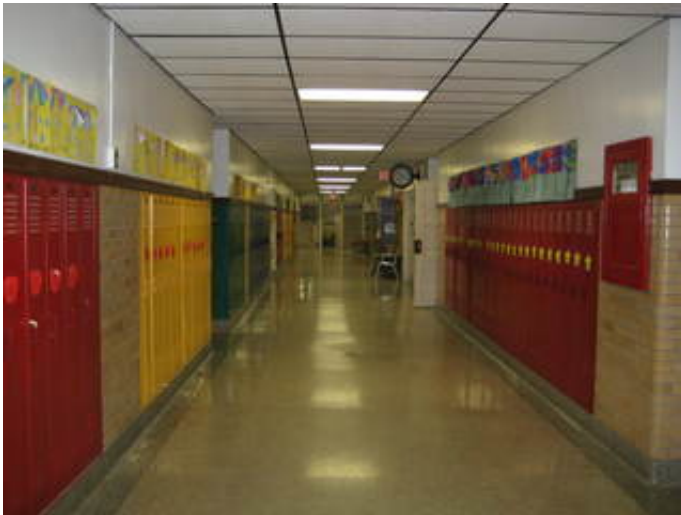
Corridor Finishes

Rating:	3 Needs Replacement
Recommendations:	<p>Provide complete replacement of finishes and casework due to installation of systems outlined in Items A, C, D, E, I, K, L, M, N, T, U, and condition. Provide for the replacement of interior doors due to condition. Provide for the replacement of Kitchen equipment due to age and condition. Provide for the replacement of the Kitchen exhaust hood due to age and condition. Provide for the replacement of toilet partitions due to condition. Provide for the replacement of toilet accessories due to condition. Provide for the replacement of Gymnasium seating due to condition. Provide for the replacement of the Art Program kiln due to condition. Provide for terrazzo repair as required in the 1930 Original Construction. Provide for replacement of reach-in cooler/freezer. Provide for the replacement of interior door transom glass. 10-02-14 Update: Exterior walls are 8" block with 4" clay fired brick and no air cavity or insulation. Provide insulation of exterior walls to meet LEED energy requirements. 06-22-18 Assessment Update: Replace stage curtain. Replace wood stage flooring. Provide for run-out wall padding at basketball goals. Replace basketball backboards and goals with new operable units. Remove wood floor and sleeper system in classrooms in 1930 Original Building and infill voids with lightweight concrete to create subflooring for new flooring material. Provide for walls patch in 1930 Original Building classrooms for wall voids following removal of built-in chalk boards and tack boards removal.</p>

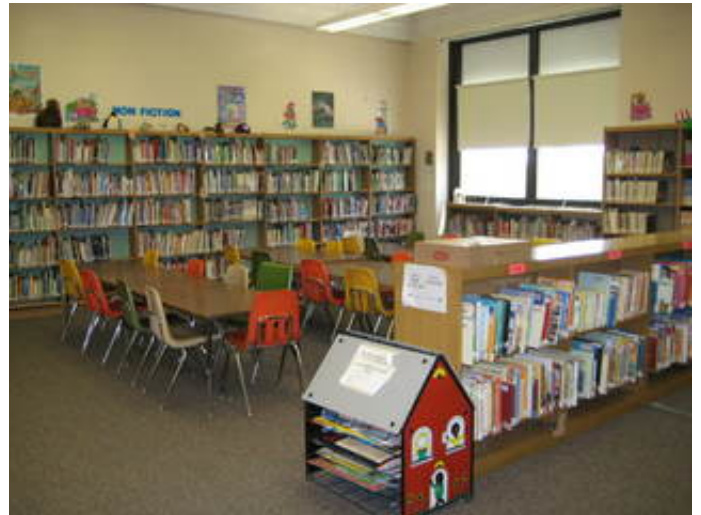
Media Center Finishes

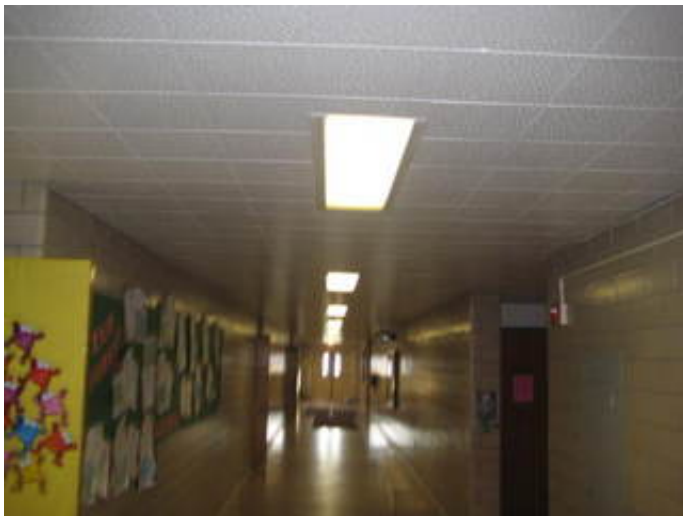
The typical Classrooms in the overall facility are equipped with T-8 1x4 suspended & T-8 2x4 lay-in direct fluorescent fixtures with single level switching. Classroom fixtures are in fair condition, providing an average illumination of 43 FC, which is less than the 50 FC recommended by the OSDM. The typical Corridors in the overall facility are equipped with T-8 1x4 surface mount & t-8 2x4 lay-in direct fluorescent fixtures with single level switching. Corridor fixtures are in fair condition, providing an average illumination of 12 FC, which is less than the 20 FC recommended by the OSDM. The Gymnasium and Student Dining spaces are combined into one Multi-Purpose Room. The Media Center is equipped with T-8 1x4 suspended fluorescent fixture type lighting in fair condition, providing an average illumination of 57 FC, thus complying with the 50 FC recommended by the OSDM. The Multi-Purpose Room (Student Dining / Gymnasium) spaces are equipped with metal halide fixture type lighting with single level switching. Multi-Purpose Room (Student Dining / Gymnasium) fixtures are in good to fair condition, providing an average illumination of 48 FC, which is less than the 50 FC recommended by the OSDM. The Kitchen spaces are equipped with T-8 1x4 suspended fluorescent fixture type lighting with single level switching. Kitchen fixtures are in poor condition, providing an average illumination of 60 FC, which is less than the 75-80 FC recommended by the OSDM. The Service Areas in the overall facility are equipped with suspended / pendant incandescent fixture type lighting in fair to poor condition, providing inadequate illumination. The typical Administrative spaces in the overall facility are equipped with T-8 2x4 lay-in direct fluorescent fixture type lighting in good condition, providing adequate illumination based on OSDM requirements. The overall lighting systems of the facility are not compliant with Ohio School Design Manual requirements due to age, condition, inadequate lighting levels, lack of multi-level switching, and the utilization of incandescent fixtures.

3 Needs Replacement

1959 Addition Fluorescent Corridor Light Fixtures

Provide complete replacement of lighting system due to age, condition, inadequate lighting levels, lack of multilevel switching, the utilization of incandescent fixtures, and installation of systems outlined in Items A, C, J, and U.

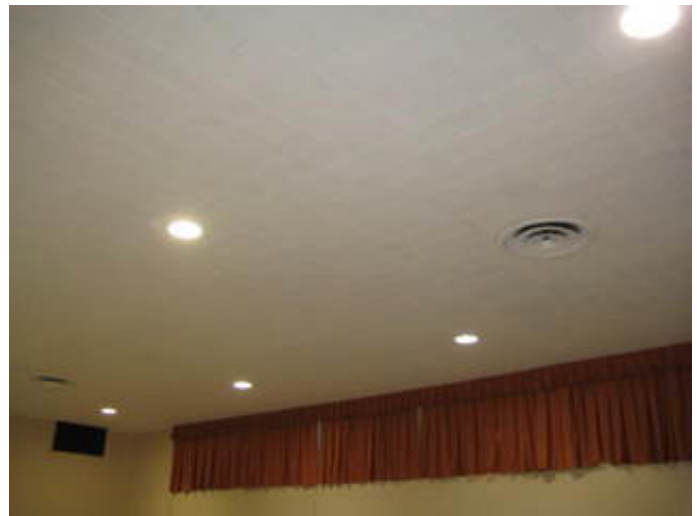
Multi-Purpose Room (Student Dining / Gymnasium) Recessed Metal Halide Light Fixtures

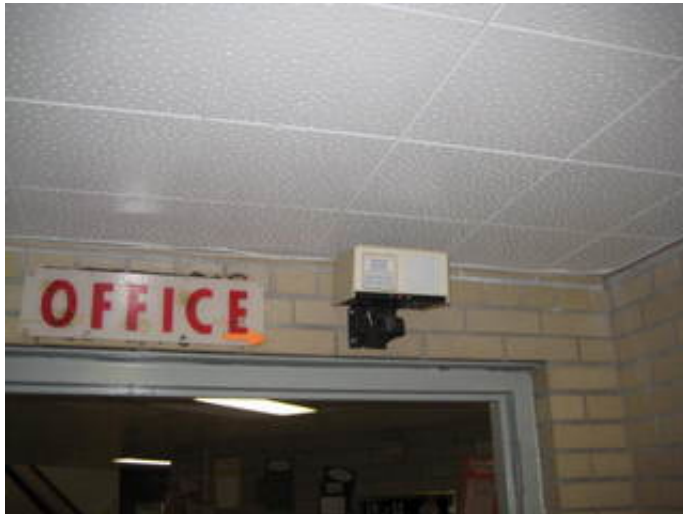
Rating: 3 Needs Replacement

Security System Motion Detection Device

Recommendations: Provide complete replacement of security system to meet Ohio School Design Manual guidelines. Provide complete replacement of exterior site lighting system to meet Ohio School Design Manual guidelines. Provide additional playground fencing to meet Ohio School Design Manual guidelines, funding included in complete replacement of security system. 06-22-18 Assessment Update: Provide for modifications on existing main entrance to provide for a security vestibule.

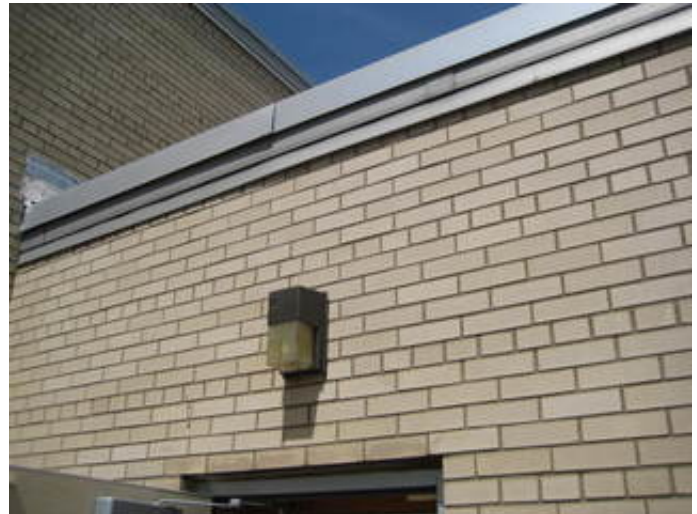
Surface Mounted HID High Pressure Sodium Light Fixture

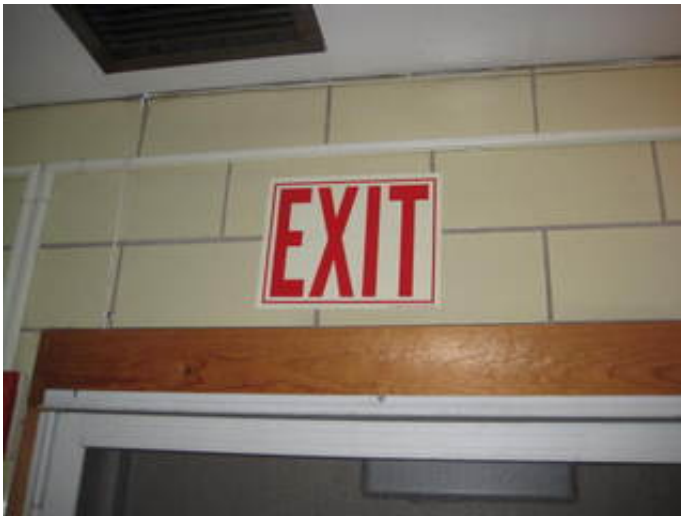
Rating: 3 Needs Replacement

Non-Compliant Non-illuminated Exit Sign

Recommendations: Provide complete replacement of emergency / egress lighting system to meet Ohio School Design Manual guidelines.

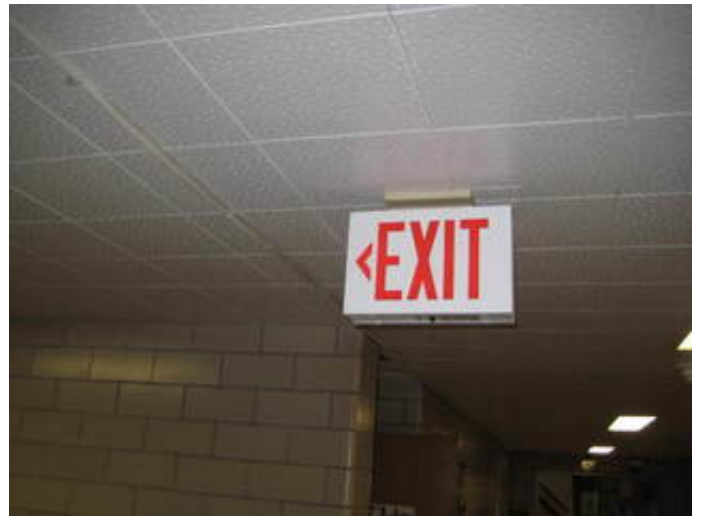
Non-Compliant Illuminated Exit Sign

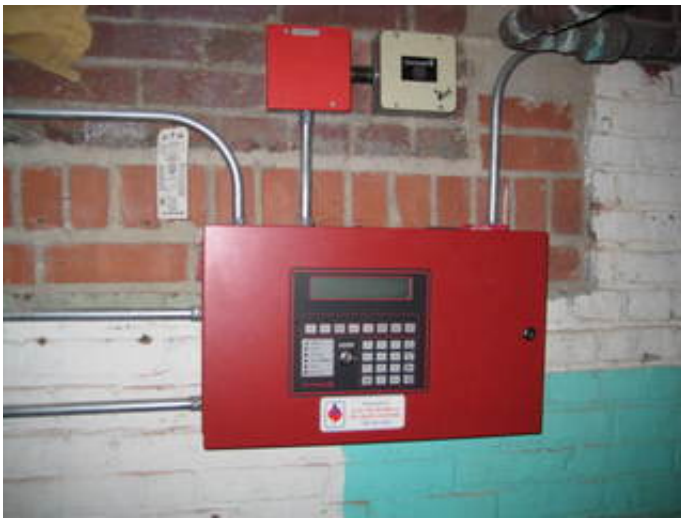
Rating: 3 Needs Replacement

Fire Alarm System Control Panel

Recommendations: Provide complete replacement of fire alarm system to meet OBC, NFPA, and Ohio School Design Manual guidelines.

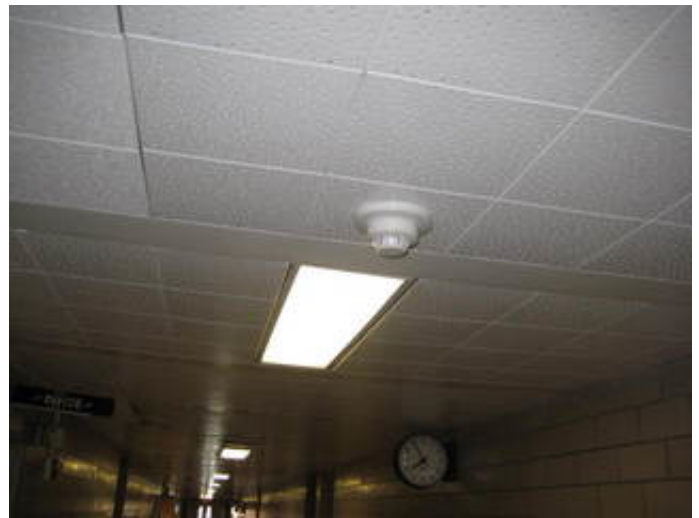
Fire Alarm System Smoke Detection Device

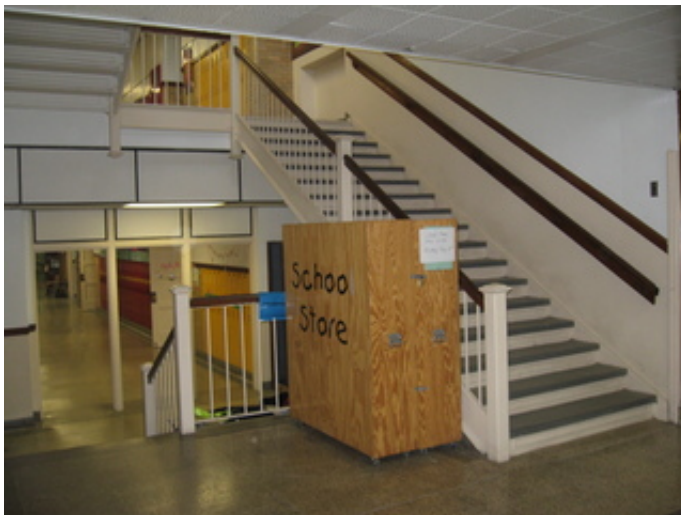
Typical Multi-Level Stairwell in the 1930 Original Construction

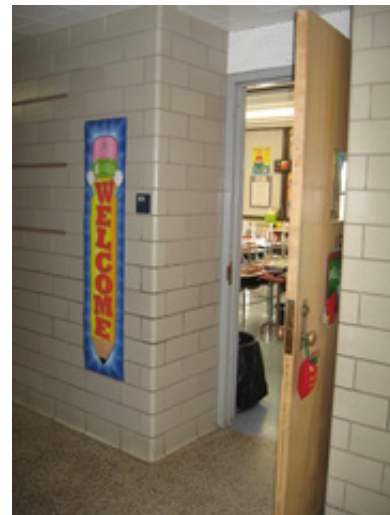
Typical Recessed Classroom Door In the 1957 Addition

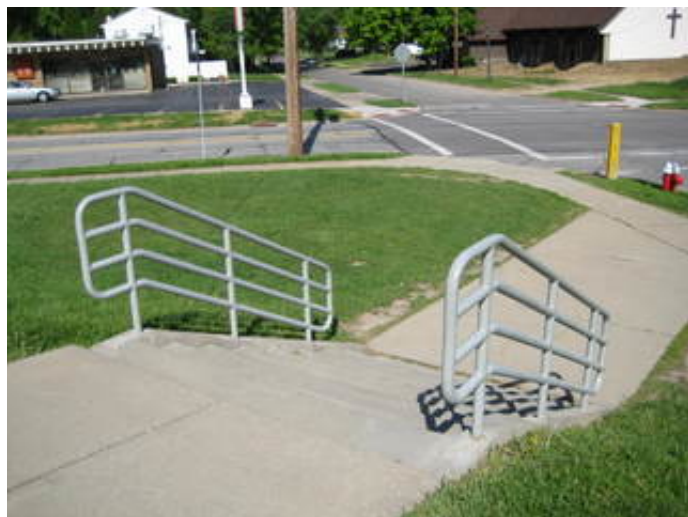
2 Needs Repair

Exterior Stairs and Handrails

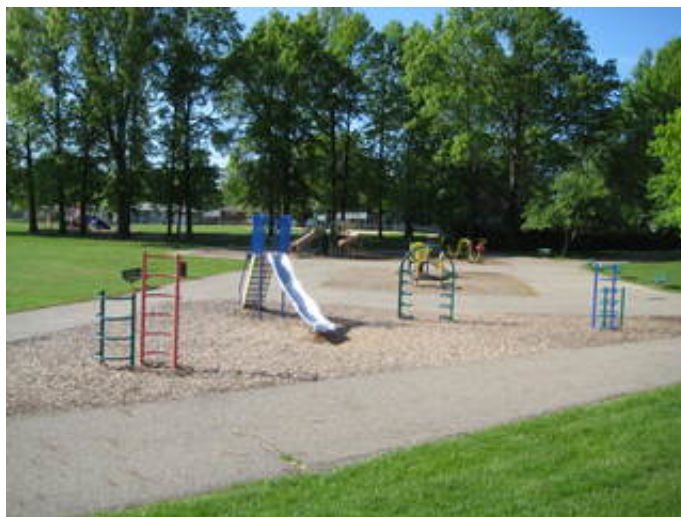
Playground Equipment

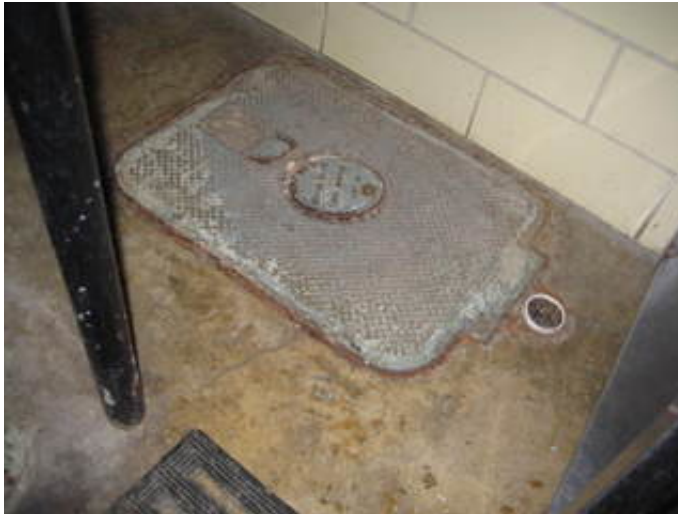
Kitchen Grease Trap Interceptor

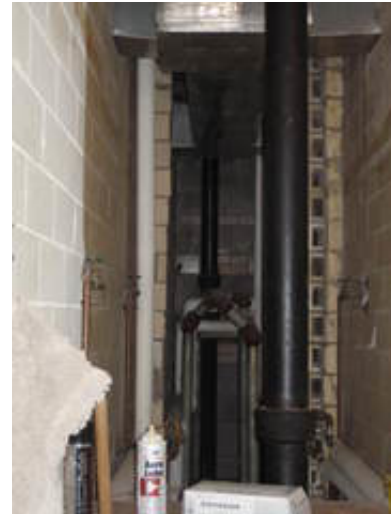
Sanitary Waste Piping

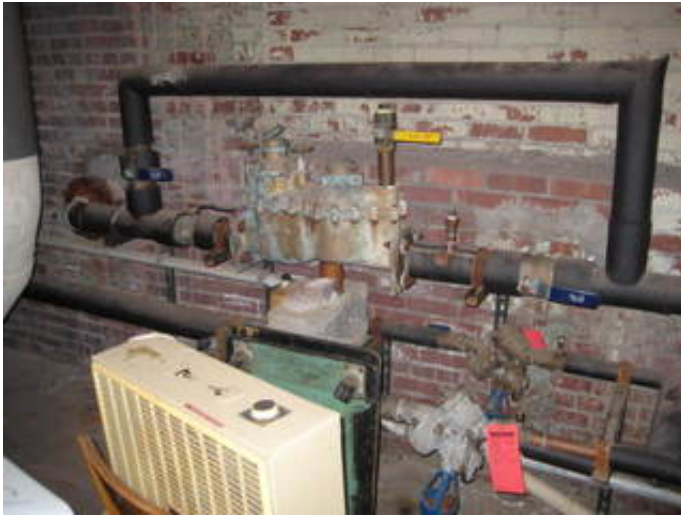
Incoming Domestic Water Service Line

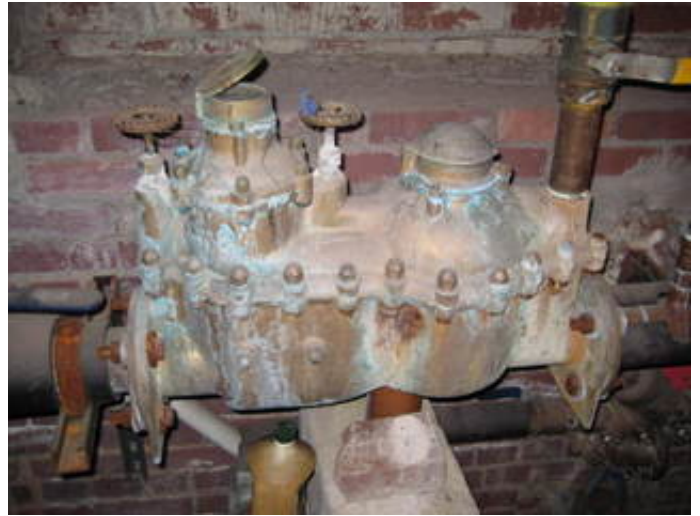
Incoming Domestic Water Service Meter

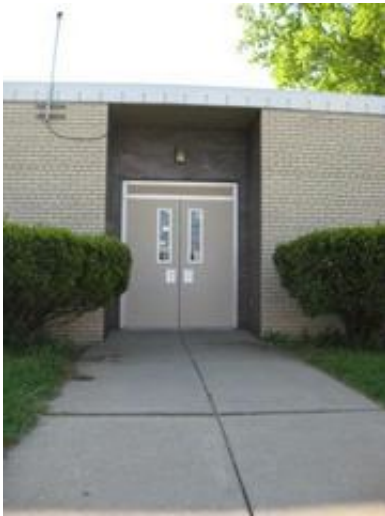
Rating: 3 Needs Replacement

Typical Entrance Door in the Overall Facility

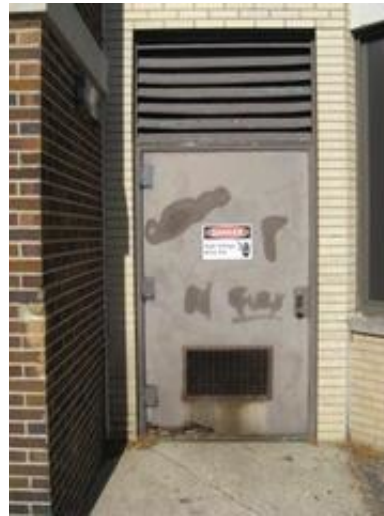
Condition of Exterior Hollow Metal Door in the 1930 Original Construction

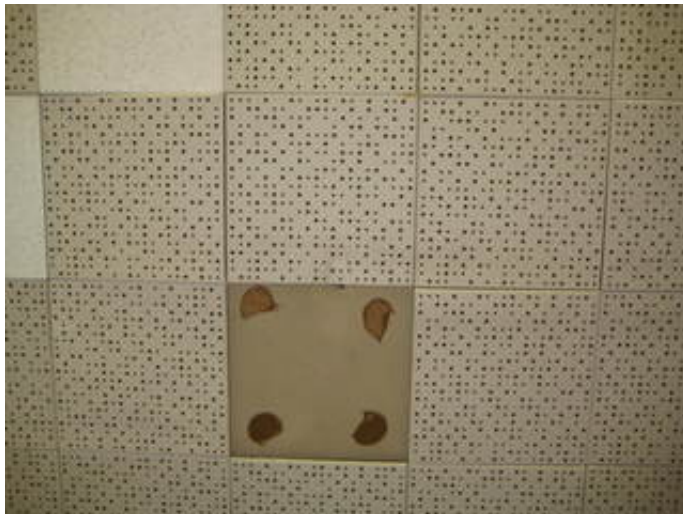
Acoustical Tile Ceiling

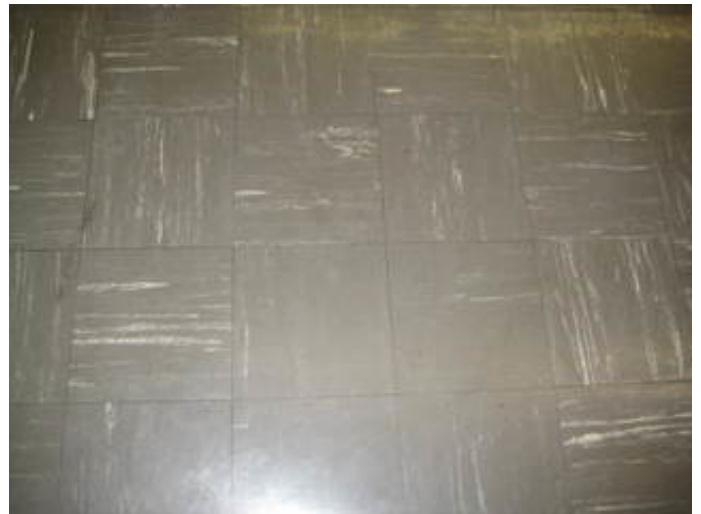
VAT is Classrooms

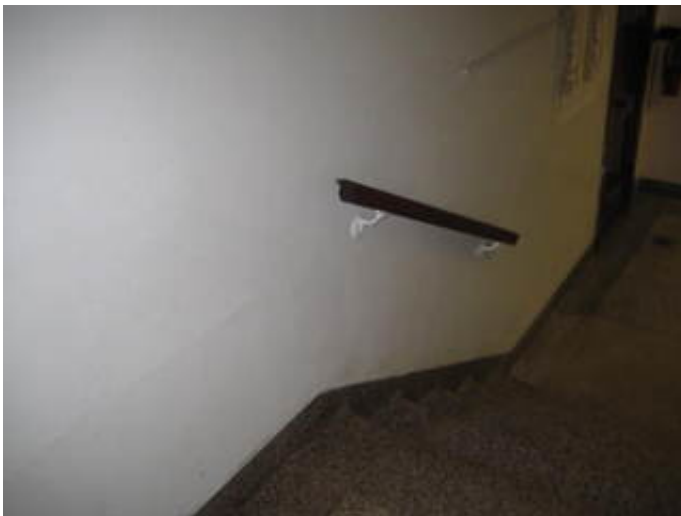
Non-Compliant Handrail

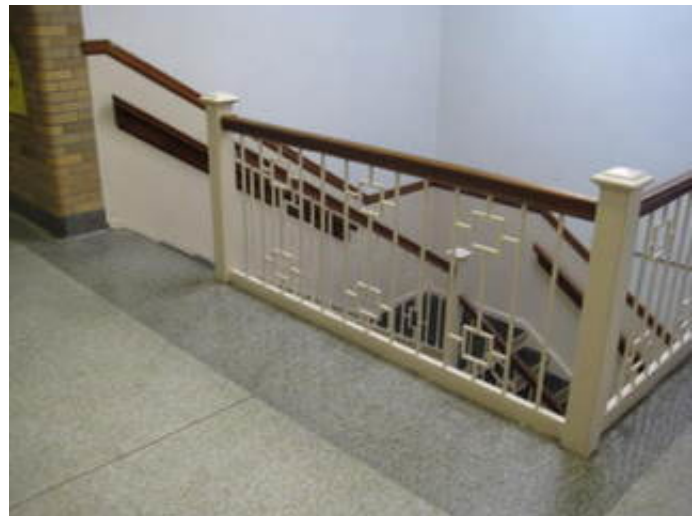
Non-Compliant Guardrail

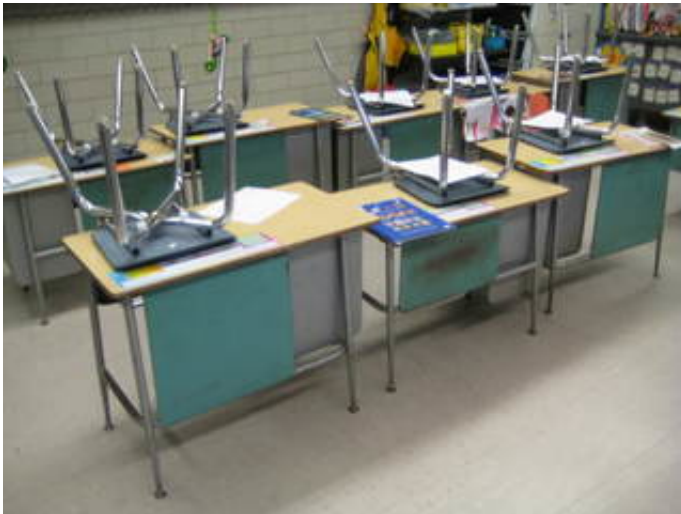
Typical Student Desks

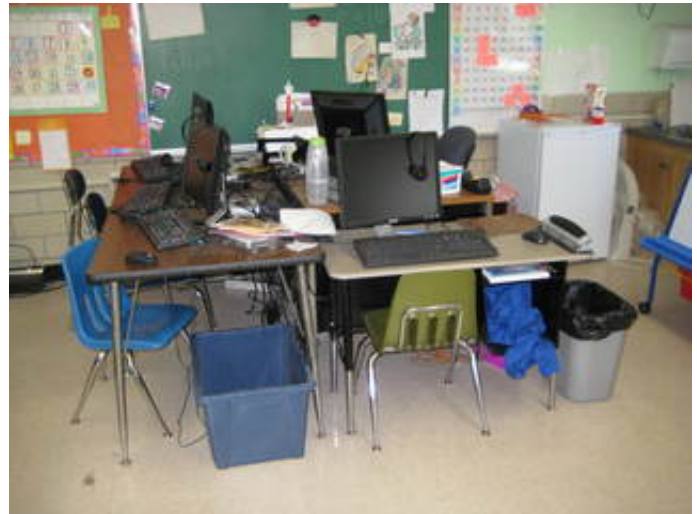
Computer Workstation

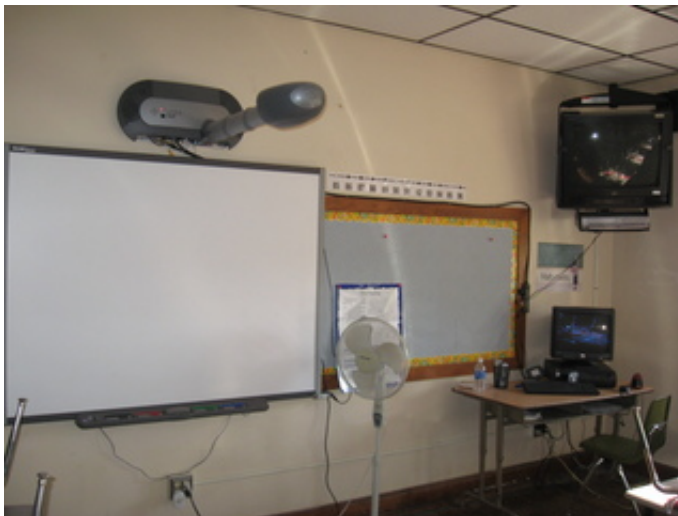
Typical Classroom Technology With Smart Board

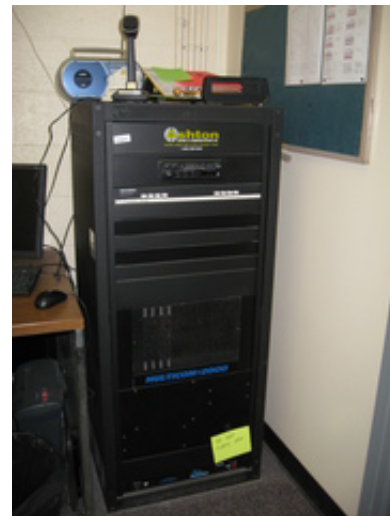
Non-Compliant Building PA System
