Building Information - Cuyahoga Falls City (43836) - Newberry Elementary

Program Type	Classroom Facilities Assistance Program (CFAP) - Regular
Setting	Suburban
Assessment Name	Newberry_ES_June_2009_Jan_2015_EEA_June_2018_Desktop_Update
Assessment Date (on-site; non-EEA)	2015-01-06
Kitchen Type	Full Kitchen
Cost Set:	2018
Building Name	Newberry Elementary
Building IRN	27029
Building Address	2800 13th Street
Building City	Cuyahoga Falls
Building Zipcode	44223
Building Phone	(330) 920-3621
Acreage	10.00
Current Grades:	PK-8
Teaching Stations	25
Number of Floors	1
Student Capacity	342
Current Enrollment	144
Enrollment Date	2009-04-14
Enrollment Date is the date in which the current enrollment was taken.	
Number of Classrooms	23
Historical Register	NO
Building's Principal	Mr. Walter Davis
Building Type	Elementary

Building Construction Information - Cuyahoga Falls City (43836) - Newberry Elementary (27029)

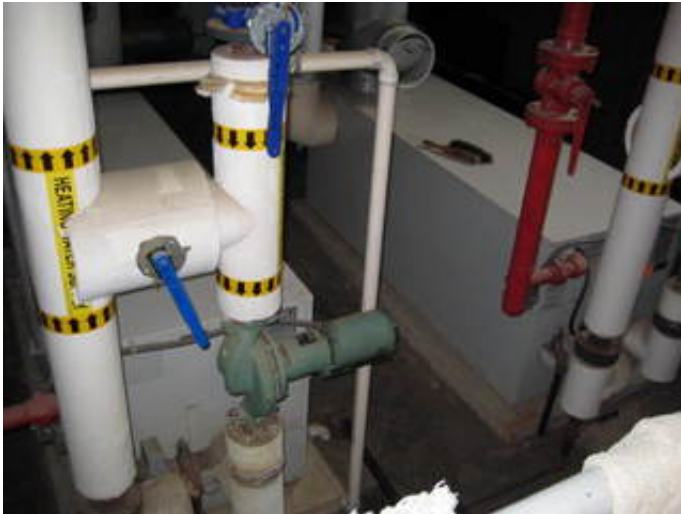
The existing system for the 1956 Original Construction is a natural gas fired heated water boiler type system, installed in 1956, and is in poor condition. The system in the 1957 Addition is an extension of that found in the 1956 Original Construction. 2-pipe vs. 4-pipe designations are not applicable in this facility, as no central air conditioning is provided. The two (2) copper fin II boilers, manufactured by Lochinvar, were installed in 1998 and are in fair condition. Heating water is distributed to terminal units consisting of unit ventilators, cabinet heaters, unit heaters, fin tubes, and air handlers. The terminal equipment is original to each addition and is in fair to poor condition. The system does not comply with the 15 CFM per person fresh air requirements of the Ohio Building Code mechanical code and Ohio School Design Manual. The pneumatic type system temperature controls are original to each addition, with upgrades in 1999, and are in fair condition. The system does not feature individual temperature controls in all spaces required by the OSDM. The overall system does not feature any central energy recovery systems. The facility is not equipped with louvered interior doors to facilitate Corridor utilization as return air plenums. The existing system in the Multi-Purpose Room (Student Dining / Gymnasium) is ducted, but the ductwork cannot be integrated into a possible future system due to arrangement, air volume, and routing of existing ductwork. The existing system in the remainder of the overall facility is not ducted, and floor to structural deck heights will accommodate the installation of properly sized ductwork for a future Ohio School Design Manual approved system. The overall heating system is evaluated as not being in safe and efficient working order, and long term life expectancy of the existing system is not anticipated. The structure is not equipped with a central air conditioning system. The site does not contain underground fuel tanks.

3 Needs Replacement

Natural Gas Fired Heated Water Boilers

Provide new overall heating, ventilating, and air conditioning system to achieve compliance with Ohio Building Code and Ohio School Design Manual standards. Convert the overall facility, except for the Multi-Purpose Room (Student Dining / Gymnasium) to a ducted system to facilitate efficient exchange of conditioned air. Replace existing ductwork in the Multi-Purpose Room (Student Dining / Gymnasium) to facilitate efficient exchange of conditioned air with pricing included in conversion to ducted system replacement.

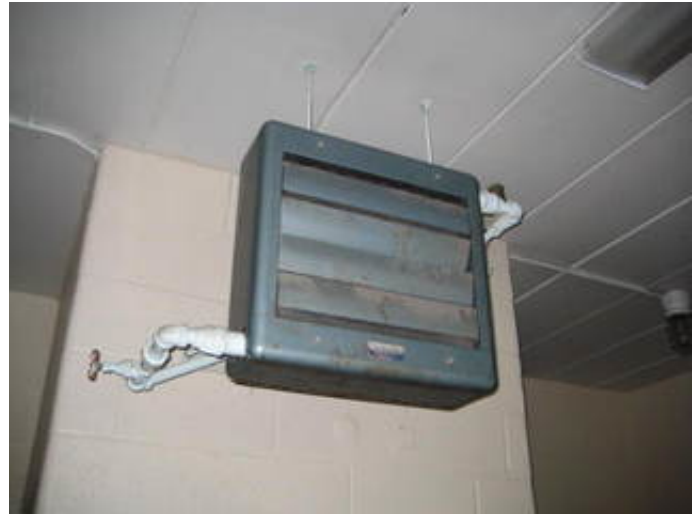
Heating Water Unit Heater

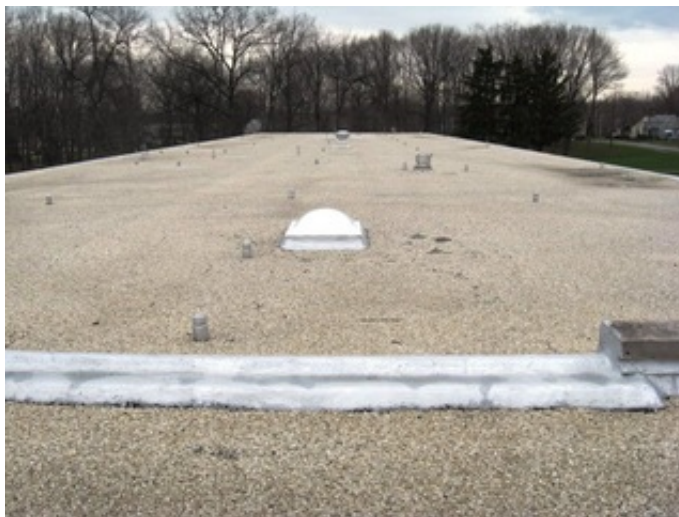
The roof over the overall facility is an asphalt built-up roof with gravel wear coat system that was installed in 1999, and is in fair condition. There are no District reports of current leaking. Signs of past leaking were also observed during the physical assessment. Access to the roof was gained by a roof access hatch and interior access ladder that are in fair to poor condition. Fall safety protection cages are not required, and are not provided. The roof over the Multipurpose space, Locker Rooms, and Warming Kitchen was inaccessible during the physical assessment due to a missing exterior roof access ladder. There were observations of standing water on the roof. Metal cap flashings and stone copings are in good to fair condition. Roof storm drainage is addressed through a system of roof drains, which are properly located, and in good condition. The roof is not equipped with overflow roof drains, though they are required on the roof over the Multipurpose space, Locker Rooms, and Warming Kitchen. No problems requiring attention were encountered with any roof penetrations. There are not any covered walkways attached to this structure. 06-22-18 Assessment Update: The roof replacement quantity for the 1956 Original Building is incorrect. Square foot quantity should be 36,766. Additional roof insulation required to meet LEED energy efficiency requirements.

3 Needs Replacement

Typical Roof Over North Classroom Wing With Skylights

The roof over the overall facility requires replacement to meet Ohio School Design Manual guidelines due to condition. The fascia on the overall facility requires replacement due to condition. Replace roof access hatch and interior access ladder due to condition. Install new exterior roof access ladder required for access to upper roof. 10-02-14 Update: Existing roof was installed over 2 previous roofs. Provide budget for additional roof tear-off. Coping will need replaced as part of roof tear-off and replacement. Provide budget for coping replacement. 06-22-18 Assessment Update: Revise sf roof replacement quantity on 1956 Original Building from 34,748 sf to 36,766 sf. Provide for additional roof insulation to meet LEED energy efficiency requirements.

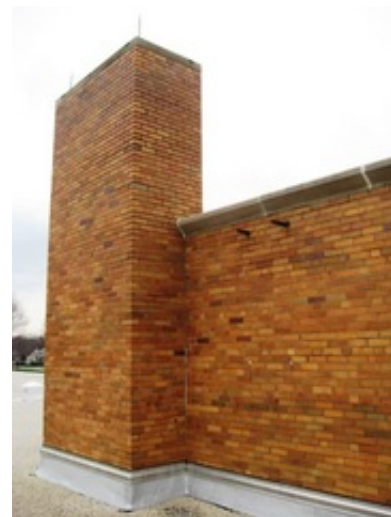
Missing Roof Access Ladder

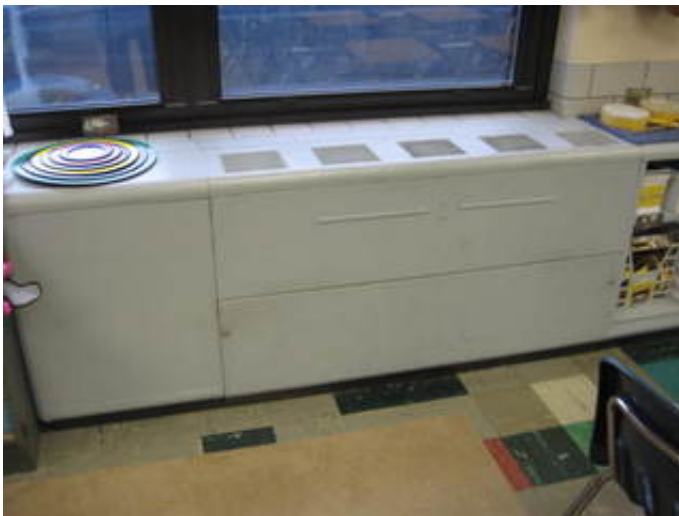
Description: The overall facility is not equipped with a central air conditioning system. Window units are provided in the Teacher's Lounge, several Classrooms, Server Room, Administrative Offices, Clinic, and Principal's Office locations. The ventilation system in the overall facility consists of unit ventilators, original to each addition and in fair condition, providing fresh air to Classrooms, and unit ventilators and air handlers, original to each addition and in fair condition, providing fresh air to other miscellaneous spaces such as the Multi-Purpose Room (Student Dining / Gymnasium) and Media Center. Relief air venting is provided by unit ventilators, air handlers, ceiling plenums, and central relief fans. The ventilation system does not meet the Ohio Building Code 15 CFM per occupant fresh air requirement. The overall system is not compliant with Ohio Building Code and Ohio School Design Manual requirements. Dust collection systems are not required in this facility. Exhaust systems for Restrooms, Storage Rooms, Custodial Closets, Maintenance Workrooms, Kitchen Dry Food Storage, Locker Rooms, P.E. Workroom & Storage, and Art Rooms are inadequately placed, and in poor condition. The Art Program is equipped with a kiln, and the existing kiln ventilation system is adequate. 06-22-18 Assessment Update: General building exhaust is included in Item A and should not be included in this line item.

Unit Ventilator

Recommendations: Provide an air conditioning system to meet with Ohio Building Code and Ohio School Design Manual requirements. Pricing included in Item A. Replace the existing general building exhaust system. 06-22-18 Assessment Update: Delete general building exhaust.

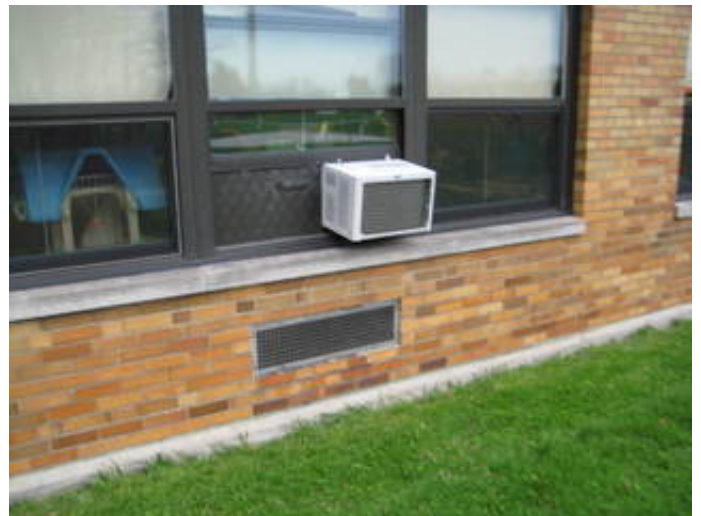
Window AC Unit

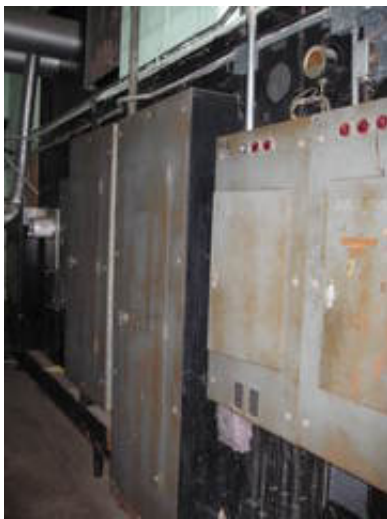
Description: The electrical system provided to the overall facility is a 120/208 volts, 400 amp, 3 phase and 4 wire system installed in 1956, and is in poor condition. The system in the 1957 Addition is an extension of that found in the 1956 Original Construction. Power is provided to the school by multiple City of Cuyahoga Falls owned, pad-mounted transformers located in a vault outside the Mechanical Room, and in fair condition. The panel system, installed in 1956, is in poor condition, and cannot be expanded to add additional capacity. The Classrooms are not equipped with adequate electrical outlets. The typical Classroom contains four (4) general purpose outlets, zero (0) dedicated outlets for each Classroom computer, and zero (0) dedicated outlets for each Classroom television. Some Classrooms are equipped with as many as six (6) general purpose outlets, while others are equipped with as few as three (3) general purpose outlets. There are not any spaces that have no electrical outlets. The Corridors are not equipped with adequate electrical outlets for servicing. Adequate GFI protected exterior outlets are not provided around the perimeter of the building. The facility is not equipped with an emergency generator. Adequate lightning protection safeguards are not provided. Stage lighting power system including control panel, breakers, and dimmers is inadequately provided, in fair to poor condition and does not meet OSDM requirements. The overall electrical system does not meet Ohio School Design Manual requirements in supporting the current needs of the school, and will be inadequate to meet the facility's future needs.

Rating: 3 Needs Replacement

Main Electrical Distribution Panel

Recommendations: The entire electrical system requires replacement to meet Ohio School Design Manual guidelines for overall capacity and Classroom capacity due to age, condition, lack of OSDM-required features, and to accommodate the addition of an air conditioning system. Provide new transformer due to age and condition, with funding to be coordinated with the utility company. Provide an emergency generator, with funding included in the electrical system replacement. Provide adequate lightning protection safeguards in the overall facility, including associated grounding system, with funding included in the electrical system replacement. Provide control panel, dimmers, and breakers to support the Stage lighting system, with funding included in the electrical system replacement.

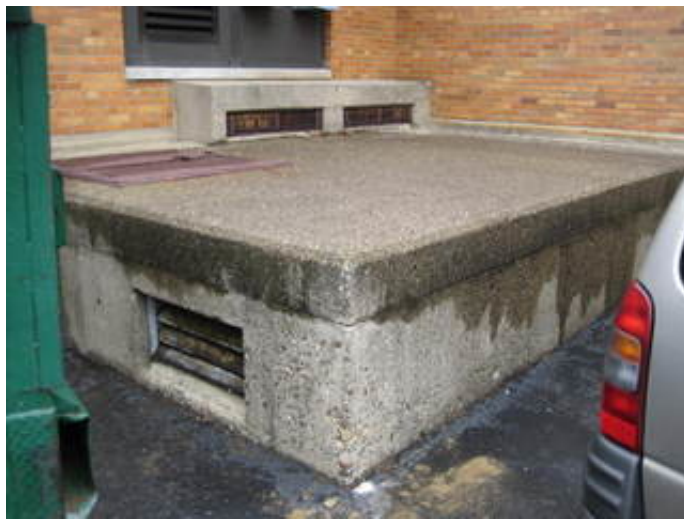
Pad Mount Transformer Vault

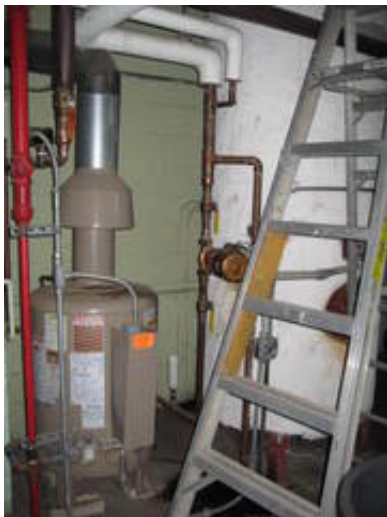
The service entrance is not equipped with a reduced pressure backflow preventer. A water treatment system is not provided, though none is needed. The domestic water supply piping in the overall facility is galvanized and copper, is original to each addition, and is in fair condition. The waste piping in the overall facility is cast iron, is original to each addition, and is in fair condition. The facility is equipped with an A.O. Smith 50 gallon electric water heater, installed in 2004, and in good condition. The facility is also equipped with one (1) A.O. Smith natural gas domestic water boiler, installed in 1998, in fair to poor condition, with one (1) separate 250 gallon storage tank, installed in 1965, in poor condition. The overall facility contains 2 Large Group Restrooms for boys, 2 Large Group Restrooms for girls, 1 Locker Room Restroom for boys, 1 Locker Room Restroom for girls, 0 Locker Room Restrooms for staff, 1 Kitchen Restroom, 1 Health Clinic Restroom, 2 Restrooms associated with Kindergarten / Pre-K Classrooms / Specialty Classrooms, and 2 Restrooms for staff. Boys' Large Group Restrooms contain 1 ADA and 3 non-ADA wall mounted flush valve toilets, 12 non-ADA floor mounted central flush urinals, as well as 1 ADA and 3 non-ADA wall mounted lavatories. Girls' Large Group Restrooms contain 1 ADA and 9 non-ADA wall mounted flush valve toilets, as well as 1 ADA and 3 non-ADA wall mounted lavatories. Boys' Locker Room Restroom contains 1 non-ADA wall mounted flush valve toilet, 1 non-ADA floor mounted flush valve urinal, 1 non-ADA wall mounted lavatory, as well as 3 non-ADA showers. Girls' Locker Room Restroom contains 1 non-ADA wall mounted flush valve toilet, 1 non-ADA wall mounted lavatory, as well as 3 non-ADA showers. Staff Restrooms contain 2 non-ADA (1 wall / 1 floor) mounted flush valve toilets, 1 non-ADA floor mounted flush valve urinal, as well as 2 non-ADA wall mounted lavatories. Condition of fixtures is fair to poor. The facility is equipped with 3 non-ADA drinking fountains, as well as 1 ADA electric water cooler, in fair condition. Elementary Classrooms are adequately equipped with required lavatory mounted type drinking fountains, which are not ADA compliant, and are in fair to poor condition. Special Education Classroom is not equipped with the required Restroom facilities. Kitchen is equipped with the required Restroom which contains 1 non-ADA wall mounted flush valve toilet, as well as 1 non-ADA wall mounted lavatory, and fixtures are in fair to poor condition. Health Clinic is equipped with the required Restroom which contains 1 non-ADA wall mounted flush valve toilet, located in a separate room, as well as 1 non-ADA wall mounted lavatory, and fixtures are in fair to poor condition. Kindergarten / Pre-K Classrooms are equipped with Restroom facilities which contain 2 non-ADA floor mounted flush valve toilets, located in separate rooms, as well as 2 non-ADA wall mounted lavatories, and fixtures are in fair to poor condition. Kitchen fixtures consist of one (1) triple-compartment sink, one (1) single-compartment sink, and one (1) dishwashing unit with built-in Hatco water heater, which are in fair condition. The Kitchen is equipped with two (2) unsatisfactory grease interceptors due to age, condition, and insufficient capacity. The Kitchen is not provided the required 140 degree hot water supply. The school meets the OBC requirements for fixtures except for electric water coolers. Per OBC and OSDM requirements this facility should be equipped with 12 toilets, 6 urinals, 12 lavatories, and 4 electric water coolers, and at present it is equipped with 22 toilets, 14 urinals, 16 lavatories, and 1 electric water cooler. ADA requirements are not met for fixtures and drinking fountains (see Item O). Custodial Closets are properly located and are adequately provided with required service sink or floor drain sink, which is in fair condition. CONTINUED

3 Needs Replacement

Domestic Water Heater and Storage Tank

Replace galvanized water supply piping in the overall facility with copper piping due to age and condition. Replace sanitary waste piping in the overall facility due to age and condition. To facilitate the school's compliance with OBC and OSFC requirements, provide 1 new electric water cooler. Due to age, condition, and OSFC standards, replace 8 lavatory mounted type drinking fountains, 16 lavatories, 22 toilets, 14 urinals, and 1 electric water cooler. See Item O for replacement of fixtures related to ADA requirements. See Item J for provisions on Kitchen related equipment. Provide the service entrance with a reduced pressure back flow preventer. Replace the A.O. Smith domestic water boiler and 250 gallon storage tank due to age and condition. Replace the Kitchen grease trap interceptors due to age, condition, and insufficient capacity. Provide the Kitchen with a water booster heater. Provide 2 additional exterior wall hydrants. Replace the existing Custodial Closet service sinks due to age and condition.

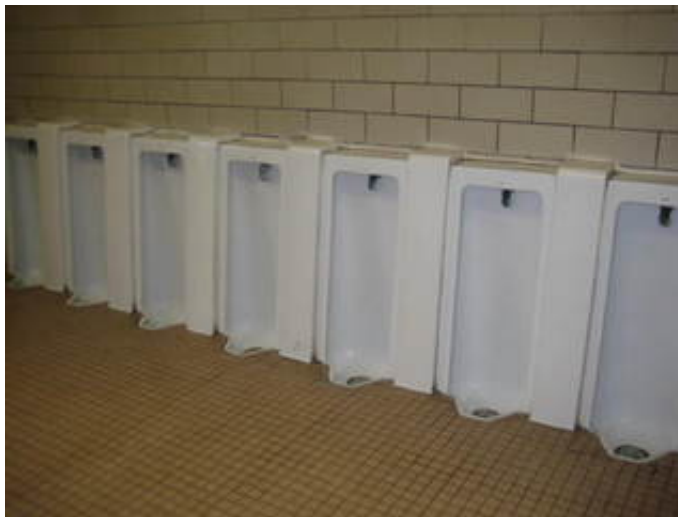
Central Flush Floor Mounted Urinals

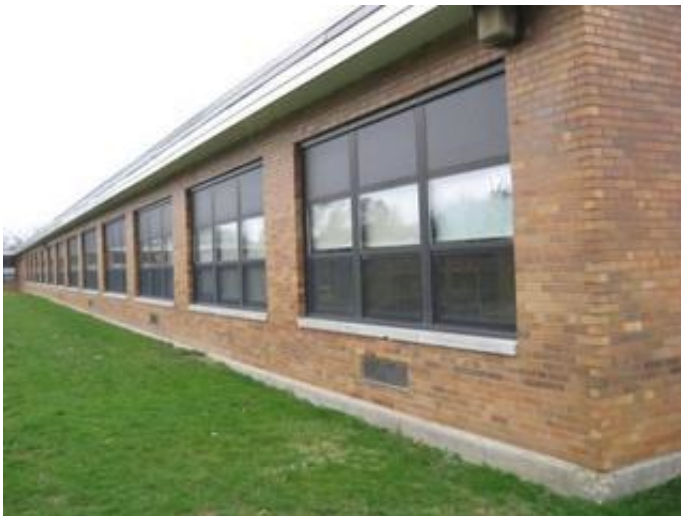
Description: The overall facility is equipped with thermally broken frame windows with double glazed insulated glazing and insulated panel type window system, which was installed in 2000, and is in good condition. Window system seals are in good condition, with no air and water infiltration being experienced. Window system hardware is in good condition. The window system features surface mounted shades, which are in good to fair condition. The window system is equipped with insect screens on operable windows, which are in good to fair condition. This facility is not equipped with any curtain wall systems. This facility does not feature any glass block windows. The exterior doors in the overall facility are equipped with thermally broken aluminum frame sidelights and transoms with double glazed insulated glazing, in good condition. The school does contain 2 acrylic bubble type skylights on aluminum frames in fair condition. Window security grilles are not provided for ground floor windows. There is no Greenhouse associated with this school 06-22-18 Assessment Update: Since windows are being replaced, line items for insect screen replacement and surface window blind replacement not required.

Rating: 2 Needs Repair

Typical Classroom Windows in the 1956 Original Construction

Recommendations: Replace skylights in the overall facility. Replace damaged insect screens as required through the overall facility. Replace damaged surface mounted shades as required through the overall facility. Replace single pane vision panels in all exterior doors through the overall facility. 10-02-14 Update: Exterior finish on windows deteriorated and chalking. Operable sashes not working and seals broke. Revise Window Replacement line item from 0 sf to 6,344 sf at 1956 Original Building and from 0 sf to 288 sf at 1957 Addition. 06-22-18 Assessment Update: Delete insect screen replacement line item. Delete replace surface blind line item.

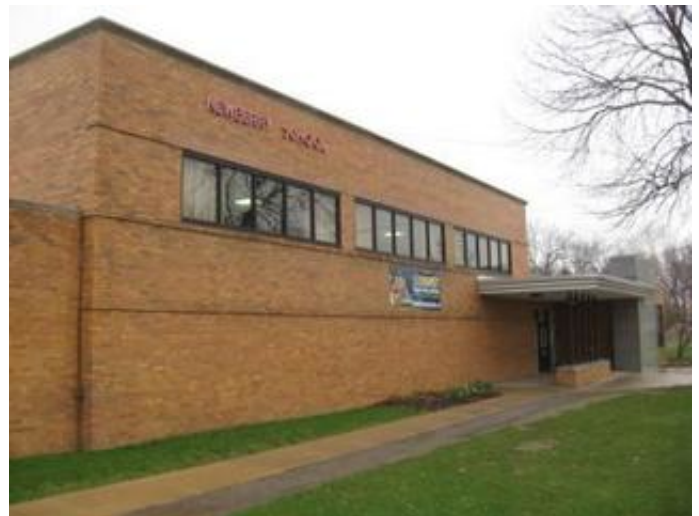
Windows in the Multi-Purpose Room

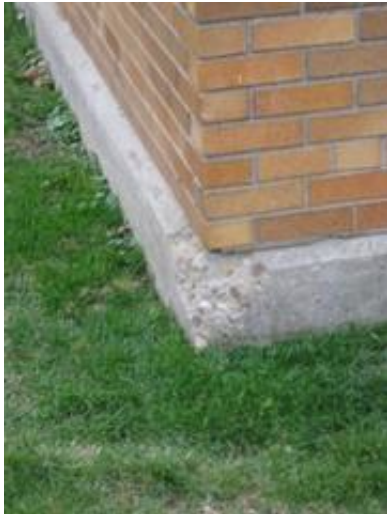
Description: The overall facility is equipped with concrete foundation walls on concrete footings, which displayed no locations of significant differential settlement. 06-22-18 Assessment Update: District personnel reported sections of the underground storm piping has collapsed many times. Areas of minor cracking and spalling were observed. The District reports that there has been past leaking through foundation walls into building crawl space due to internal storm drain openings. The District indicated that some remedial work has been done to correct the problem but there are still areas that leak. No grading or site drainage deficiencies were noted around the perimeter of the structure that are contributing or could contribute to foundation / wall structural deterioration.

Rating: 2 Needs Repair

Exposed Concrete Foundation at Grade

Recommendations: Address foundation leak issues as required through the overall facility. Repair minor cracks and spalling as required through the overall facility. 06-22-18 Assessment Update: Provide for new underground storm piping.

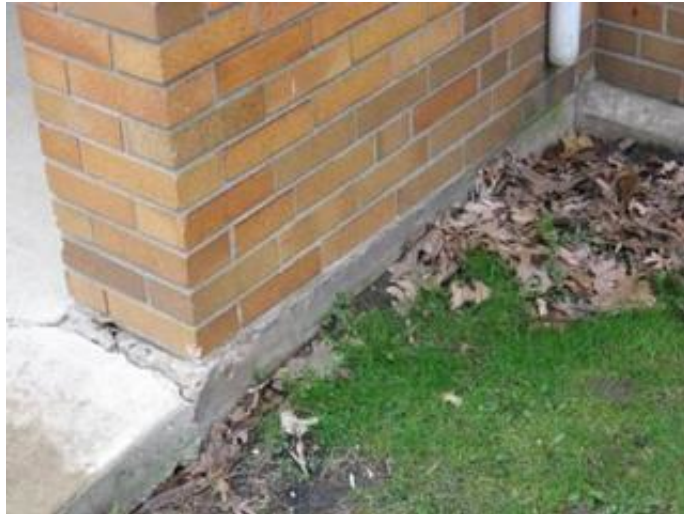
Exposed Concrete Foundation at Building Entry

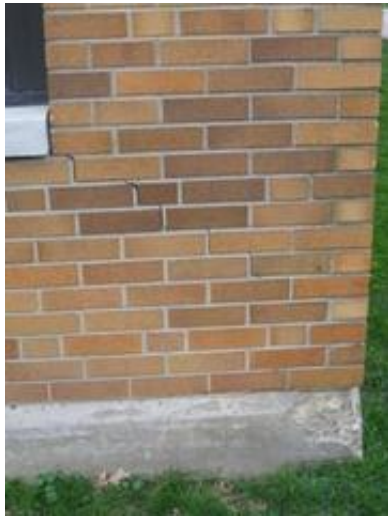
Description: The overall facility has a brick veneer on a masonry bearing wall system, which displayed locations of deterioration, and is in fair condition. The exterior masonry does not contain control joints. The school does have sufficient expansion joints, and they are in fair to poor condition. The exterior masonry has not been cleaned and sealed in recent years, and shows evidence of mortar deterioration and locations of staining. Architectural exterior accent material consists of stone which is in fair condition. Interior walls are painted concrete masonry units and glazed block and are in good to fair condition. Interior masonry appears to have adequately spaced and caulked control joints in good condition. The window sills are stone and an element of the aluminum window system, and are in good to fair condition. The exterior lintels are steel, and are rusting in fair condition. The chimney is in fair condition requiring masonry tuckpointing, cleaning and sealing. Canopies over entrances are plaster and concrete type construction, and are in fair condition. A loading dock has not been provided to facilitate unloading of trucks and receipt of product / supplies / foodstuffs.

Rating: 2 Needs Repair

Area Requiring Masonry Repairs in the 1956 Original Construction

Recommendations: Provide tuckpointing in all areas of mortar deterioration as required through the overall facility. Provide masonry cleaning, sealing and caulking as required through the overall facility. Sawcut and caulk new appropriately spaced control joints in existing masonry through the overall facility. Recaulk existing expansion joints as required through the overall facility. Prep and paint exposed steel lintels through the overall facility. Repoint stone window sill joints through the overall facility. Provide masonry repairs as required through the overall facility. Repair chimney masonry as required. Repoint stone copings in the 1956 Original Construction. Prep and paint exterior soffits as required through the overall facility. Provide masonry infill for unit ventilator exterior wall openings as required through the overall facility. 10-02-14 Update: Several stone Sills damaged beyond repair. Remove and replace stone window sills.

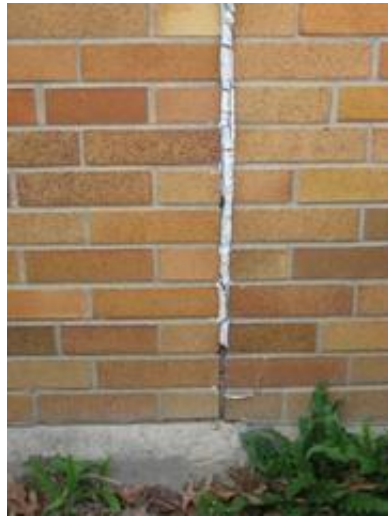
Typical Condition of Expansion Joints in Exterior Walls

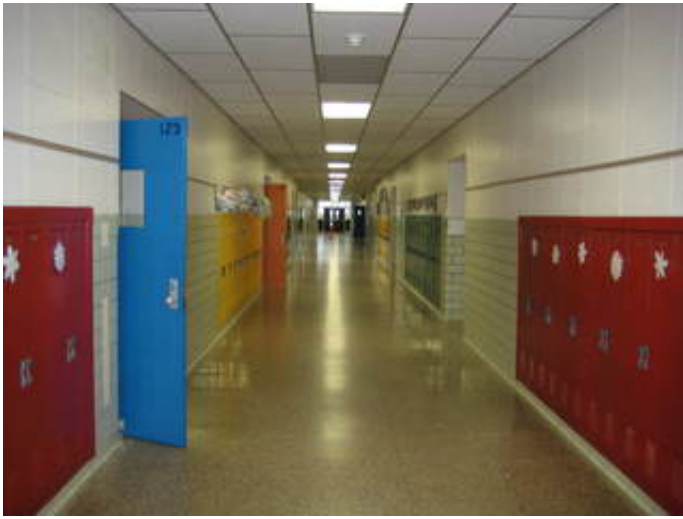
The overall facility features conventionally partitioned Classrooms with VAT, VCT, and carpet flooring, acoustical tile ceilings, as well as brick, glazed block, and painted block wall finishes, and they are in fair to poor condition. The overall facility has Corridors with terrazzo flooring, acoustical tile ceilings, as well as glazed and painted block wall finishes, and they are in fair condition. The overall facility has Restrooms with ceramic tile flooring, painted precast plank ceilings, as well as glazed and painted block wall finishes, and they are in fair condition. Toilet partitions are mostly metal, and are in poor condition. Classroom casework in the overall facility is metal type construction with metal tops, is inadequately provided, and in poor condition. The typical Classroom contains 12 lineal feet of casework, and Classroom casework provided ranges from 4 to 20 feet. Classrooms are provided adequate chalkboards, markerboards, and tackboards, which are in fair condition. The lockers, located in the Corridors, are adequately provided, and in fair to poor condition. The Art program is equipped with a kiln in fair to poor condition, and existing kiln ventilation is adequate. The facility is equipped with hollow metal non-louvered interior doors that are partially recessed without proper ADA hardware and clearances, and in fair condition. The Gymnasium spaces have VCT flooring, acoustical tile ceilings, as well as painted block wall finishes, and they are in fair to poor condition. Gymnasium telescoping stands are wood type construction in fair condition. Gymnasium basketball backboards are fixed type, and are in good condition. The Media Center, located in the 1956 Original Construction, has carpet type flooring, acoustical tile ceilings, as well as glazed and painted block wall finishes, and they are in good condition. Student Dining shares the Gymnasium space. OSDM-required fixed equipment for Stage is inadequately provided, and in poor condition. The existing Kitchen is a Warming Kitchen only, is oversized based on current enrollment, and the existing Kitchen equipment, installed in 1956 with incremental upgrades, is in poor condition. The Kitchen hood is in poor condition, and is not equipped with the required UL 300 compliant wet chemical fire suppression system. The required 6" overhang on all three exposed sides of the cooking equipment is not provided by the hood. Kitchen hood exhaust ductwork is not of proper construction material and/or installed as required by the OSDM and OBMC. Reach-in refrigerators are located within the Kitchen spaces, are not commercial, and are in poor condition. 06-22-18 Assessment Update: Floor infill, patch, floor tile repair and wall tile repair will be required following removal of floor mounted urinals. Basketball backboards are worn and should be replaced with new operable units. Gandee Associates EEA report reflects the perforated cement board wall panels above corridor lockers contain Asbestos and are noted to be abated under item T. Framing and wall board required for build back after removal of the perforated board. Stage curtain is old and worn and should be replaced. Wood stage flooring is worn and should be replaced

3 Needs Replacement

Typical Corridor Finishes

Provide complete replacement of finishes and casework due to installation of systems outlined in Items A, C, D, E, I, K, L, M, N, T, U, and condition. 10-02-14 Update: Exterior walls are 8" block with 4" clay fired brick and no air cavity or insulation. Provide insulation of exterior walls to meet LEED energy requirements. Provide for the replacement of interior doors due to condition. Other doors are funded in Item O due to opening expansion. Provide for the replacement of Kitchen equipment due to age and condition. Provide for the replacement of the Kitchen exhaust hood due to age and condition. Provide for the replacement of toilet partitions due to condition. Provide for the replacement of toilet accessories due to condition. Provide for the replacement of Gymnasium seating due to condition. Provide for the replacement of the Art Program kiln due to condition. Provide for terrazzo repair as required in the 1956 Original Construction. 10-02-14 Update: Exterior walls are 8" block with 4" clay fired brick and no air cavity or insulation. Provide insulation of exterior walls to meet LEED energy requirements. 06-22-18 Assessment Update: Provide budget for floor infill, patch, floor tile repair and wall tile repair for removal of floor mounted urinals. Replace stage curtain. Replace wood stage flooring. Provide for wall build back following perforated wall board removal above lockers in corridors.

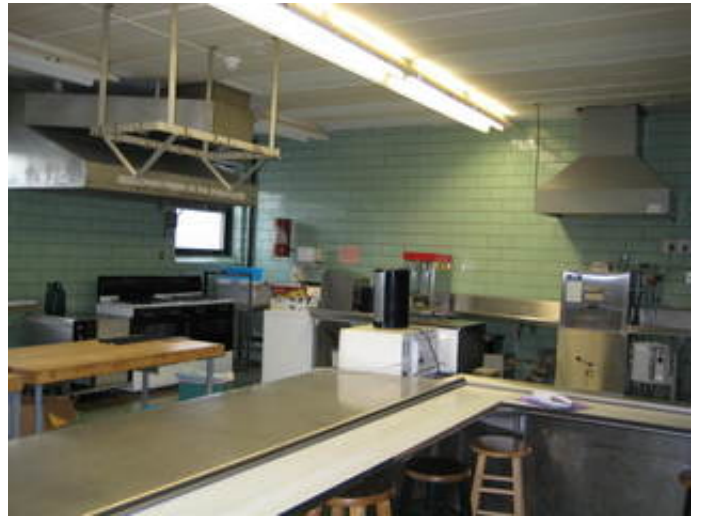
Warming Kitchen

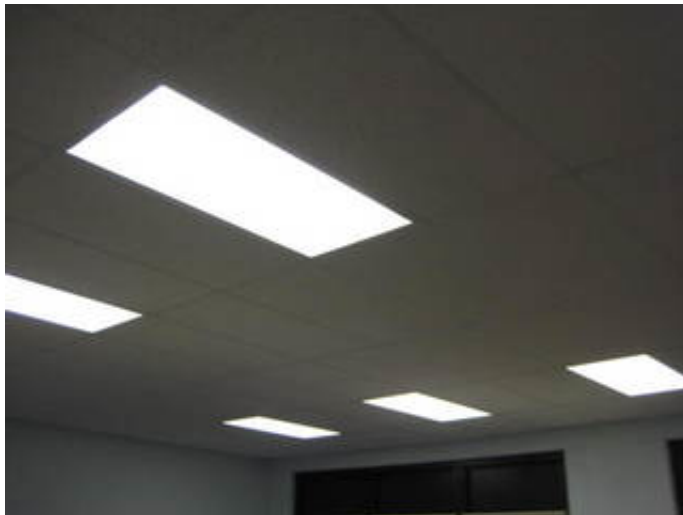
The typical Classrooms in the overall facility are equipped with some T-8 2x4 lay-in direct fluorescent fixtures with single level switching. Classroom fixtures are in fair condition, providing an average illumination of 53 FC, thus complying with the 50 FC recommended by the OSDM. The typical Corridors in the overall facility are equipped with T-8 2x4 lay-in direct fluorescent fixtures with single level switching. Corridor fixtures are in fair to poor condition, providing an average illumination of 20 FC, thus complying with the 20 FC recommended by the OSDM. The Multi-Purpose Room (Student Dining / Gymnasium) spaces are equipped with surface mount metal halide type lighting, in poor condition, providing an average illumination of 37 FC, which is less than the 50 FC recommended by the OSDM. The Media Center is equipped with T-8 2x4 lay-in direct fluorescent fixture type lighting in fair condition, providing an average illumination of 56 FC, thus complying with the 50 FC recommended by the OSDM. The Student Dining and Gymnasium spaces are incorporated into the Multi-Purpose Room (Student Dining / Gymnasium). The Kitchen spaces are equipped with T-8 1x4 surface mount fluorescent fixture type lighting with single level switching. Kitchen fixtures are in good condition, providing an average illumination of 76 FC, thus complying with the 75-80 FC recommended by the OSDM. The Service Areas in the overall facility are equipped with incandescent and T-8 1x4 surface mount fluorescent fixture type lighting in fair condition, providing inadequate illumination. The typical Administrative spaces in the overall facility are equipped with T-8 2x4 lay-in direct fluorescent fixture type lighting in good condition, providing adequate illumination based on OSDM requirements. The overall lighting systems of the facility are not compliant with Ohio School Design Manual requirements due to age, condition, inadequate lighting levels, lack of multi-level switching, and the utilization of incandescent fixtures.

3 Needs Replacement

Classroom Fluorescent Light Fixtures

Provide complete replacement of lighting system due to age, condition, inadequate lighting levels, lack of multilevel switching, the utilization of incandescent fixtures, and installation of systems outlined in Items A, C, J, and U.

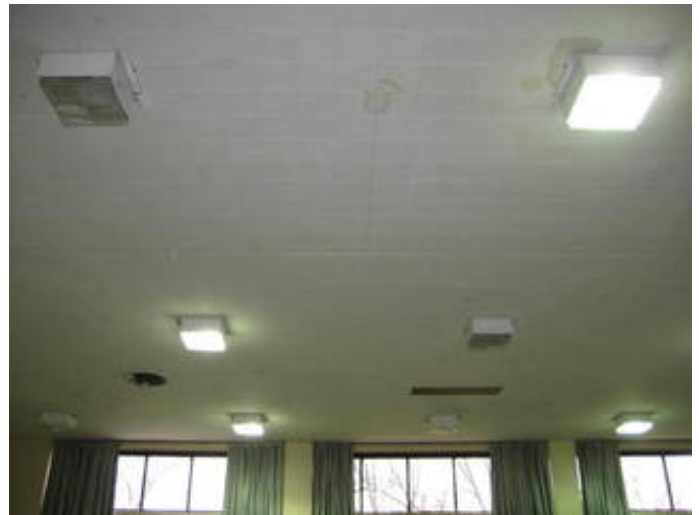
Multi-Purpose Room (Student Dining / Gymnasium) Metal Halide Light Fixtures

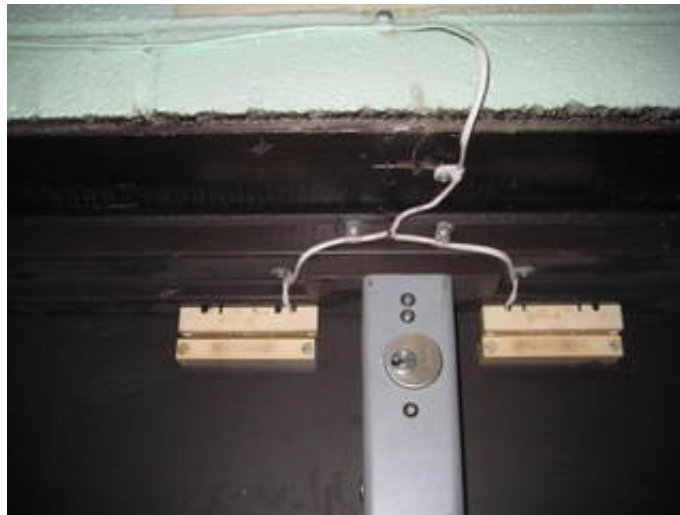
Description: The overall facility contains a Honeywell motion sensor and door contact type security system in fair condition. Motion detectors are inadequately provided in main entries, central gathering areas, offices, main Corridors, and spaces where 6 or more computers are located. Exterior doors are inadequately equipped with door contacts. An automatic visitor control system is not provided. Compliant color CCTV cameras are not provided at main entry areas, parking lots, central gathering areas, and main Corridors. A compliant computer controlled access control system integrating alarms and video signals, with appropriate UPS backup, is not provided. The system is not equipped with card / biometric readers. The security system is inadequately provided throughout, and the system is not fully compliant with Ohio School Design Manual guidelines. The site is not equipped with existing playground fencing per Ohio School Design Manual guidelines. The exterior site lighting system is equipped with surface mounted HID high pressure sodium entry lights in fair condition. Pedestrian walkways are not illuminated. Parking and bus pick-up / drop off areas are not illuminated. The exterior site lighting system provides inadequate coverage. 06-22-18 Assessment Update: The main entry into the building is not adjacent to the main office located on the East side of the 1956 Original Building and does not provide for adequate security. Modifications are required to achieve a secure main entrance into the building.

Rating: 3 Needs Replacement

Security System Door Contact

Recommendations: Provide complete replacement of security system to meet Ohio School Design Manual guidelines. Provide complete replacement of exterior site lighting system to meet Ohio School Design Manual guidelines. Provide playground fencing to meet Ohio School Design Manual guidelines, funding included in complete replacement of security system. 06-22-18 Assessment Update: Provide for modifications on existing main entrance to provide for a security vestibule.

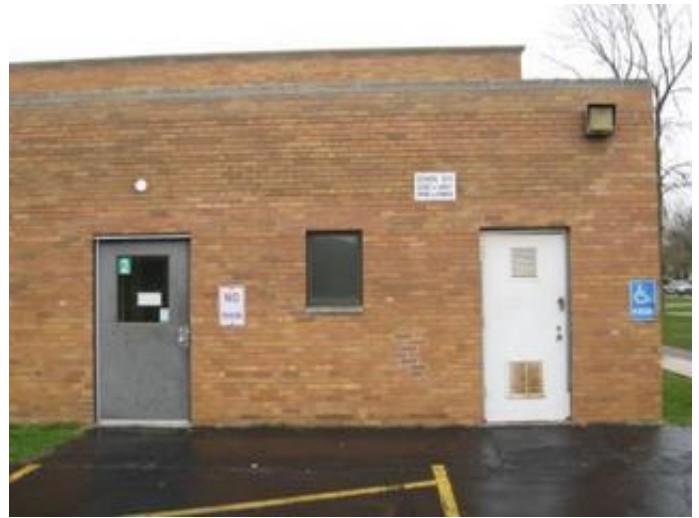
Rating: 2 Needs Repair

Exterior Hollow Metal Doors

Recommendations: Replace all hollow metal exterior doors and frames due to condition. Replace fire door identified in Item T. Replacement of single glazed exterior door vision panels is addressed in Item F.

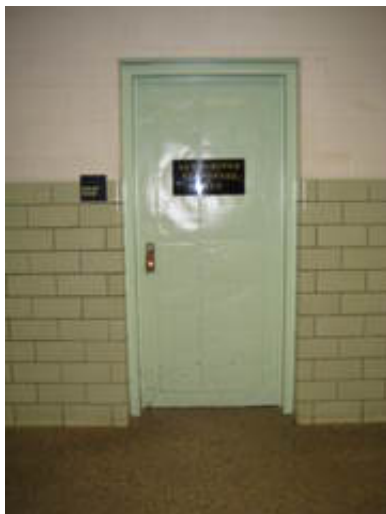
Rating: 3 Needs Replacement

Fire Door in the Corridor

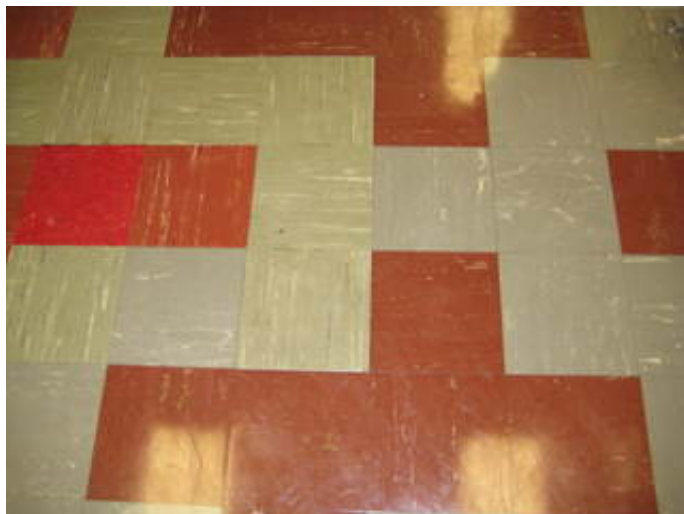
VAT in the Classroom

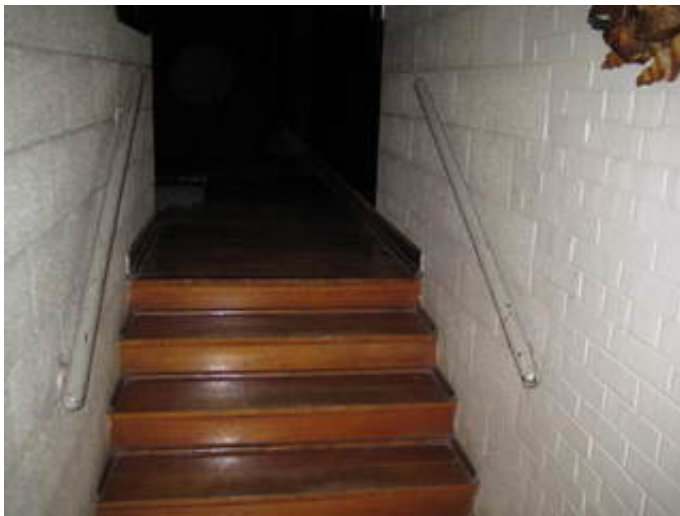
Stage Non-compliant Handrails

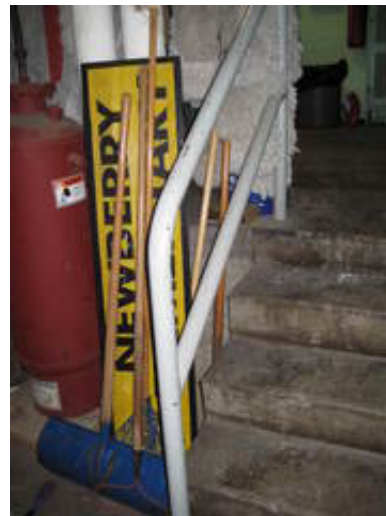
Mechanical Room Handrails

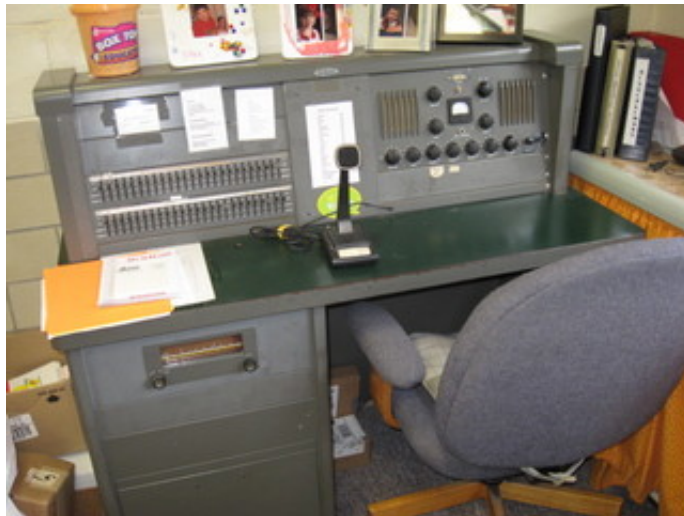
Outdated 2-Way PA System
