Building Information - Cuyahoga Falls City (43836) - Preston Elementary

Program Type	Classroom Facilities Assistance Program (CFAP) - Regular
Setting	Suburban
Assessment Name	Preston_ES_June_2009_Jan_2015_EEA_June_2018_Desktop_Update
Assessment Date (on-site; non-EEA)	2015-01-06
Kitchen Type	Full Kitchen
Cost Set:	2018
Building Name	Preston Elementary
Building IRN	30700
Building Address	800 Tallmadge Road
Building City	Cuyahoga Falls
Building Zipcode	44221
Building Phone	(330) 920-3613
Acreage	13.50
Current Grades:	K-5
Teaching Stations	24
Number of Floors	1
Student Capacity	317
Current Enrollment	285
Enrollment Date	2009-04-13
Enrollment Date is the date in which the current enrollment was taken.	
Number of Classrooms	22
Historical Register	NO
Building's Principal	Ms. Alicia Lenczewski
Building Type	Elementary

Preston Elementary School, which is not on the National Register of Historic Buildings, and originally constructed in 1959, is a one story, 39,578 square foot brick school building located in a suburban residential setting. The existing facility features a conventionally partitioned design, and does not utilize modular buildings. The structure of the overall facility conta

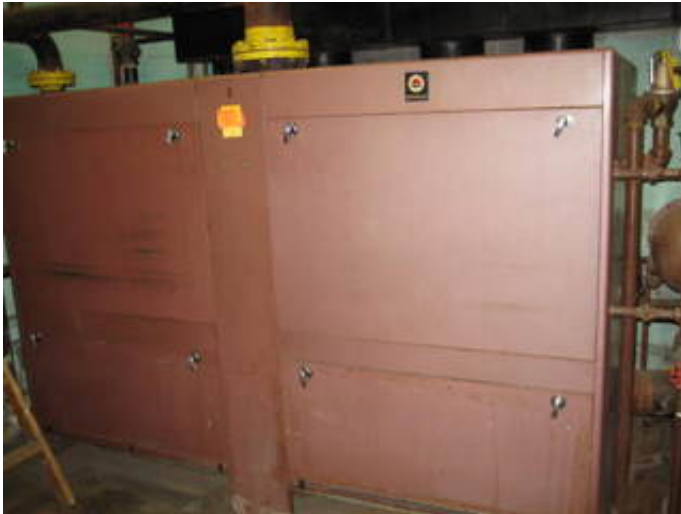
Description: The existing system for the 1958 Original Construction is a natural gas fired heated water boiler type system, installed in 1958, and is in fair to poor condition. The system in the 1963 Addition is an extension of that found in the 1958 Original Construction. 2-pipe vs. 4-pipe designations are not applicable in this facility, as no central air conditioning is provided. The two (2) cast iron boilers, manufactured by American Standard, were installed in 1958 and are in poor condition. Heating water is distributed to terminal units consisting of unit ventilators, cabinet heaters, unit heaters, fin tubes, and air handlers. The terminal equipment is original to each addition and is in fair to poor condition. The system does not comply with the 15 CFM per person fresh air requirements of the Ohio Building Code mechanical code and Ohio School Design Manual. The pneumatic type system temperature controls are original to each addition, with upgrades in 1999, and are in fair condition. The system does not feature individual temperature controls in all spaces required by the OSDM. The overall system does not feature any central energy recovery systems. The facility is equipped with louvered interior doors in the 1958 Original Construction to facilitate Corridor utilization as return air plenums. See Items J and O for replacement of doors. The existing system in the Multi-Purpose Room (Student Dining / Gymnasium) is ducted, but the ductwork cannot be integrated into a possible future system due to arrangement, air volume, and routing of existing ductwork. The existing system in the remainder of the overall facility is not ducted, and floor to structural deck heights will accommodate the installation of properly sized ductwork for a future Ohio School Design Manual approved system. The overall heating system is evaluated as not being in safe and efficient working order, and long term life expectancy of the existing system is not anticipated. The structure is not equipped with a central air conditioning system. The site does not contain underground fuel tanks.

Rating: 3 Needs Replacement

Natural Gas Fired Heated Water Boilers

Recommendations: Provide new overall heating, ventilating, and air conditioning system to achieve compliance with Ohio Building Code and Ohio School Design Manual standards. Convert the overall facility, except for the Multi-Purpose Room (Student Dining / Gymnasium) to a ducted system to facilitate efficient exchange of conditioned air. Replace existing ductwork in the Multi-Purpose Room (Student Dining / Gymnasium) to facilitate efficient exchange of conditioned air with pricing included in conversion to ducted system replacement.

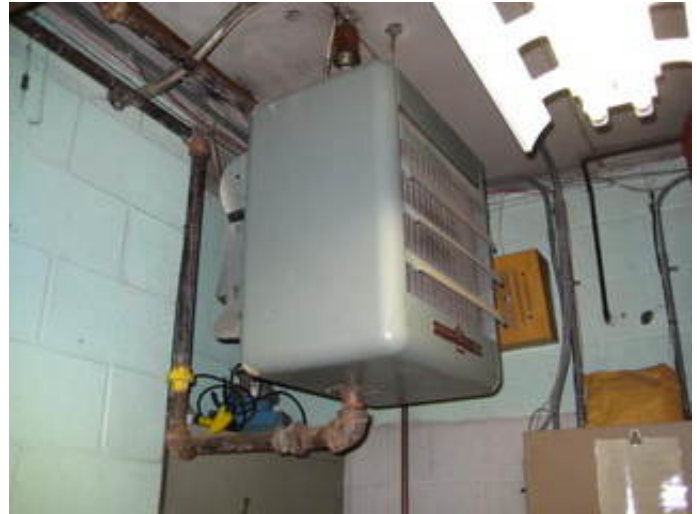
Heating Water Unit Heater

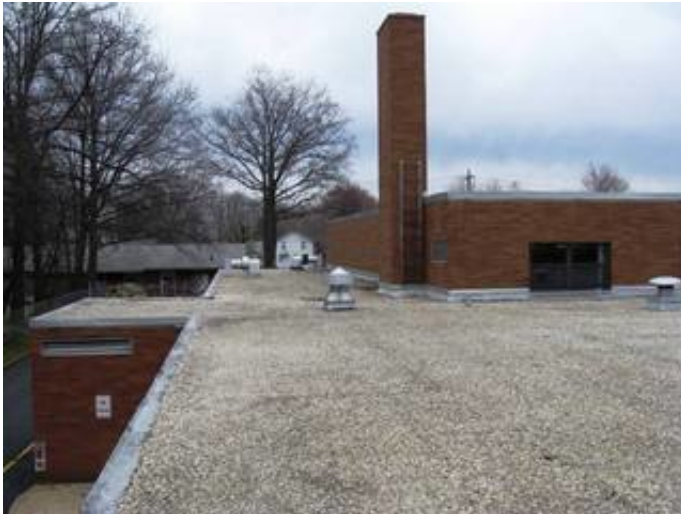
Roof Access to Roof Over the Multipurpose Space

Recommendations: The roof over the overall facility requires replacement to meet Ohio School Design Manual guidelines due to condition. Replace the exterior roof access ladder to the roof over the Multipurpose space. 06-22-18 Assessment Update: Provide for additional roof tear-off due to recovery roof system installed over existing roof. Provide for additional roof insulation to meet LEED energy efficiency requirements.

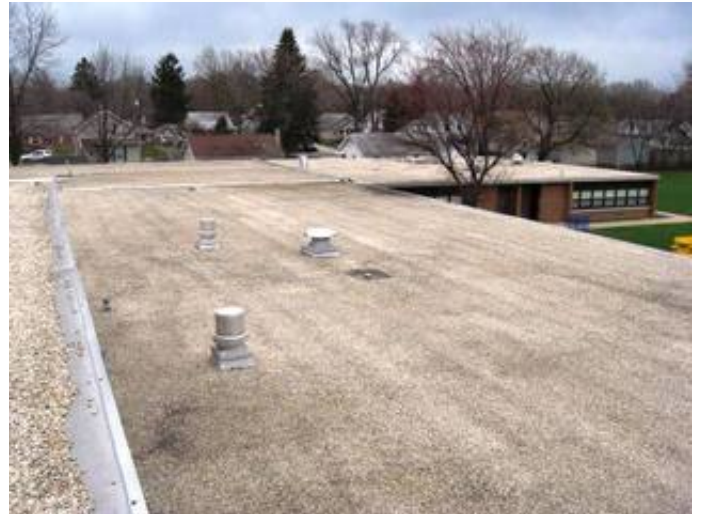
Description: The roof over the overall facility is an asphalt built-up roof with gravel wear coat system that was installed in 1999, and is in fair condition. There are District reports of current leaking in the west Girl's Group Restroom. Signs of past leaking were observed during the physical assessment. Access to the roof was gained by a roof access hatch with interior access ladder that is in good condition. Access to the roof over the Multipurpose space was gained by an exterior roof access ladder that is in poor condition. Fall safety protection cages are not required, and are not provided. There were no observations of standing water on the roof. Metal cap flashings are in good condition. Roof storm drainage is addressed through a system of roof drains, which are properly located, and in good condition. The roof is not equipped with overflow roof drains, though they are not required. No problems requiring attention were encountered with any roof penetrations. There are not any covered walkways attached to this structure. 06-22-18 Assessment Update: It was reported by district personnel, and observed, the original roof area was not removed prior to installing the current roof system. Therefore, additional tear-off costs required. Additional roof insulation required to meet LEED energy efficiency requirements.

Rating: 3 Needs Replacement

Typical Roof On the Overall Facility

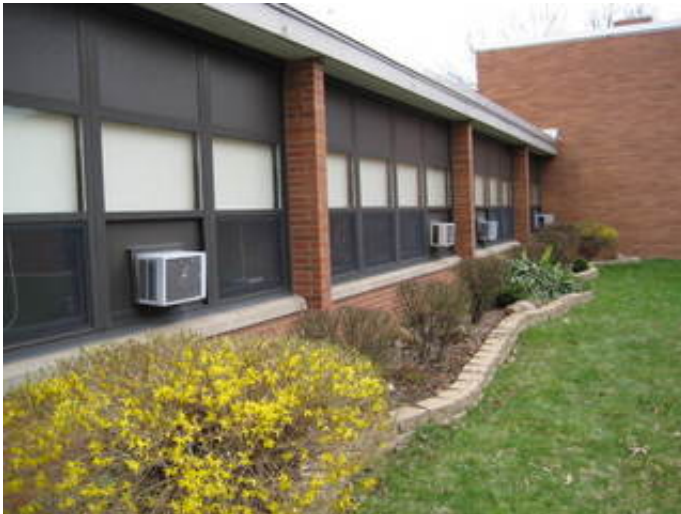
Description: The overall facility is not equipped with a central air conditioning system. Window units are provided in the Principal's Office, Teacher's Lounge, Media Center, Classroom, and Administrative Offices locations. The ventilation system in the overall facility consists of unit ventilators, original to each addition and in fair condition, providing fresh air to Classrooms, and unit ventilators and air handlers, original to each addition and in fair condition, providing fresh air to other miscellaneous spaces such as the Multi-Purpose Room (Student Dining / Gymnasium) and Media Center. Relief air venting is provided by louvered interior doors, unit ventilators, air handlers, ceiling plenums, and central relief fans. The ventilation system does not meet the Ohio Building Code 15 CFM per occupant fresh air requirement. The overall system is not compliant with Ohio Building Code and Ohio School Design Manual requirements. Dust collection systems are not required in this facility. Exhaust systems for Restrooms, Storage Rooms, Custodial Closets, Maintenance Workrooms, Kitchen Dry Food Storage, Locker Rooms, P.E. Workroom & Storage, and Art Rooms are inadequately placed, and in poor condition. The Art Program is equipped with a kiln located in the Mechanical Room, and no kiln ventilation system is provided. 06-22-18 Assessment Update: General building exhaust is included in Item A and should not be included in this line item.

Rating: 2 Needs Repair

Window AC Units

Recommendations: Provide an air conditioning system to meet with Ohio Building Code and Ohio School Design Manual requirements. Pricing included in Item A. Replace the existing general building exhaust system. Provide the existing Art Program the required kiln ventilation system. 06-22-18 Assessment Update: Delete general building exhaust.

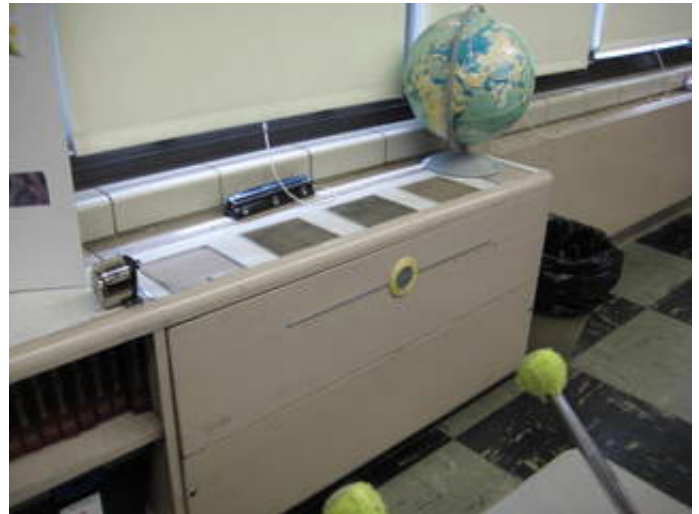
Unit Ventilator

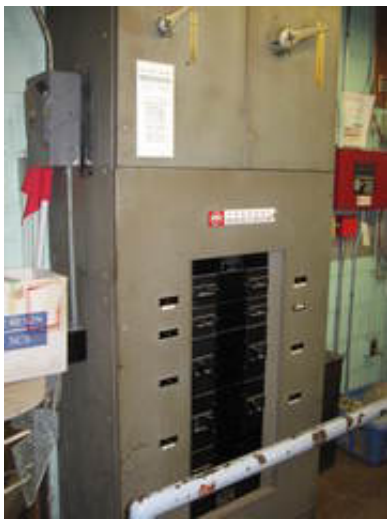
Description: The electrical system provided to the 1958 Original Construction is a 120/208 volts, 800 amp, 3 phase and 4 wire system installed in 1958, and is in poor condition. The system in the 1963 Addition is an extension of that found in the 1958 Original Construction. Power is provided to the school by multiple City of Cuyahoga owned, pad-mounted transformers located in a vault outside the Mechanical Room, and in fair condition. The panel system, installed in 1958, is in poor condition, and cannot be expanded to add additional capacity. The Classrooms are not equipped with adequate electrical outlets. The typical Classroom contains five (5) general purpose outlets, zero (0) dedicated outlets for each Classroom computer, and zero (0) dedicated outlets for each Classroom television. Some Classrooms are equipped with as many as six (6) general purpose outlets, while others are equipped with as few as three (3) general purpose outlets. There are not any spaces that have no electrical outlets. The Corridors are not equipped with adequate electrical outlets for servicing. Adequate GFI protected exterior outlets are not provided around the perimeter of the building. The facility is not equipped with an emergency generator. Adequate lightning protection safeguards are not provided. Stage lighting power system including control panel, breakers, and dimmers is inadequately provided, in poor condition and does not meet OSDM requirements. The overall electrical system does not meet Ohio School Design Manual requirements in supporting the current needs of the school, and will be inadequate to meet the facility's future needs.

Rating: 3 Needs Replacement

Main Electrical Distribution Panel

Recommendations: The entire electrical system requires replacement to meet Ohio School Design Manual guidelines for overall capacity and Classroom capacity due to age, condition, lack of OSDM-required features, and to accommodate the addition of an air conditioning system. Provide new transformers due to age and condition, with funding to be coordinated with the utility company. Provide an emergency generator, with funding included in the electrical system replacement. Provide adequate lightning protection safeguards in the overall facility, including associated grounding system, with funding included in the electrical system replacement. Provide control panel, dimmers, and breakers to support the Stage lighting system, with funding included in the electrical system replacement.

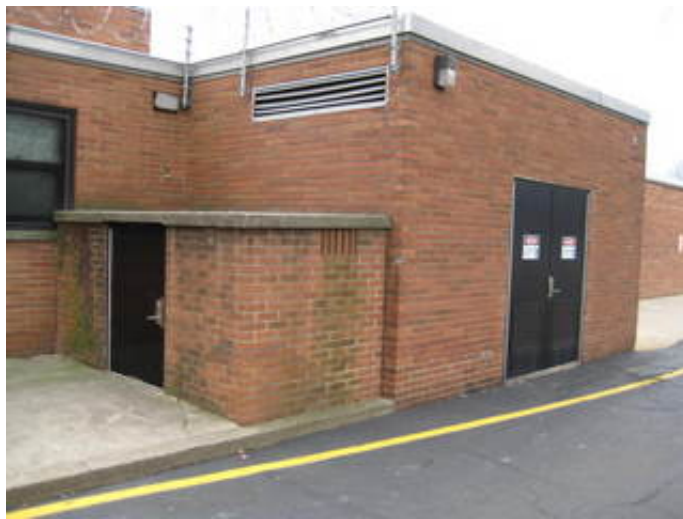
Pad Mounted Transformer Vault

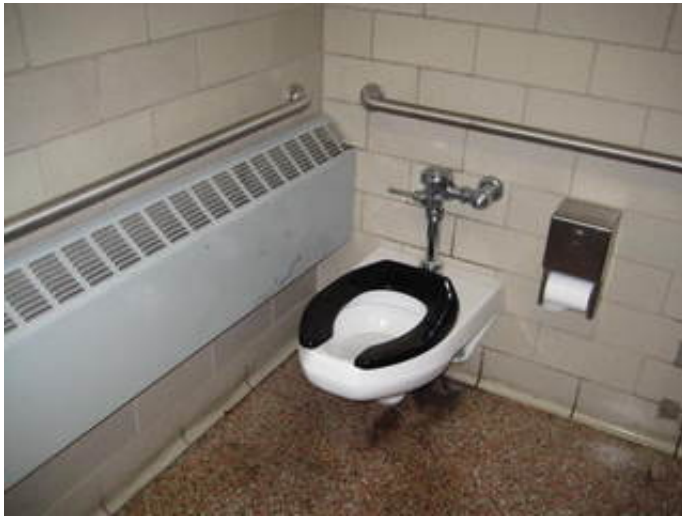
ADA Compliant Wall Hung Flush Valve Toilet

Replace galvanized water supply piping in the overall facility with copper piping due to age and condition. Replace sanitary waste piping in the overall facility due to age and condition. To facilitate the school's compliance with OBC and OSFC requirements, provide 5 lavatory mounted type drinking fountains and 2 electric water coolers. Due to age, condition, and OSFC standards, replace 18 lavatory mounted type drinking fountains, 27 lavatories, 31 toilets, 13 urinals, and 1 electric water cooler. See Item O for replacement of fixtures related to ADA requirements. See Item J for provisions on Kitchen related equipment. Replace the service entrance reduced pressure back flow preventers due to age and condition. Replace the domestic hot water heater and 250 gallon storage tank due to age and condition. Replace the Kitchen grease trap interceptors due to age, condition, and insufficient capacity. Provide the Kitchen with a water booster heater. Replace the existing Custodial Closet service sinks due to age and condition.

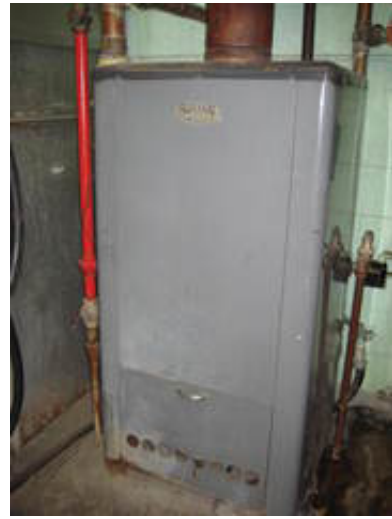
Domestic Hot Water Boiler

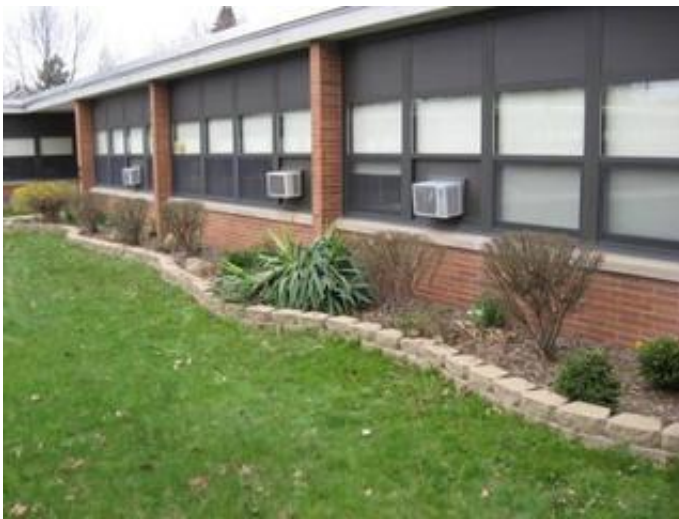
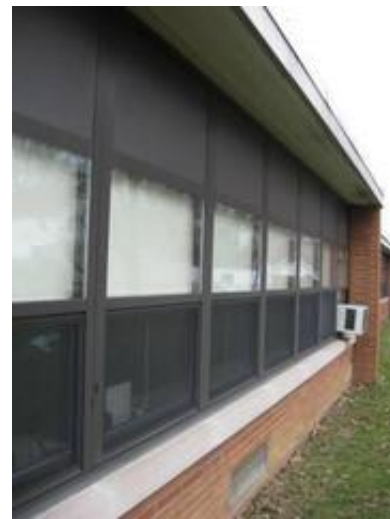
Description: The overall facility is equipped with thermally broken aluminum frame windows with double glazed insulated glazing type window system, which was installed in 2000, and is in good condition. Window system seals are in good condition, with no air and water infiltration being experienced. Window system hardware is in good condition. The window system features surface mounted shades, which are in good to fair condition. The window system is equipped with insect screens on operable windows, which are in good to fair condition. This facility is not equipped with any curtain wall systems. This facility does not feature any glass block windows. The exterior doors in the overall facility are equipped with thermally broken aluminum frame sidelights and transoms with double glazed insulated glazing, in good condition. The school does not contain skylights. Window security grilles are not provided for ground floor windows. There is no Greenhouse associated with this school. 06-22-18 Assessment Update: The existing windows are in good condition in the 1958 Original Building and 1963 Addition and district personnel reported no uses with the windows; therefore, replacement is not necessary.

Rating: 2 Needs Repair

Typical Classroom Windows in the 1958 Original Construction

Typical Classroom Windows in the 1963 Addition

Recommendations: Replace window single pane glazed vision panels in exterior doors of the overall facility with approved insulating safety glass. Replace damaged and cracked glazing panels as required in the overall facility. Replace damaged insect screens as required in the overall facility; Replace damaged surface mounted blinds as required in the overall facility. 10-02-14 Update: Exterior finish on windows deteriorated and chalking. Operable sashes not working and seals broke. Revise Window Replacement line item from 0 sf to 6,822 sf at 1958 Original Building and from 0 sf to 328 sf at 1963 Addition. 06-22-18 Assessment Update: Delete window system replacement for 1958 Original building and 1963 Addition.

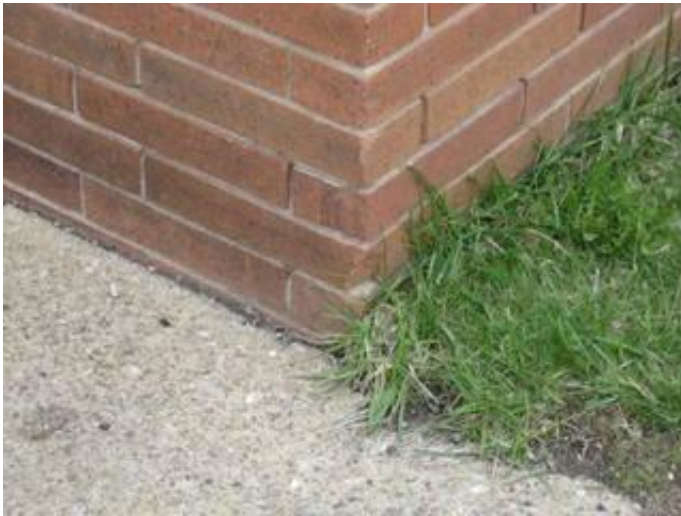
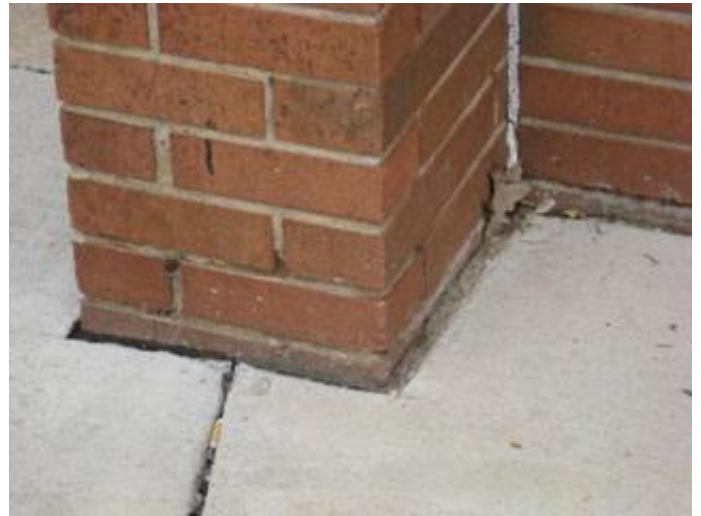
Description: The overall facility is equipped with concrete masonry unit foundation walls on concrete footings, which displayed minor locations of settlement and cracking at the electrical vault walls, and are in good to fair condition. The District reports that there has been no past leaking. Some grading or site drainage deficiencies were noted around the perimeter of the structure where the site drained towards the building instead of away from the building that could contribute to future foundation / wall structural deterioration.

Rating: 2 Needs Repair

Typical Condition of Exterior Walls at Grade and Pavement

Exterior Wall at Exterior Sidewalk

Recommendations: Address settlement issues at electrical vault walls. Regrade site as required to provide positive drainage away from the building.

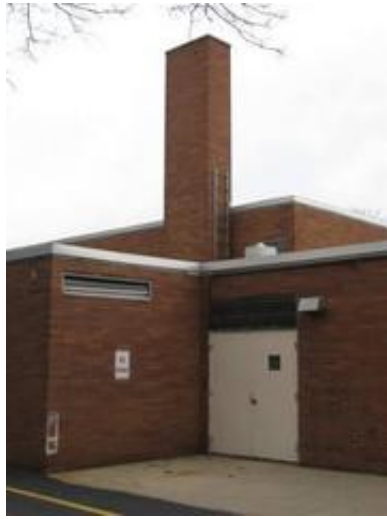
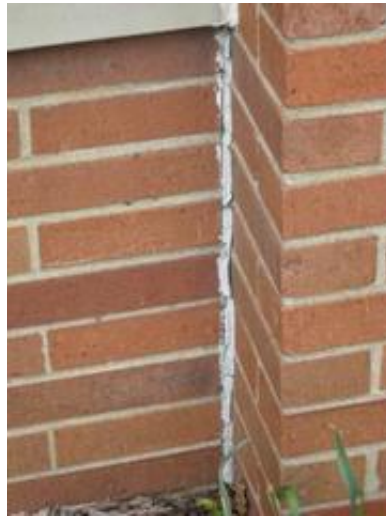
Description: The overall facility has a brick veneer on a masonry bearing wall system which displayed locations of deterioration, and is in fair condition. The exterior masonry appears to have inappropriately spaced and inadequately caulked control joints in fair condition. Control joints are not provided at lintel locations at doors and windows. The exterior masonry has not been cleaned and sealed in recent years and shows evidence of mortar deterioration and locations of efflorescence, graffiti and staining. The facility has no architectural exterior accent materials. Interior walls are brick, painted concrete masonry units and glazed block which are in good to fair condition. Interior masonry appears to have adequately spaced and inadequately caulked control joints in fair condition. Exterior soffits are exposed and painted precast concrete planks in good to fair condition. The window sills are stone, and are in fair condition. The exterior lintels are steel are rusting and in good to fair condition. The existing chimney is in fair condition requiring masonry tuckpointing, cleaning and sealing. Canopies and soffits at entrances are precast concrete plank type construction, and are in good to fair condition. A loading dock has not been provided to facilitate unloading of trucks and receipt of product / supplies / foodstuffs. The school does have sufficient expansion joints, and they are in fair to poor condition. 06-22-18 Assessment Update: Corner of East elevation of 1958 Original Building has settled and significant cracks observed.

Rating: 2 Needs Repair

Exterior Masonry and Chimney in the 1958 Original Construction

Typical Condition of Existing Control Joints

Recommendations: Provide tuckpointing in all areas of mortar deterioration as required through the overall facility. Provide masonry repairs as required through the overall facility. Provide masonry cleaning, sealing and caulking as required through the overall facility. Sawcut and caulk new appropriately spaced control joints in existing exterior masonry as required in the overall facility. Recaulk existing control joints in the overall facility. Recaulk existing expansion joints in the overall facility. Prep and paint exposed steel lintels in the overall facility. Repoint stone window sills in the overall facility. Provide masonry infill for existing unit ventilator openings in exterior walls. Prep and paint exposed concrete soffits through the overall facility. Repair chimney masonry as required. 10-02-14 Update: Exterior walls are 8" block with 4" clay fired brick and no air cavity or insulation. Provide insulation of exterior walls to meet LEED energy requirements. 06-22-18 Assessment Update: Corner of East elevation of 1958 Original Building has settled and significant cracks observed.

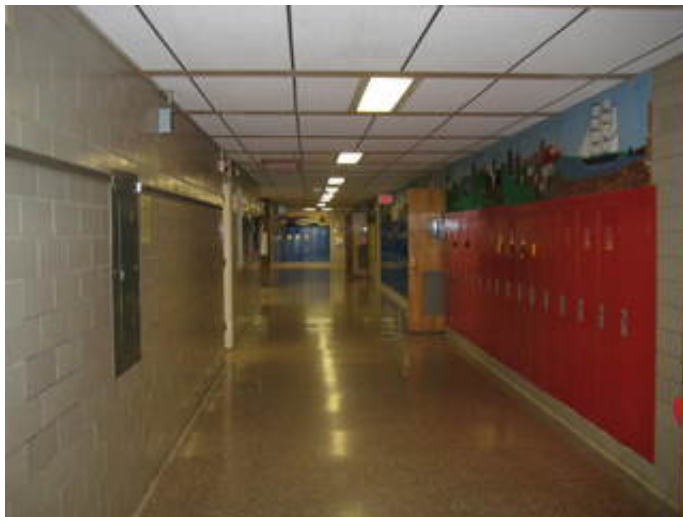
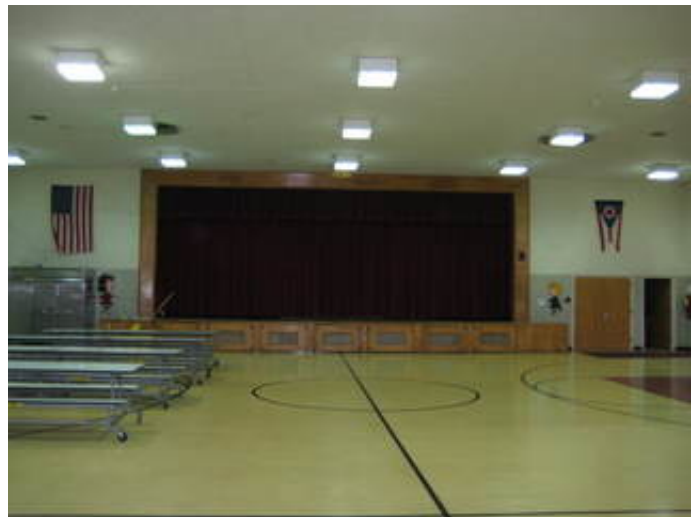
The overall facility features conventionally partitioned Classrooms with VAT flooring, acoustical tile ceilings, as well as glazed and painted block wall finishes, and they are in fair condition. The overall facility has Corridors with terrazzo flooring, acoustical tile ceilings, as well as glazed and painted block wall finishes, and they are in fair condition. The overall facility has Restrooms with terrazzo flooring, acoustical tile ceilings, as well as glazed block wall finishes, and they are in fair to poor condition. Toilet partitions are metal, and are in poor condition. Classroom casework in the overall facility is wood type construction with plastic laminate tops, is inadequately provided, and in poor condition. The typical Classroom contains 8 lineal feet of casework, and Classroom casework provided ranges from 8 to 16 feet. Classrooms are provided with adequate chalkboards, markerboards, and tackboards, which are in fair condition. The lockers, located in the Corridors, are adequately provided, and in fair condition. The Classroom storage cubbies, located in the Classrooms, are adequately provided, and in poor condition. The Art program is equipped with a kiln in fair to poor condition, and existing kiln ventilation is inadequate. The facility is equipped with wood louvered interior doors that are flush mounted partially recessed without proper ADA hardware and clearances, and in fair to poor condition. The Gymnasium spaces have VCT flooring, acoustical tile ceilings, as well as glazed and painted block wall finishes, and they are in good condition. Gymnasium telescoping stands are wood type construction in poor condition. Gymnasium basketball backboards are manually operated type, and are in good condition. The Media Center, located in the 1958 Original Construction, has carpet flooring, acoustical tile ceilings, as well as glazed and painted block wall finishes, and they are in fair condition. Student Dining shares the Gymnasium space. OSDM-required fixed equipment for Stage is inadequately provided, and in poor condition. The existing Kitchen is full service, is undersized based on current enrollment, and the existing Kitchen equipment, installed in 1958 with incremental upgrades, is in fair condition. The Kitchen hood is in fair condition, and is not equipped with the required UL 300 compliant wet chemical fire suppression system. The required 6" overhang on all three exposed sides of the cooking equipment is provided by the hood. Kitchen hood exhaust ductwork is not of proper construction material and/or installed as required by the OSDM and OBMC. Reach-in cooler and freezer are located within the Kitchen spaces, and are in fair condition. 06-22-18 Assessment Update: Stage curtain is old and worn and should be replaced. Wood stage flooring is worn and should be replaced. Run-out wall padding needed. The terrazzo floor at the main entry is worn and pitted.

3 Needs Replacement

Typical Corridor Finishes

Multi-Purpose Room Finishes

Provide complete replacement of finishes and casework due to installation of systems outlined in Items A, C, D, E, I, K, L, M, N, T, U, and due to condition. Provide for the replacement of interior doors due to condition. Other doors are funded in Item O due to opening expansion. Provide for the replacement of Kitchen equipment due to age and condition. Provide for the replacement of the Kitchen exhaust hood due to age and condition. Provide for the replacement of toilet partitions due to condition. Provide for the replacement of toilet accessories due to condition. Provide for the replacement of Gymnasium seating due to condition. Provide for the replacement of the Art Program kiln due to condition, with funding for the ventilation provided in Item C. 06-22-18 Assessment Update: Replace stage curtain. Replace wood stage flooring. Provide for run-out wall padding at basketball goals. Repair terrazzo flooring at main entry.

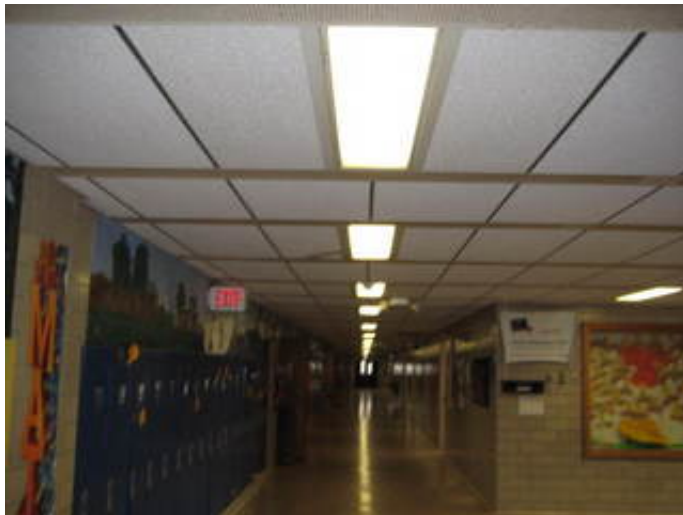
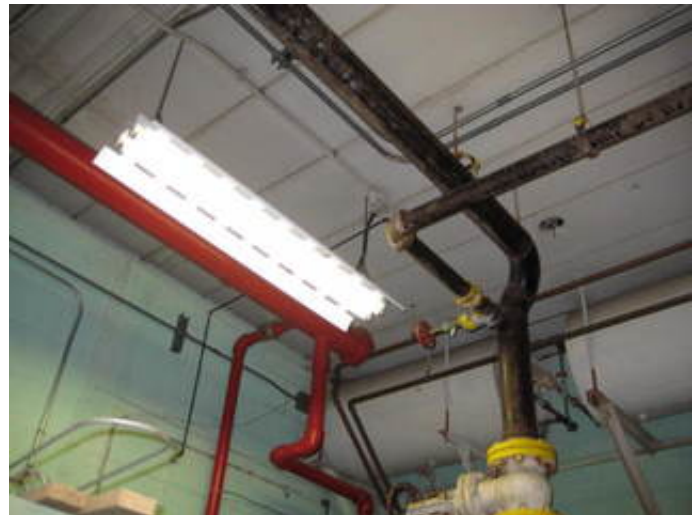
The typical Classrooms in the overall facility are equipped with T-8 1x4 surface mount fluorescent fixtures with single level switching. Classroom fixtures are in fair condition, providing an average illumination of 43 FC, which is less than the 50 FC recommended by the OSDM. The typical Corridors in the overall facility are equipped with T-8 1x4 lay-in direct and T-8 2x4 lay-in direct fluorescent fixtures with single level switching. Corridor fixtures are in fair condition, providing an average illumination of 11 FC, which is less than the 20 FC recommended by the OSDM. The Multi-Purpose Room (Student Dining / Gymnasium) spaces are equipped with surface mount and recessed metal halide type lighting, in poor condition, providing an average illumination of 36 FC, which is less than the 50 FC recommended by the OSDM. The Media Center is equipped with T-8 1x4 surface mount direct fluorescent fixture type lighting in fair condition, providing an average illumination of 67 FC, which is less than (thus complying with) the 50 FC recommended by the OSDM. The Student Dining and Gymnasium spaces are incorporated into the Multi-Purpose Room (Student Dining / Gymnasium). The Kitchen spaces are equipped with T-12 1x4 surface mount direct fluorescent fixture type lighting with single level switching. Kitchen fixtures are in poor condition, providing an average illumination of 44 FC, which is less than the 75-80 FC recommended by the OSDM. The Service Areas in the overall facility are equipped with incandescent and T-8 1x4 suspended fluorescent fixture type lighting in fair condition, providing inadequate illumination. The typical Administrative spaces in the overall facility are equipped with T-8 2x4 lay-in direct fluorescent fixture type lighting in good condition, providing adequate illumination based on OSDM requirements. The overall lighting systems of the facility are not compliant with Ohio School Design Manual requirements due to age, condition, inadequate lighting levels, lack of multi-level switching, the utilization of incandescent fixtures, and the utilization of T-12 fluorescent fixtures.

3 Needs Replacement

Corridor Fluorescent Light Fixtures

Service Area Suspended Fluorescent Light Fixture

Provide complete replacement of lighting system due to age, condition, inadequate lighting levels, lack of multilevel switching, the utilization of incandescent fixtures, the utilization of T-12 fixtures, and installation of systems outlined in Items A, C, J, and U.

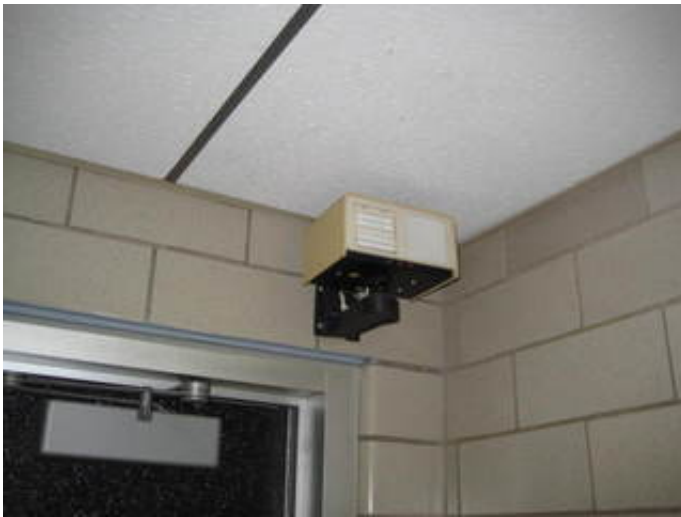
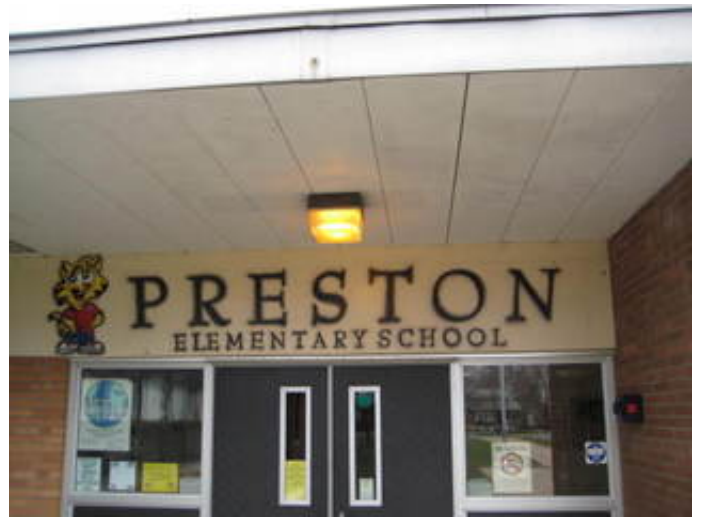
Description: The overall facility contains a Honeywell motion sensor and door contact type security system in fair condition. Motion detectors are inadequately provided in main entries, central gathering areas, offices, main Corridors, and spaces where 6 or more computers are located. Exterior doors are inadequately equipped with door contacts. An automatic visitor control system is not provided. Compliant color CCTV cameras are not provided at main entry areas, parking lots, central gathering areas, and main Corridors. A compliant computer controlled access control system integrating alarms and video signals, with appropriate UPS backup, is not provided. The system is not equipped with card / biometric readers. The security system is inadequately provided throughout, and the system is not fully compliant with Ohio School Design Manual guidelines. Existing playground fencing is not fully compliant with Ohio School Design Manual guidelines. The exterior site lighting system is equipped with surface mounted HID high pressure sodium entry lights in fair condition. Pedestrian walkways are not illuminated. Parking and bus pick-up / drop off areas are not illuminated. The exterior site lighting system provides inadequate coverage. 06-22-18 Assessment Update: The main entry into the building is at the South central portion of the 1958 Original Building does not provide for adequate security. Modifications are required to achieve a secure main entrance into the building.

Rating: 3 Needs Replacement

Security System Montion Detection Device

Surface Mounted HID High Pressure Sodium Entry Light Fixture

Recommendations: Provide complete replacement of security system to meet Ohio School Design Manual guidelines. Provide complete replacement of exterior site lighting system to meet Ohio School Design Manual guidelines. Provide additional playground fencing to meet Ohio School Design Manual guidelines, funding included in complete replacement of security system. 06-22-18 Assessment Update: Provide for modifications on existing main entrance to provide for a security vestibule.

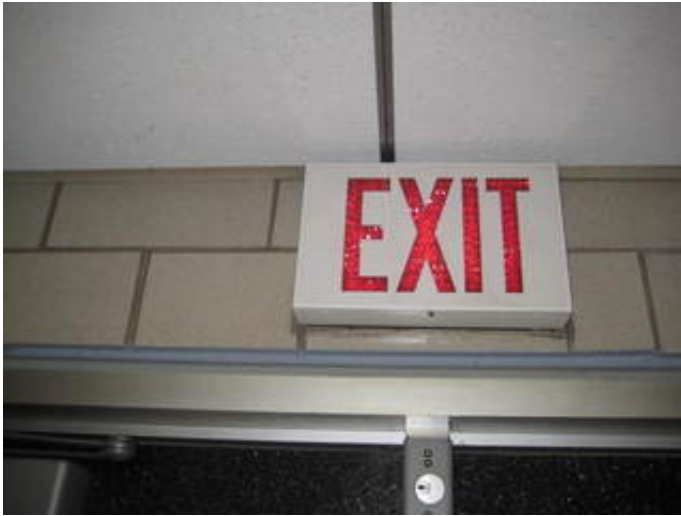
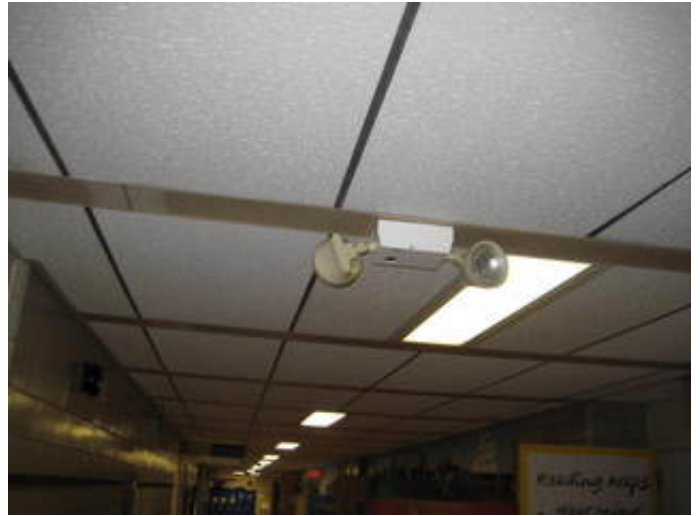
Description: The overall facility is equipped with an emergency egress lighting system consisting of non compliant plastic construction exit signs, as well as OSDM compliant red lettered, cast aluminum construction, and LED illuminated exit signs and the system is in fair condition. The facility is not adequately equipped with emergency egress floodlighting and the system is in fair to poor condition. The system is not provided with appropriate battery backup and emergency generator on separate circuits. The system is inadequately provided throughout, and does not meet Ohio School Design Manual and Ohio Building Code requirements.

Rating: 3 Needs Replacement

Compliant Illuminated Exit Sign

Emergency Egress Light Fixture

Recommendations: Provide complete replacement of emergency / egress lighting system to meet Ohio School Design Manual guidelines.

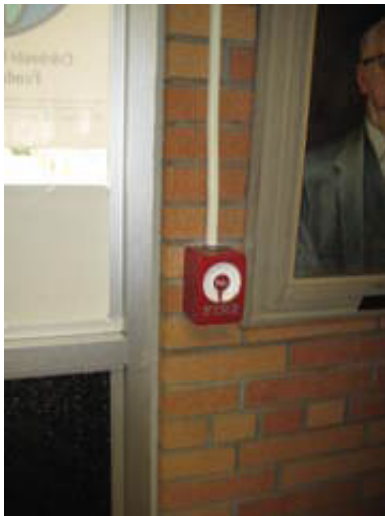
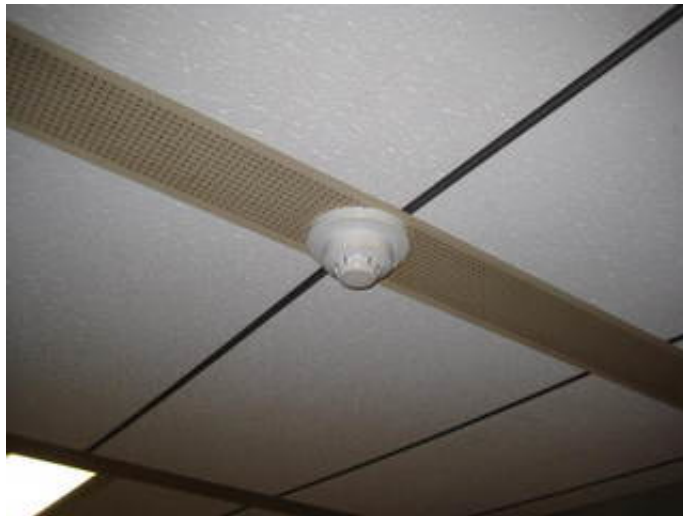
Description: The overall facility is equipped with an addressable Gamewell Flex 610 fire alarm system, installed in 1999, and in good to fair condition, consisting of manual pull stations, smoke detectors, and horn and strobe indicating devices. The system is automatic and is monitored by a third party. The system is not equipped with sufficient audible horns, strobe indicating devices, and smoke detectors. The system is not equipped with any flow switches, tamper switches, or heat sensors. The system thus will not support future fire suppression systems. The system is not adequately provided throughout, and does not have additional zone capabilities. The system is not fully compliant with Ohio Building Code, NFPA, and Ohio School Design Manual requirements.

Rating: 3 Needs Replacement

Fire Alarm System Manual Pull Station

Fire Alarm System Smoke Detection Device

Recommendations: Provide complete replacement of fire alarm system to meet OBC, NFPA, and Ohio School Design Manual guidelines.

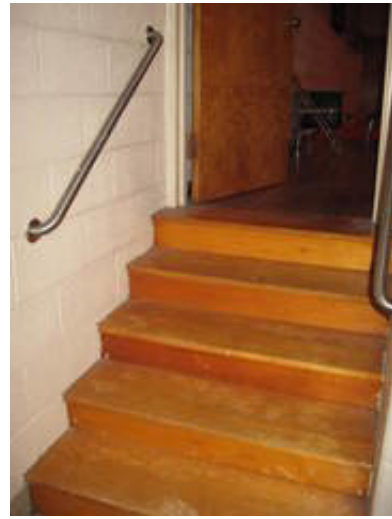
Non-Compliant Handrails At the Stage Steps

Other: Add Handrails	\$20.00	ln.ft.		42 Required		\$840.00	Add/Replace ADA Compliant handrails at the steps to the Stage
Other: Enlarge existing Restroom to meet ADA requirements	\$16,761.00	each		6 Required	2 Required	\$134,088.00	Enlarge existing Restroom to meet ADA requirements
Sum:			\$343,935.00	\$283,413.00	\$60,522.00

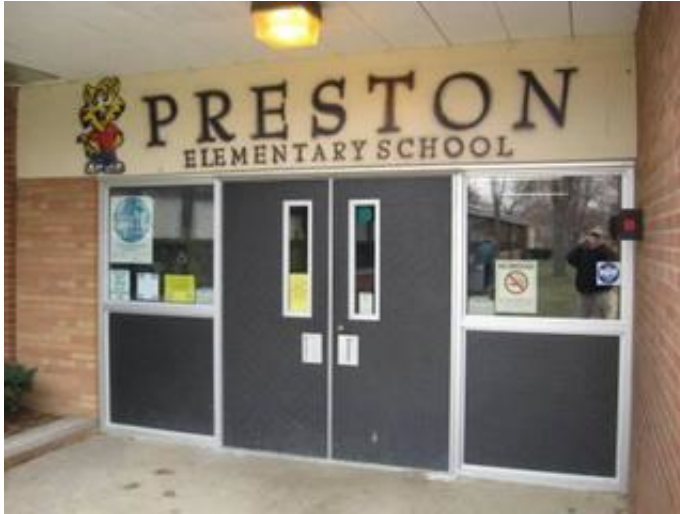
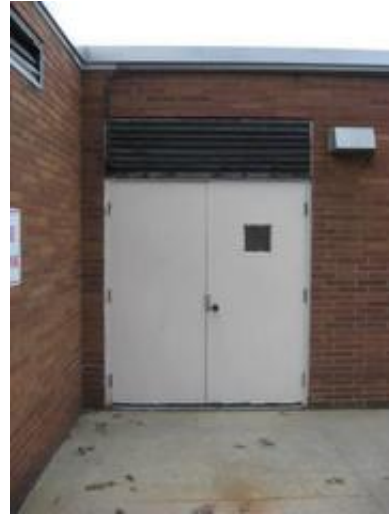
Rating: 2 Needs Repair

Main Entry Doors to the 1958 Original Construction

Exterior Hollow Metal Doors in the 1958 Original Construction

Recommendations: Replace all exterior hollow metal doors and frames, due to poor condition. Replacement of single glazed door vision panels is addressed in Item F. 06-22-18 Assessment Update: Revised numbers of leaves to be replaced from 6 to 4

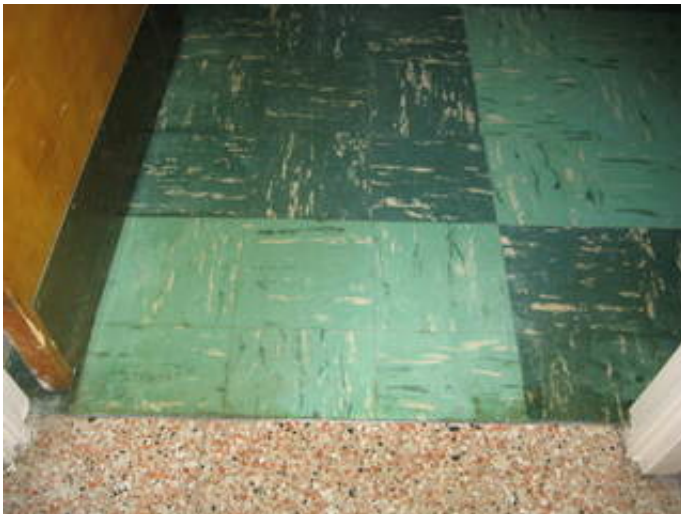
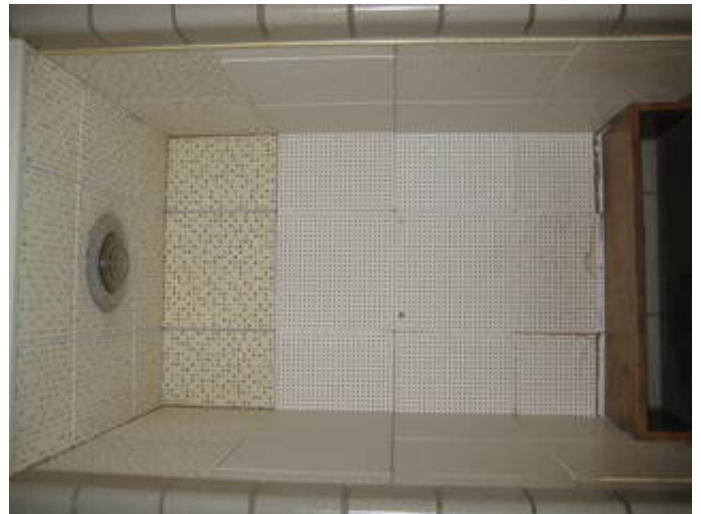
Rating: 3 Needs Replacement

VAT in Classrooms

Acoustical Tile

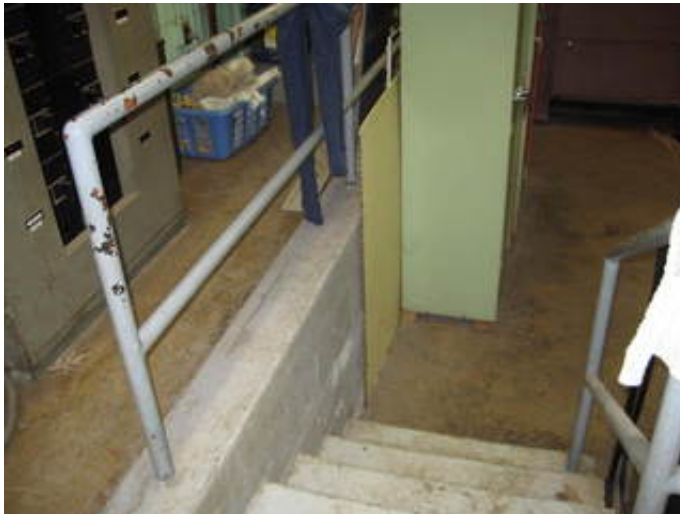
3 Needs Replacement

Mechanical Room Non-compliant Guardrail and Handrail

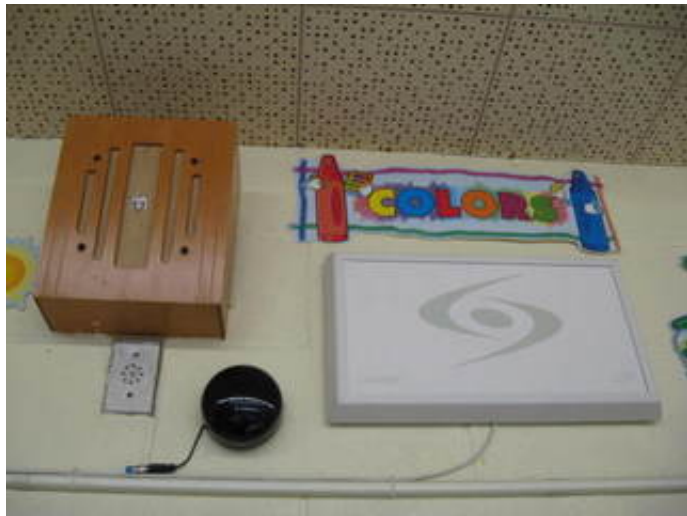
Outdated PA System and Infrared Classroom Amplification Technology System
