Building Information - Cuyahoga Falls City (43836) - Richardson Elementary

Program Type	Classroom Facilities Assistance Program (CFAP) - Regular
Setting	Suburban
Assessment Name	Richardson_ES_June_2009_Jan_2015_EEA_June_2018_Desktop_Update
Assessment Date (on-site; non-EEA)	2015-01-06
Kitchen Type	Full Kitchen
Cost Set:	2018
Building Name	Richardson Elementary
Building IRN	31476
Building Address	2226 23rd Street
Building City	Cuyahoga Falls
Building Zipcode	44223
Building Phone	(330) 920-3630
Acreage	10.00
Current Grades:	K-5
Teaching Stations	16
Number of Floors	1
Student Capacity	387
Current Enrollment	397
Enrollment Date	2009-04-14
Enrollment Date is the date in which the current enrollment was taken.	
Number of Classrooms	13
Historical Register	NO
Building's Principal	Ms. Julie Petruna
Building Type	Elementary

William H. Richardson Elementary School, which is not on the National Register of Historic Buildings, and originally constructed in 1952, is a one story, 48,411 square foot brick and corrugated metal panel school building located in a suburban residential and commercial setting. The existing facility features a conventionally partitioned design, and does not utilize mod

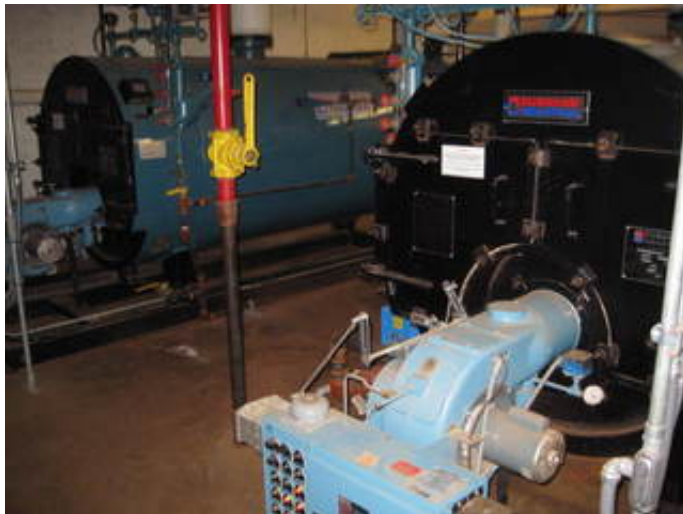
The existing system for the 1951 Original Construction is a natural gas fired steam boiler type system, installed in 1951, and is in fair condition. The system in the 1978 Addition is an extension of that found in the 1951 Original Construction. 2-pipe vs. 4-pipe designations are not applicable in this facility, as no central air conditioning is provided. The two (2) three-pass boilers, manufactured by Burnham Industrial, were installed in 2002 and are in good to fair condition. Steam is distributed to terminal units consisting of cabinet heaters, unit heaters, radiators / fin tubes, unit ventilators, air handlers. The terminal equipment is original to each addition and is in fair to poor condition. The system does not comply with the 15 CFM per person fresh air requirements of the Ohio Building Code mechanical code and Ohio School Design Manual. The pneumatic type system temperature controls are original to each addition, with upgrades in 1999, and are in fair condition. The system does not feature individual temperature controls in all spaces required by the OSDM. The overall system does not feature any central energy recovery systems. The facility is not equipped with louvered interior doors to facilitate Corridor utilization as return air plenums. The existing system in the Gymnasium is ducted, but the ductwork cannot be integrated into a possible future system due to arrangement, air volume, and routing of existing ductwork. The existing system in the remainder of the overall facility is not ducted, and floor to structural deck heights will accommodate the installation of properly sized ductwork for a future Ohio School Design Manual approved system. The overall heating system is evaluated as not being in safe and efficient working order, and long term life expectancy of the existing system is not anticipated. The structure is not equipped with a central air conditioning system. The site does not contain underground fuel tanks.

Natural Gas Fired Steam Boilers

Provide new overall heating, ventilating, and air conditioning system to achieve compliance with Ohio Building Code and Ohio School Design Manual standards. Convert the overall facility, except for the Gymnasium, to a ducted system to facilitate efficient exchange of conditioned air. Replace existing ductwork in the Gymnasium to facilitate efficient exchange of conditioned air with pricing included in conversion to ducted system replacement.

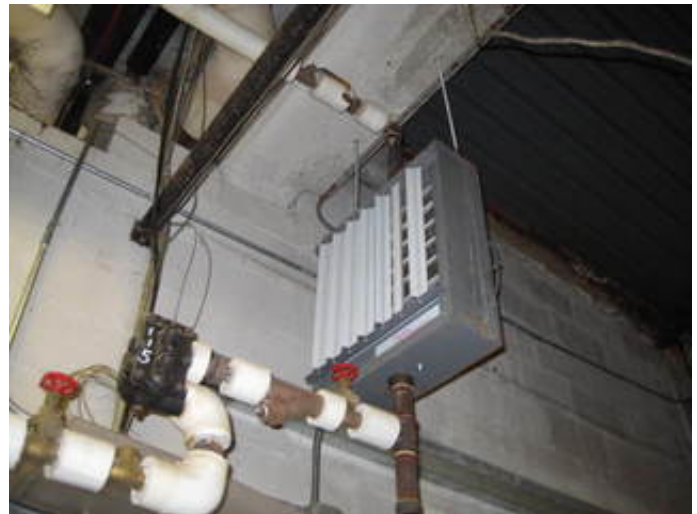
Steam Unit Heater

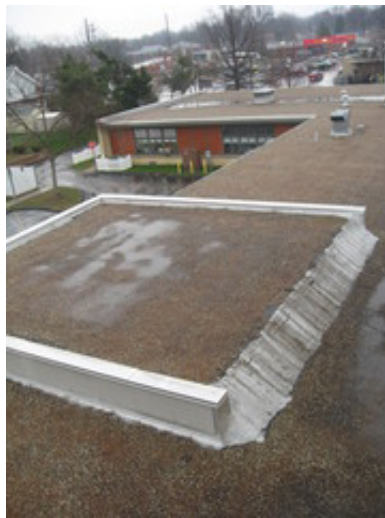
Description: The roof over the overall facility is an asphalt built-up roof with gravel wear coat system that was installed in 1999, and is in fair condition. There are no District reports of current leaking. Signs of past leaking were observed during the physical assessment. Access to the lower roof was gained by a roof access door that is in fair to poor condition. Access to the upper roof over the Gymnasium and Stage was gained by a roof access hatch that is in poor condition and interior access ladder that is in good condition. Fall safety protection cages are not required, and are not provided. There were observations of standing water on the roof. Metal cap flashings are in good condition. Roof storm drainage is addressed through a system of roof drains and through-wall scuppers. Roof drains are properly located, and in good to fair condition. Through-wall scuppers are improperly located over the exits, and in fair condition. The roof is equipped with overflow roof drains over the Gymnasium and Stage, though they are not required on the remainder of the building. No problems requiring attention were encountered with any roof penetrations. There are not any covered walkways attached to this structure.

Rating: 3 Needs Replacement

Typical Roof On the Overall Facility

Recommendations: The roof over the overall facility requires replacement to meet Ohio School Design Manual guidelines due to condition. The roof access door and roof access hatch requires replacement due to condition. Relocate two through-wall scuppers which are improperly located over the exits.

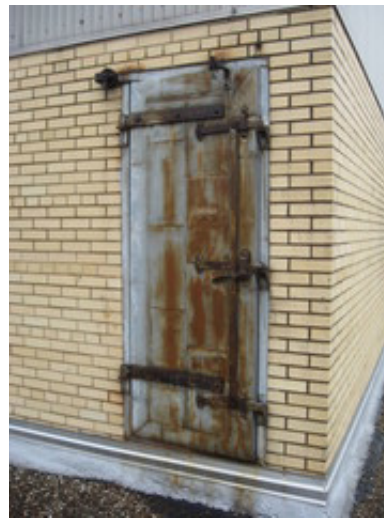
Roof Access Door

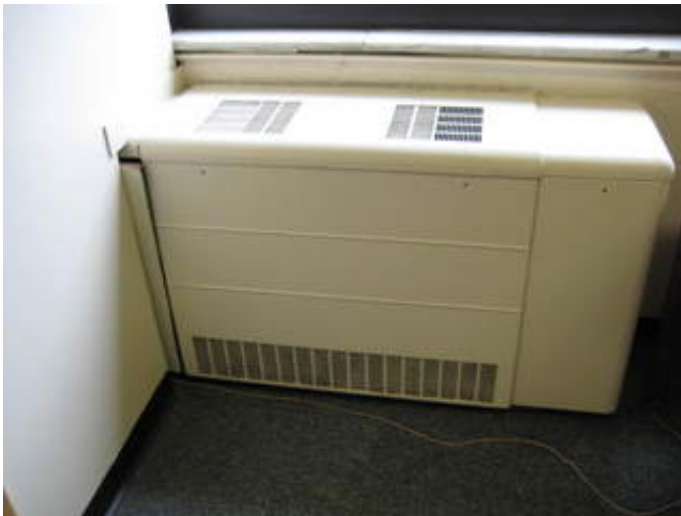
Description: The overall facility is not equipped with a central air conditioning system. Window units are provided in the Computer Lab, Teacher's Lounge, several Classrooms, Administrative Offices, Principal's Office, and Teacher Office locations. The ventilation system in the overall facility consists of unit ventilators, is original to each addition and in fair to poor condition, providing fresh air to Classrooms, and unit ventilators and air handlers, is original to each addition and in fair to poor condition, providing fresh air to other miscellaneous spaces such as the Gymnasium, Student Dining, and Media Center. Relief air venting is provided by unit ventilators, air handlers, and central relief fans. The ventilation system does not meet the Ohio Building Code 15 CFM per occupant fresh air requirement. The overall system is not compliant with Ohio Building Code and Ohio School Design Manual requirements. Dust collection systems are not required in this facility. Exhaust systems for Restrooms, Storage Rooms, Custodial Closets, Maintenance Workrooms, Kitchen Dry Food Storage, Locker Rooms, P.E. Workroom & Storage, and Art Rooms are inadequately placed, and in poor condition. The Art Program is equipped with a kiln, and no existing kiln ventilation system is provided. 06-22-18 Assessment Update: General building exhaust is included in Item A and should not be included in this line item.

Unit Ventilator

Recommendations: Provide an air conditioning system to meet with Ohio Building Code and Ohio School Design Manual requirements. Pricing included in Item A. Replace the existing general building exhaust system. Provide the existing Art Program the required kiln ventilation system. 06-22-18 Assessment Update: Delete general building exhaust.

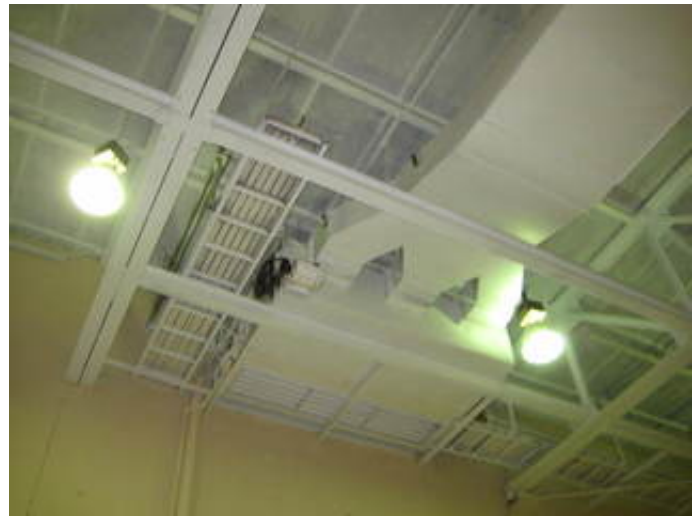
Gymnasium Air Handler Unit

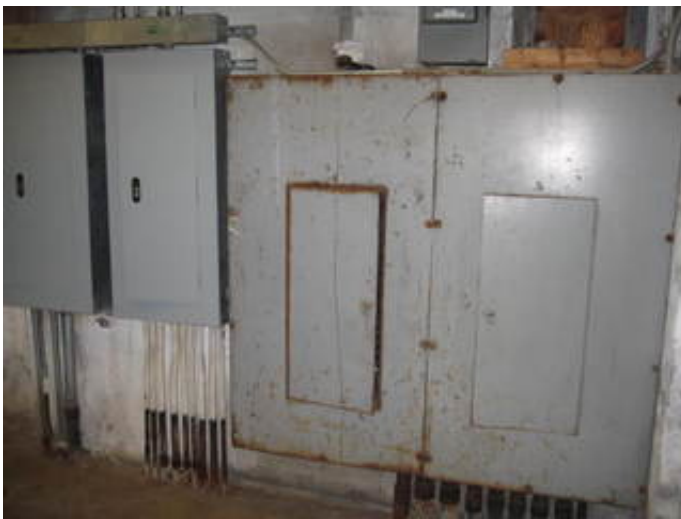
Description: The electrical system provided to the 1951 Original Construction is a 120/208 volts, 400 amp, 3 phase and 4 wire system installed in 1951, and is in fair to poor condition. The system in the 1978 Addition is an extension of that found in the 1951 Original Construction. Power is provided to the school by a single City of Cuyahoga Falls owned, pad-mounted transformer located at the Mechanical side entrance to the building, and in fair condition. The panel system, installed in 1951, is in fair condition, and cannot be expanded to add additional capacity. The Classrooms are not equipped with adequate electrical outlets. The typical Classroom contains four (4) general purpose outlets, zero (0) dedicated outlets for each Classroom computer, and zero (0) dedicated outlets for each Classroom television. Some Classrooms are equipped with as many as six (6) general purpose outlets, while others are equipped with as few as three (3) general purpose outlets. There are not any spaces that have no electrical outlets. The Corridors are not equipped with adequate electrical outlets for servicing. Adequate GFI protected exterior outlets are not provided around the perimeter of the building. The facility is not equipped with an emergency generator. Adequate lightning protection safeguards are not provided. Stage lighting power system including control panel, breakers, and dimmers is inadequately provided, in fair to poor condition and does not meet OSDM requirements. The overall electrical system does not meet Ohio School Design Manual requirements in supporting the current needs of the school, and will be inadequate to meet the facility's future needs.

Rating: 3 Needs Replacement

Main Electrical Distribution Panel

Recommendations: The entire electrical system requires replacement to meet Ohio School Design Manual guidelines for overall capacity and Classroom capacity due to age, condition, lack of OSDM-required features, and to accommodate the addition of an air conditioning system. Provide new transformer due to age and condition, with funding to be coordinated with the utility company. Provide an emergency generator, with funding included in the electrical system replacement. Provide adequate lightning protection safeguards in the overall facility, including associated grounding system, with funding included in the electrical system replacement. Provide control panel, dimmers, and breakers to support the Stage lighting system, with funding included in the electrical system replacement.

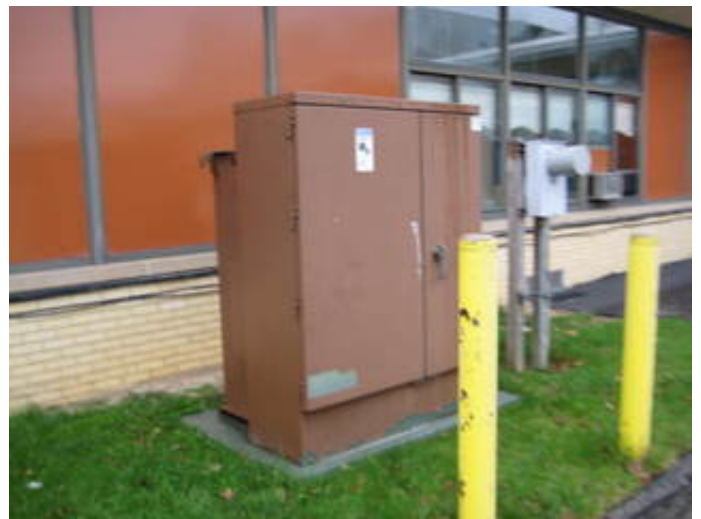
Pad Mounted Transformer

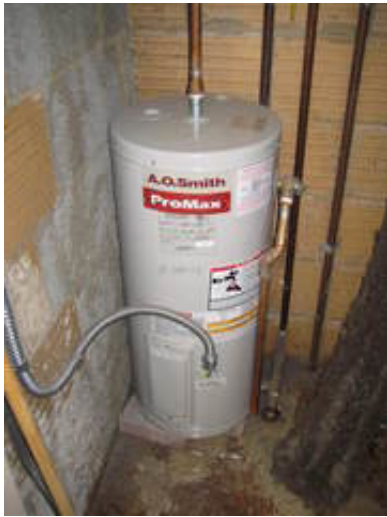
The service entrance is not equipped with a reduced pressure backflow preventer. A water treatment system is provided for the steam boilers only, and is in good condition. The domestic water supply piping in the overall facility is galvanized and copper, is original to each addition, and is in fair condition. The waste piping in the overall facility is cast iron and galvanized, is original to each addition, and is in fair condition. The facility is equipped with four separate water heaters. Two are 40 gallon electric water heaters, installed in 1992, and in poor condition. The third is a 30 gallon electric water heater, installed in 1992, and in poor condition. The fourth is a 15 gallon electric water heater, installed in 2005, and in good condition. The facility is also equipped with one (1) A.O. Smith natural gas domestic water boiler, installed in 1993, in fair to poor condition, with one (1) separate 150 gallon storage tank, installed in 1969, and in poor condition. The overall facility contains 3 Large Group Restrooms for boys, 3 Large Group Restrooms for girls, 1 Locker Room Restroom for boys, 1 Locker Room Restroom for girls, 0 Locker Room Restrooms for staff, 0 Kitchen Restrooms, 1 Health Clinic Restroom, 4 Restrooms associated with Kindergarten / Pre-K Classrooms / Specialty Classrooms, and 3 Restrooms for staff. Boys' Large Group Restrooms contain 2 ADA and 9 non-ADA floor mounted (7 flush valve / 4 infra-red) toilets, 18 non-ADA floor mounted (12 central flush / 6 infra-red) urinals, as well as 2 ADA and 4 non-ADA wall mounted lavatories. Girls' Large Group Restrooms contain 2 ADA and 19 non-ADA floor mounted flush valve toilets, as well as 2 ADA and 4 non-ADA wall mounted lavatories. Boys' Locker Room Restroom contains 1 non-ADA floor mounted flush valve toilet, 1 non-ADA floor mounted flush valve urinal, 1 non-ADA wall mounted lavatory, as well as 6 non-ADA showers. Girls' Locker Room Restroom contains 1 non-ADA floor mounted flush valve toilet, 1 non-ADA wall mounted lavatory, as well as 5 non-ADA showers. Staff Restrooms contain 3 non-ADA floor mounted flush valve toilets, as well as 3 non-ADA wall mounted lavatories. Condition of fixtures is fair to poor. The facility is equipped with 1 non-ADA drinking fountains, as well as 6 ADA electric water coolers, in fair to poor condition. Elementary Classrooms are not equipped with required lavatory mounted type drinking fountains. Special Education Classroom is not equipped with the required Restroom facilities. Kitchen is not equipped with the required Restroom facilities. Health Clinic is equipped with the required Restroom which contains 1 non-ADA wall mounted flush valve toilet, as well as 1 non-ADA wall mounted lavatory, and fixtures are in fair to poor condition. Kindergarten / Pre-K Classrooms are equipped with Restroom facilities which contain 4 non-ADA floor mounted flush valve toilets, as well as 4 non-ADA wall mounted lavatories, and fixtures are in fair to poor condition. Kitchen fixtures consist of one (1) triple-compartment sink and one (1) dishwashing unit with built-in Hatco water heater, which are in fair condition. The Kitchen is not equipped with a grease interceptor. The Kitchen is not provided the required 140 degree hot water supply. The school meets the OBC requirements for fixtures. Per OBC and OSDM requirements this facility should be equipped with 18 toilets, 9 urinals, 18 lavatories, and 4 electric water coolers, and at present it is equipped with 42 toilets, 19 urinals, 13 lavatories, and 6 electric water coolers. ADA requirements are not met for fixtures and drinking fountains (see Item O). Custodial Closets are properly located and are adequately provided with required service sink or floor drain sink, which is in fair to poor condition. CONTINUED

Electric Domestic Water Heater

Replace galvanized water supply piping in the overall facility with copper piping due to age and condition. Replace sanitary waste piping in the overall facility due to age and condition. To facilitate the school's compliance with OBC and OSFC requirements, provide 18 lavatory mounted type drinking fountains. Due to age, condition, and OSFC standards, replace 42 faucets and valves, 13 lavatories, 19 urinals, and 4 electric water coolers. See Item O for replacement of fixtures related to ADA requirements. See Item J for provisions on Kitchen related equipment. Provide the service entrance with a reduced pressure back flow preventer. Replace all domestic hot water heaters, except for the 15 gallon water heater, due to age and condition. Replace 150 gallon domestic hot water storage tank due to age and condition. Provide the Kitchen with a grease trap interceptor. Provide the Kitchen with a water booster heater. Provide 2 additional exterior wall hydrants. Replace the existing Custodial Closet service sinks due to age and condition.

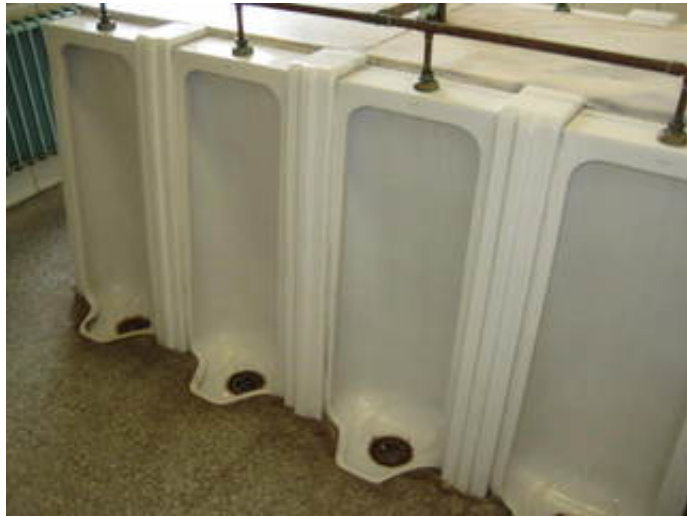
Central Flush Floor Mounted Urinals

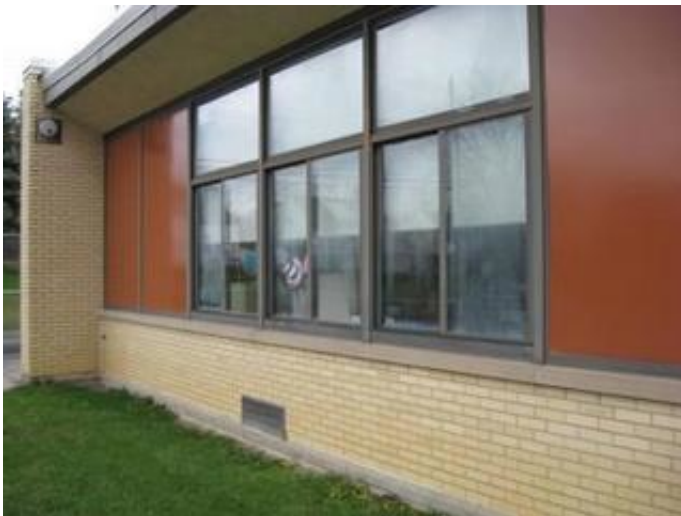
Description: The overall facility is equipped with thermally broken aluminum frame windows with double glazed insulated glazing and insulated panel type window system, which was installed in 1982, and is in fair to poor condition. The Gymnasium window openings are equipped with thermally broken aluminum frames with translucent insulating fiberglass panels, which were installed in 1982, and are in fair condition. Window system seals are in fair condition, with minimal air and water infiltration being experienced. Window system hardware is in fair condition. The insulating glazing panel seals have failed in numerous window openings. The window system features surface mounted shades, which are in fair condition. The window system is partially equipped with insect screens on operable windows, which are in good to fair condition. This facility is not equipped with any curtain wall systems. This facility does not feature any glass block windows. The exterior doors in the overall facility are equipped with thermally broken aluminum frame sidelights and transoms with double glazed insulated glazing, in good condition. The school does not contain skylights. Window security grilles are not provided for ground floor windows. There is no Greenhouse associated with this school. 06-22-18 Assessment Update: Due to the activities in the gymnasium and to ensure safety, the gymnasium windows should be translucent panel system in lieu of glass.

Rating: 3 Needs Replacement

Typical Classroom Windows with Broken Glazing Seals

Recommendations: Provide a new insulated window system with integral blinds to meet with Ohio School Design Manual requirements. Replace single pane vision panels in exterior doors of the overall facility with approved insulating safety glass. 06-22-18 Assessment Update: Due to the activities in the gymnasium and to ensure safety, the gymnasium windows should be translucent panel system in lieu of glass.

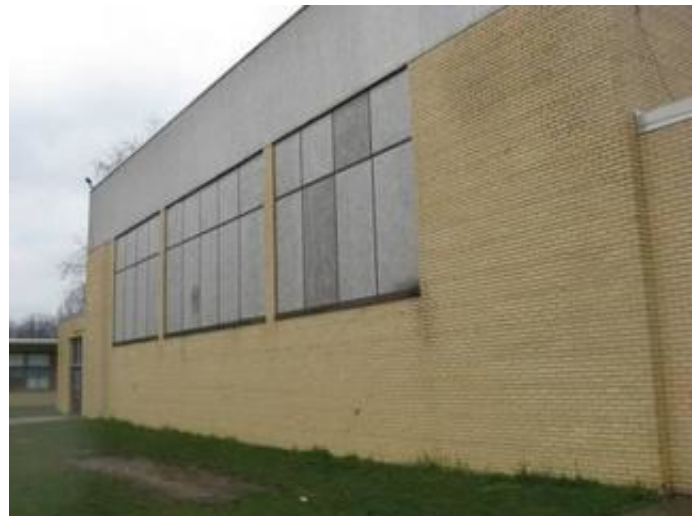
Window Openings at the 1951 Original Construction Gymnasium

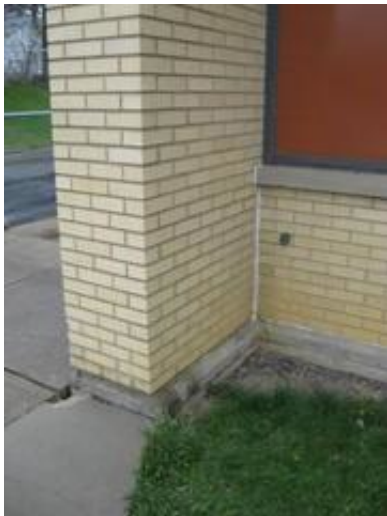
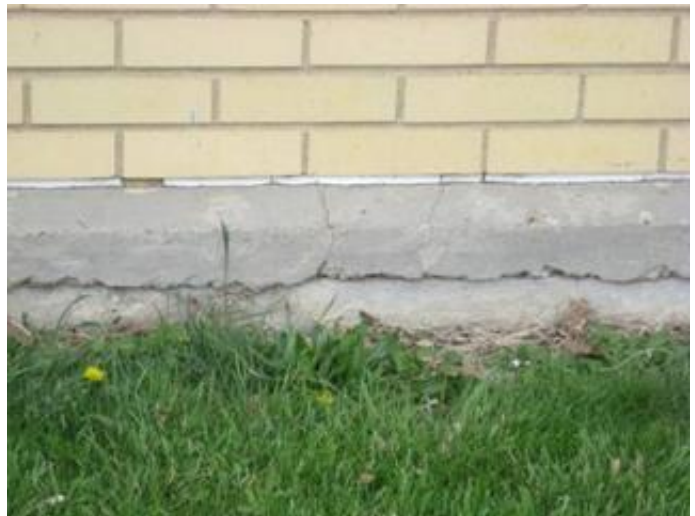
Description: The overall facility is equipped with concrete foundation walls on concrete footings, which displayed no locations of significant differential settlement. Areas of minor cracking and spalling were observed. The District reports that there has been past leaking through foundation walls in the utility tunnels and basement walls. No grading or site drainage deficiencies were noted around the perimeter of the structure that are contributing or could contribute to foundation / wall structural deterioration

Rating: 2 Needs Repair

Typical Condition of Exposed Concrete Foundation Wall at Sidewalk and Grade

Typical Condition of Exposed Concrete Foundation Wall at Grade

Recommendations: Repair minor cracks and spalled areas on exposed concrete foundations through the overall facility. Address leakage issues in the utility tunnel and basement walls.

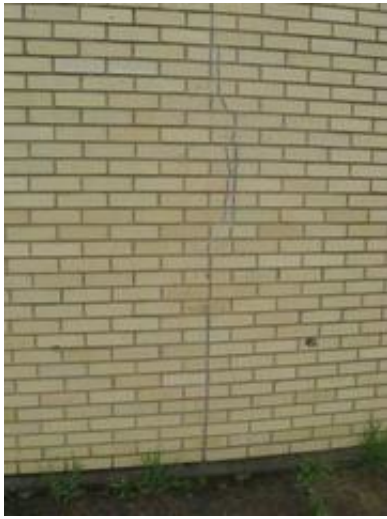
Description: The overall facility has a brick veneer and corrugated metal panels on a masonry bearing wall system, which displayed locations of deterioration, and is in fair condition. The exterior masonry appears to have inappropriately spaced and inadequately caulked control joints in poor condition. Control joints are not provided at lintel locations at doors and windows. The school does contain expansion joints, and are in fair condition. The exterior masonry has not been cleaned and sealed in recent years, and shows evidence of mortar deterioration and locations of staining. There are no architectural accent materials. Interior walls are painted concrete masonry units, glazed block, and wood framed partitions with gypsum board and are in good to fair condition. Interior masonry appears to have adequately spaced and inadequately caulked control joints in fair condition. Some cracking was observed in interior masonry walls. The window sills are stone, and are in fair condition. The exterior lintels are steel, and are rusting / in good to fair condition. There are no chimneys. Canopies over entrances are wood and shingle type construction, and are in fair condition. Exterior soffits are plaster type construction, and are in fair condition. A loading dock has not been provided to facilitate unloading of trucks and receipt of product / supplies / food stuffs. 06-22-18 Assessment Update: The budget for canopies replacement is insufficient for the work necessary to demolish and install new canopies.

Rating: 2 Needs Repair

Area of Exterior Masonry Wall Requiring Repairs

Recommendations: Provide tuckpointing in all areas of mortar deterioration as required through the overall facility. Provide masonry cleaning, sealing and caulking as required through the overall facility. Sawcut and caulk new appropriately spaced control joints in existing masonry through the overall facility. Recaulk existing control joints. Recaulk existing exterior expansion joints. Prep and paint exposed steel lintels through the overall facility. Repoint stone window sills through the overall facility. Replace existing wood and shingle canopies at building entries. Repair and paint exterior plaster soffits. Provide masonry repairs as required through the overall facility. Provide masonry infill for existing unit ventilator openings in exterior walls. Recaulk interior control joints as required through the overall facility. Repair interior masonry walls as required through the overall facility. 06-22-18 Assessment Update: Provide budget to demolish existing canopies, excavate and install footers, structural steel framing.

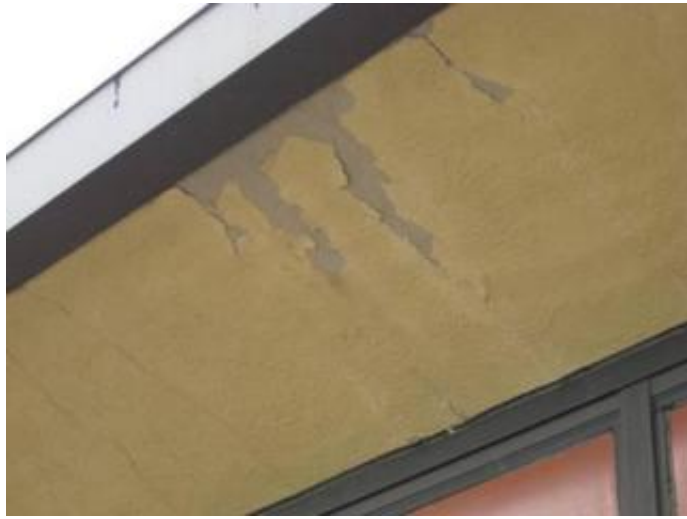
Typical Condition of Exterior Plaster Soffit Over Classroom Windows

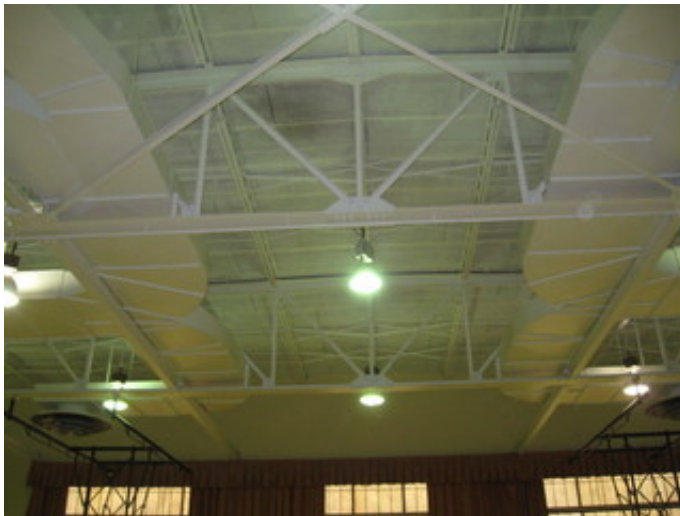
Typical Roof Structure Over the Gymnasium

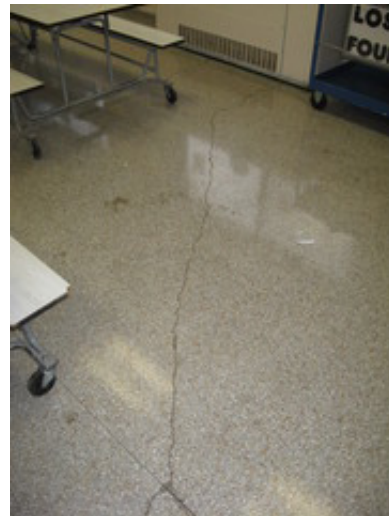
Description: The floor construction of the base floor of the overall facility is concrete slab-on-grade type construction, and is in fair condition, due to cracks in the Corridors and Student Dining. A pipe chase crawl space is located along the perimeter of the overall facility with above floor structure of cast-in-place reinforced concrete with concrete topping type construction. The floor construction of the Mechanical Mezzanine on either side of the Stage is cast-in-place reinforced concrete with concrete topping type construction, and is in good condition. There are no intermediate floors in this single story structure. Ceiling to structural deck spaces are sufficient to accommodate HVAC, electrical, and plumbing scopes of work in required renovations. The roof construction of the overall facility, except over the Gymnasium and Stage, is metal form deck on steel joist type construction, and is in good condition. The roof construction of the Gymnasium and Stage is tectum deck on steel truss type construction, and is in good condition.

Rating: 2 Needs Repair

Crack In Floor Slab-On-Grade of Student Dining

Recommendations: Repair cracks in the Corridor and Student Dining concrete slab.

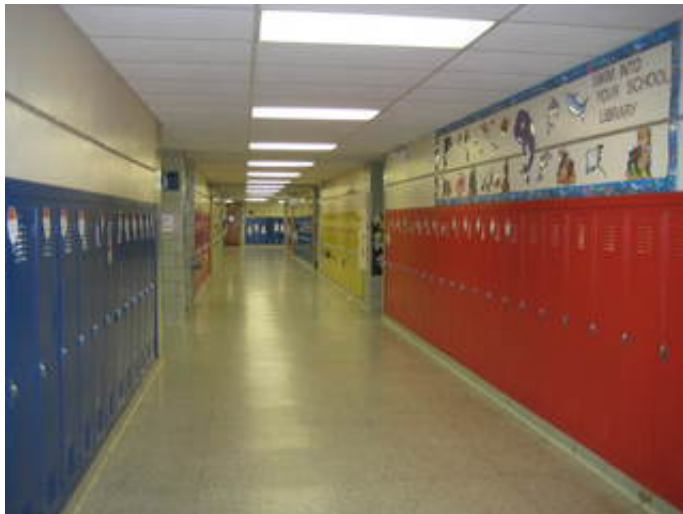
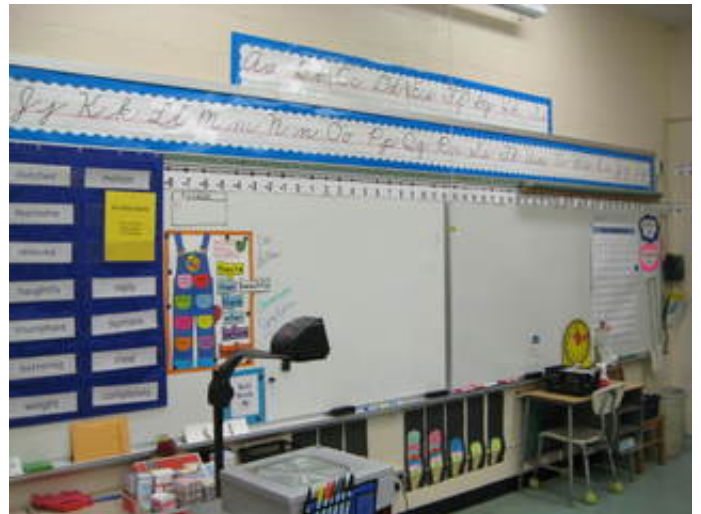
Description:	<p>The overall facility features conventionally partitioned Classrooms with VAT, VCT and carpet flooring, plaster ceilings, as well as painted block wall finishes, and they are in fair to poor condition. The overall facility has Corridors with terrazzo flooring, acoustical tile ceilings, as well as glazed block and gypsum board wall finishes, and they are in fair condition. The 1951 Original Construction has Restrooms with terrazzo flooring, plaster ceilings, as well as glazed block wall finishes, and they are in poor condition. Toilet partitions are metal, marble and wood, and are in poor condition. Classroom casework in the overall facility is wood type construction with wood tops, is adequately provided, and in poor condition. The typical Classroom contains 26 lineal feet of casework, and Classroom casework provided ranges from 20 to 28 feet. Classrooms are provided with adequate chalkboards, markerboards, and tackboards, which are in fair condition. The lockers, located in the Corridors, are adequately provided, and in fair condition. The Art program is equipped with a kiln in fair condition, and existing kiln ventilation is inadequate. The facility is equipped with wood non-louvered interior doors that are partially recessed without proper ADA hardware and clearances, and in fair condition. The Gymnasium spaces have wood flooring, tectum ceilings, as well as painted block and wood panel wall finishes, and they are in fair to poor condition. Wood Gymnasium flooring has been well maintained, will accommodate no future sandings and refinishings, and is rated at an advanced stage of its product lifecycle. Gymnasium telescoping stands are wood type construction in poor condition. Gymnasium basketball backboards are manually operated type, and are in poor condition. The Media Center has carpet flooring, plaster ceilings, as well as painted block wall finishes, and they are in good to fair condition. Student Dining, located in the 1951 Original Construction and 1978 Addition, has terrazzo flooring, acoustical tile ceilings, as well as painted block wall finishes, and they are in fair condition. OSDM-required fixed equipment for Stage is inadequately provided, and in poor condition. The existing Kitchen is full service, is undersized based on current enrollment, and the existing Kitchen equipment, installed in 1951, is in poor condition. The Kitchen hood is in poor condition, and is not equipped with the required UL 300 compliant wet chemical fire suppression system. The required 6" overhang on all three exposed sides of the cooking equipment is not provided by the hood. Kitchen hood exhaust ductwork is not of proper construction material and/or installed as required by the OSDM and OBMC. Reach-in coolers and freezers are located within the Student Dining, and are in fair condition. 06-22-18 Assessment Update: Floor infill, patch, floor tile repair and wall tile repair will be required following removal of floor mounted urinals. Stage curtain is old and worn and should be replaced. Wood stage flooring is worn same age as gymnasium floor and should be replaced.</p>

Typical Corridor Finishes

Typical Classroom Markerboard

Rating:	3 Needs Replacement
Recommendations:	<p>Provide complete replacement of finishes and casework due to installation of systems outlined in Items A, C, D, E, I, K, L, M, N, T, U, and due to condition. Provide for the replacement of interior doors due to condition. Other doors are funded in Item O due to opening expansion. Provide for the replacement of Kitchen equipment due to age and condition. Provide for the replacement of the Kitchen exhaust hood due to age and condition. Provide for the replacement of toilet partitions due to condition. Provide for the replacement of toilet accessories due to condition. Provide for the replacement of Gymnasium seating due to condition. Provide for the replacement of the Gymnasium wood floor due to product life cycle. Provide for the replacement of Gymnasium basketball goals due to condition. Provide for the replacement of the Art Program kiln due to condition. Provide for the replacement of hard plaster due to work in Item T. Provide for replacement of interior wood partition walls to meet OSDM and OBC requirements. 10-02-14 Update: Exterior walls are 8" block with 4" clay fired brick and no air cavity or insulation. Provide insulation of exterior walls to meet LEED energy requirements. 06-22-18 Assessment Update: Provide budget for floor infill, patch, floor tile repair and wall tile repair for removal of floor mounted urinals. Replace stage curtain. Replace wood stage flooring.</p>

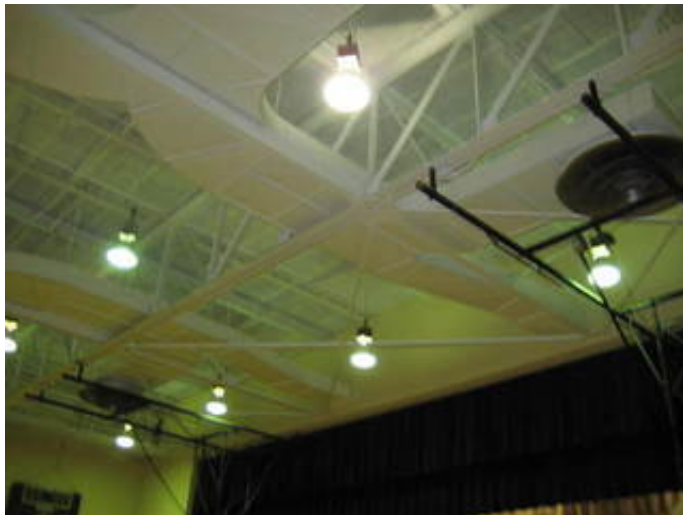
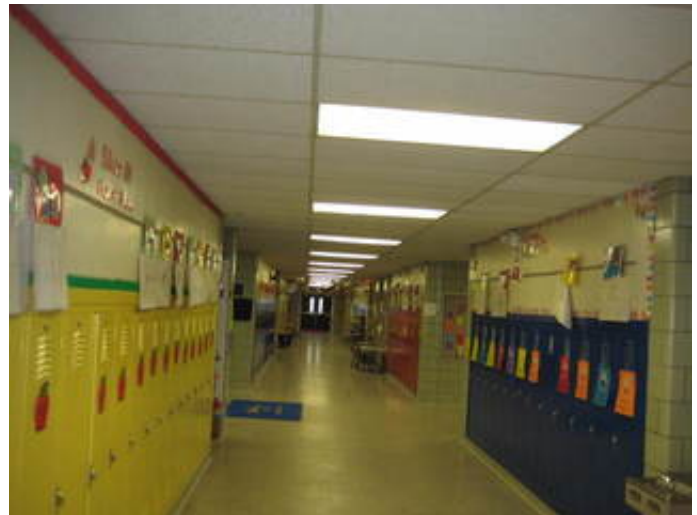
The typical Classrooms in the overall facility are equipped with T-8 1x4 surface mount fluorescent fixtures with single level switching. Classroom fixtures are in fair condition, providing an average illumination of 60 FC, thus complying with the 50 FC recommended by the OSDM. The typical Corridors in the overall facility are equipped with T-8 2x4 lay-in direct fluorescent fixtures with single level switching. Corridor fixtures are in good to fair condition, providing an average illumination of 22 FC, thus complying with the 20 FC recommended by the OSDM. The Gymnasium spaces are equipped with pendant metal halide type lighting, in fair to poor condition, providing an average illumination of 33 FC, which is less than the 50 FC recommended by the OSDM. The Media Center is equipped with T-8 1x4 surface mount fluorescent fixture type lighting in fair condition, providing an average illumination of 63 FC, thus complying with the 50 FC recommended by the OSDM. The Student Dining spaces are equipped with T-8 2x4 lay-in direct fluorescent fixture type lighting with single level switching. Student Dining fixtures are in fair condition, providing an average illumination of 44 FC, which is less than the 50 FC recommended by the OSDM. The Kitchen spaces are equipped with T-8 1x4 surface mount fluorescent fixture type lighting with single level switching. Kitchen fixtures are in fair to poor condition, providing an average illumination of 53 FC, which is less than the 75-80 FC recommended by the OSDM. The Service Areas in the overall facility are equipped with T-8 1x4 suspended and surface mount fluorescent fixture type lighting in fair condition, providing inadequate illumination. The typical Administrative spaces in the overall facility are equipped with T-8 1x4 surface mount fluorescent fixture type lighting in fair condition, providing adequate illumination based on OSDM requirements. The overall lighting systems of the facility are not compliant with Ohio School Design Manual requirements due to age, condition, inadequate lighting levels, lack of multi-level switching, and the utilization of incandescent fixtures.

Gymnasium Pendant Metal Halide Light Fixtures

Corridor Fluorescent Light Fixtures

Provide complete replacement of lighting system due to age, condition, inadequate lighting levels, lack of multilevel switching, the utilization of incandescent fixtures, and installation of systems outlined in Items A, C, J, and U.

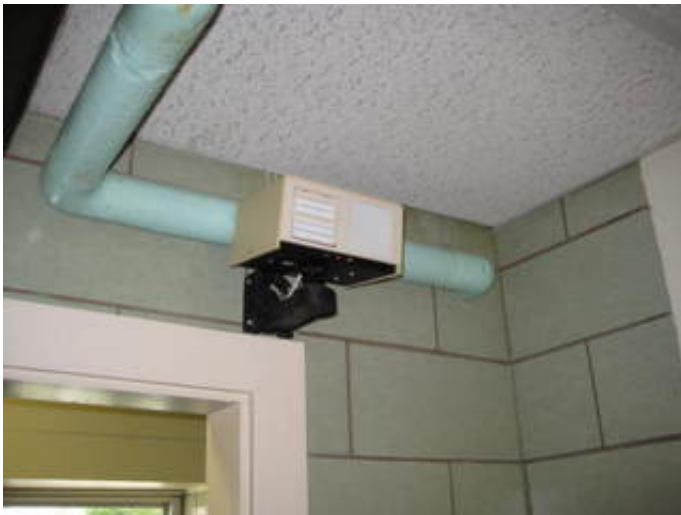
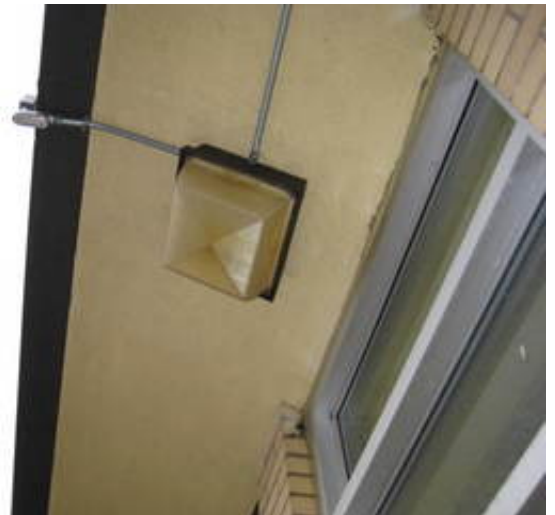
Description: The overall facility contains a Honeywell motion sensor and door contact type security system in fair condition. Motion detectors are inadequately provided in main entries, central gathering areas, offices, main Corridors, and spaces where 6 or more computers are located. Exterior doors are inadequately equipped with door contacts. An automatic visitor control system is not provided. Compliant color CCTV cameras are not provided at main entry areas, parking lots, central gathering areas, and main Corridors. A compliant computer controlled access control system integrating alarms and video signals, with appropriate UPS backup, is not provided. The system is not equipped with card / biometric readers. The security system is inadequately provided throughout, and the system is not fully compliant with Ohio School Design Manual guidelines. Existing playground fencing is not fully compliant with Ohio School Design Manual guidelines. The exterior site lighting system is equipped with surface mounted HID high pressure sodium / mercury vapor entry lights in fair condition. Pedestrian walkways are not illuminated. Parking and bus pick-up / drop off areas are not illuminated. The exterior site lighting system provides inadequate coverage. 06-22-18 Assessment Update: The main office is interior to the building and the main entry does not provide for adequate security. Modifications are required to achieve a secure main entrance into the building.

Security System Motion Detection Device

Surface Mounted HID High Pressure Sodium Light Fixture

Recommendations: Provide complete replacement of security system to meet Ohio School Design Manual guidelines. Provide complete replacement of exterior site lighting system to meet Ohio School Design Manual guidelines. Provide additional playground fencing to meet Ohio School Design Manual guidelines, funding included in complete replacement of security system. 06-22-18 Assessment Update: Provide for modifications on existing main entrance to provide for a security vestibule.

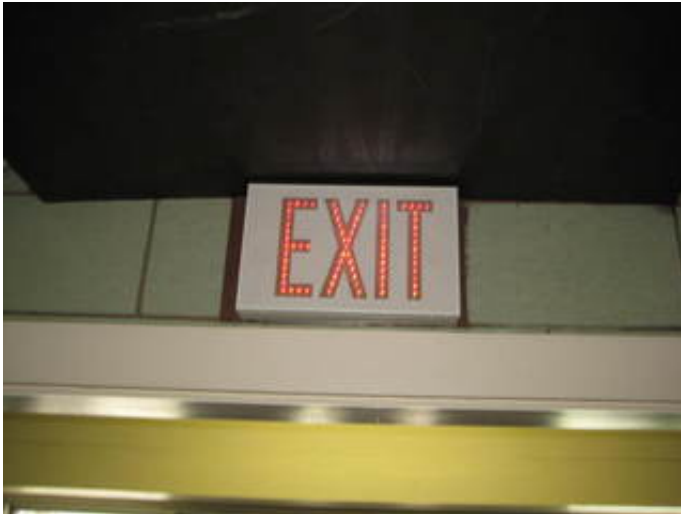
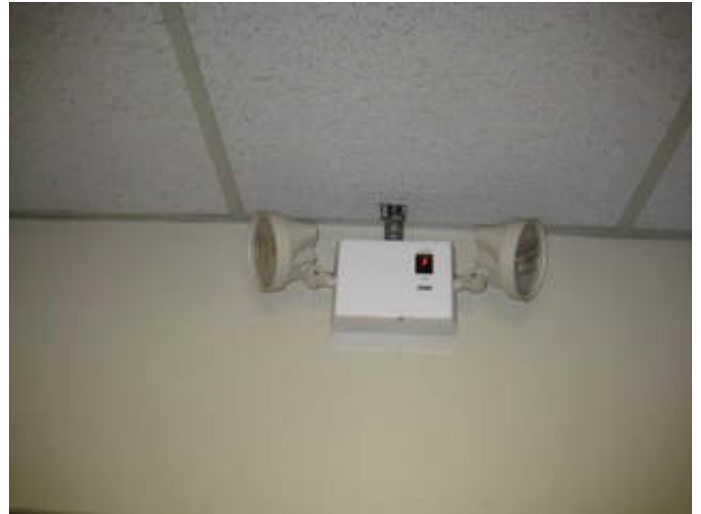
Description: The overall facility is equipped with an emergency egress lighting system consisting of non compliant plastic construction exit signs, as well as OSDM compliant red lettered, cast aluminum construction, and LED illuminated exit signs and the system is in fair condition. The facility is not adequately equipped with emergency egress floodlighting, and the system is in fair condition. The system is not provided with appropriate battery backup and emergency generator on separate circuits. The system is inadequately provided throughout, and does not meet Ohio School Design Manual and Ohio Building Code requirements.

Compliant Illuminated Exit Sign

Emergency Egress Light Fixture

Recommendations: Provide complete replacement of emergency / egress lighting system to meet Ohio School Design Manual guidelines.

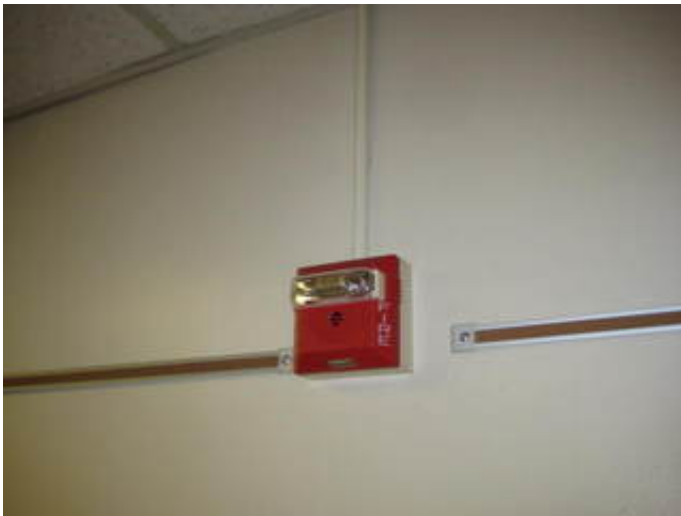
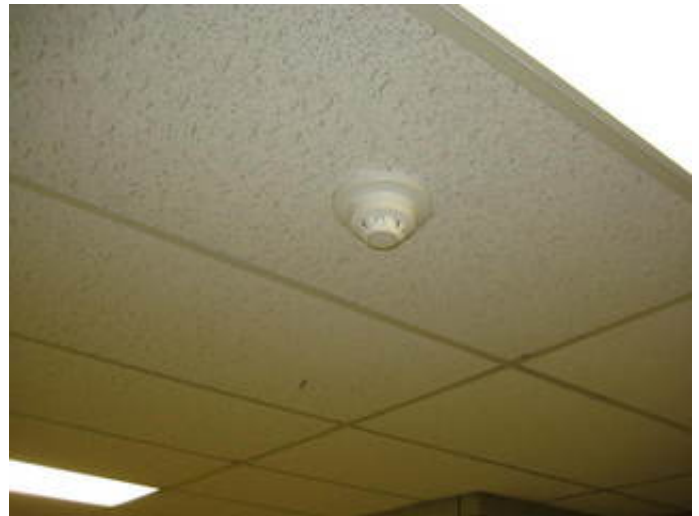
Description: The overall facility is equipped with an addressable Gamewell Flex 610 fire alarm system, installed in 1999, and in good to fair condition, consisting of manual pull stations, smoke detectors, and horn and strobe indicating devices. The system is automatic and is monitored by a third party. The system is not equipped with sufficient flow switches, tamper switches, and heat sensors. The system is not equipped with any flow switches, tamper switches, or heat sensors. The system thus will not support future fire suppression systems. The system is not adequately provided throughout, and does not have additional zone capabilities. The system is not compliant with Ohio Building Code, NFPA, and Ohio School Design Manual requirements.

Fire Alarm System Horn and Strobe Indicating Device

Fire Alarm System Smoke Detection Device

Recommendations: Provide complete replacement of fire alarm system to meet OBC, NFPA, and Ohio School Design Manual guidelines.

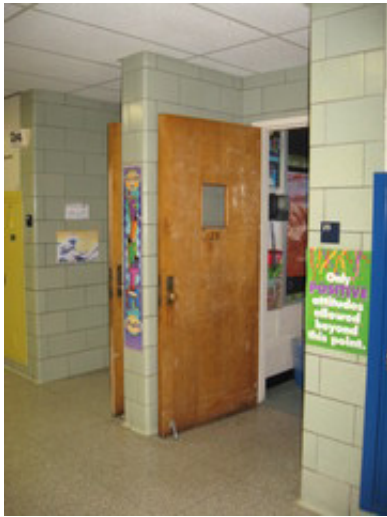
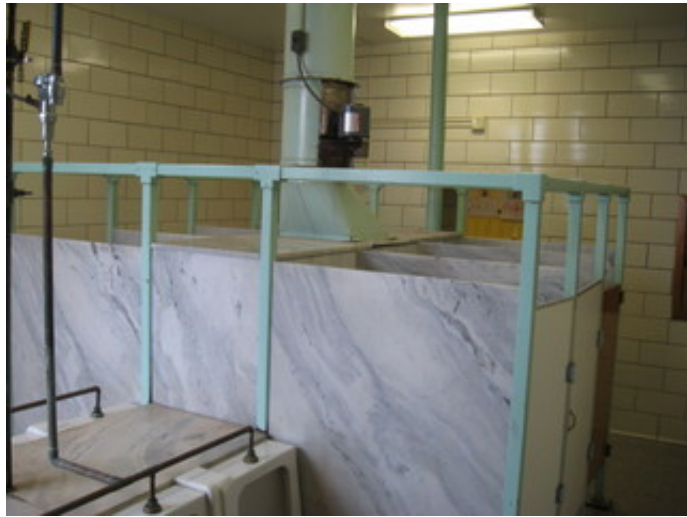
Typical Classroom Entry

Group Boy's Restroom

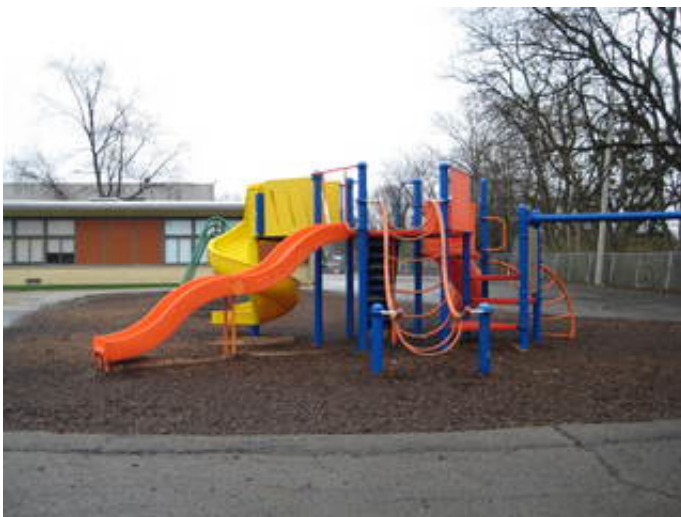
Playground Equipment

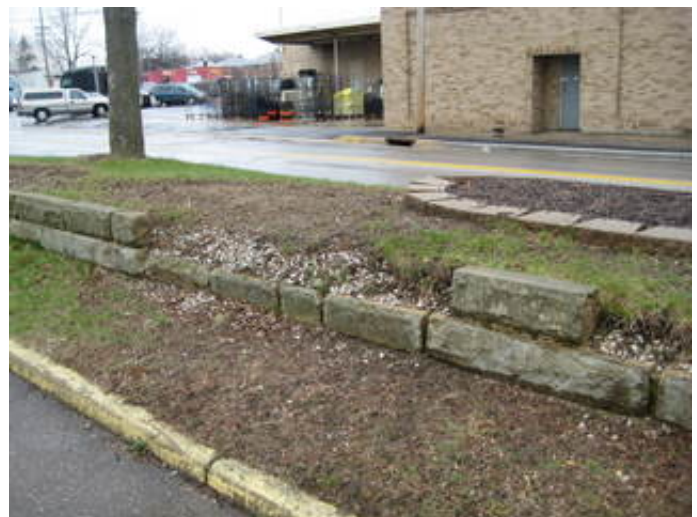
The 7.9 acre slightly sloped site is located in a suburban residential and commercial setting with moderate tree and shrub type landscaping. There are no outbuildings. There are apparent problems with ponding near the baseball field and the sidewalk to the northeast of the building. Ponding is caused by improper grading. The site is bordered by moderately traveled city streets. A single entrance onto the site impedes proper separation of bus and other vehicular traffic, and one way bus traffic is not provided. A bus loop is provided for student loading and unloading. Staff and visitor parking is facilitated by multiple asphalt parking lots in fair to poor condition, containing 52 parking places, which provides adequate parking for staff members, visitors, and the disabled. The site and parking lot drainage design, consisting of sheet drainage and catch basins, provides adequate evacuation of storm water, and no problems with parking lot ponding were observed. Concrete and asphalt curbs in fair condition are appropriately placed. Concrete sidewalks are properly sloped, are located to provide a logical flow of pedestrian traffic, and are in fair condition. Trash pick-up and service drive pavement is heavy duty and is in fair to poor condition, and is equipped with a concrete pad area for dumpsters, which is in good condition. There are no exterior stairs and handrails associated with this facility. Site fencing is partially provided at the property lines to the north and south. There is a retaining wall at the north property line and it is in good condition. There is a small garden wall at the center drive island in front of the school, which is in poor condition. The playground equipment is primarily constructed of coated steel and high density plastic, is in good to fair condition, placed to provide compliant fall zones, and on a compliant mulch soft surface of sufficient depth, with a basketball court being provided on an asphalt surface. The playground area is not equipped with sufficient tables and benches. The athletic facilities are comprised of 2 baseball fields, and are in fair condition. Site features are suitable for outdoor instruction, though no related equipment has been provided to facilitate doing so. There is an area for expansion of approximately 22,000 SF located to the west of the building. Expansion would require relocation of some of the parking as well as the Playground. There is a grocery store located directly across the street to the East.

Retaining Wall Condition

Provide for the replacement of the asphalt wear layer due to condition. Replace concrete sidewalks as required due to condition. Provide for soil stabilization at the baseball infield to prevent future ponding and erosion. Provide for the replacement of the center drive island retaining wall due to condition. Provide site contingency allowances for unforeseen conditions.

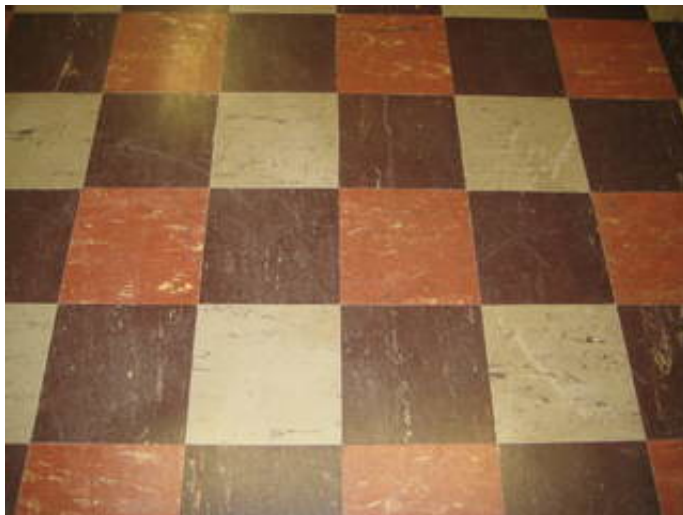
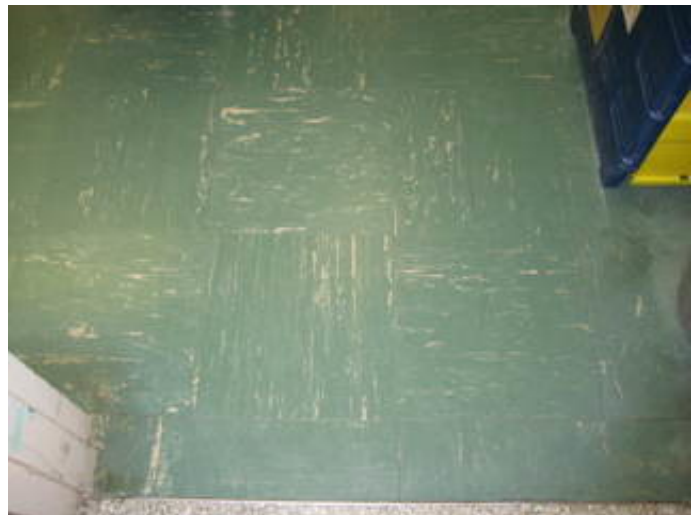
Rating: 3 Needs Replacement

VAT in Office

VAT in Classrooms

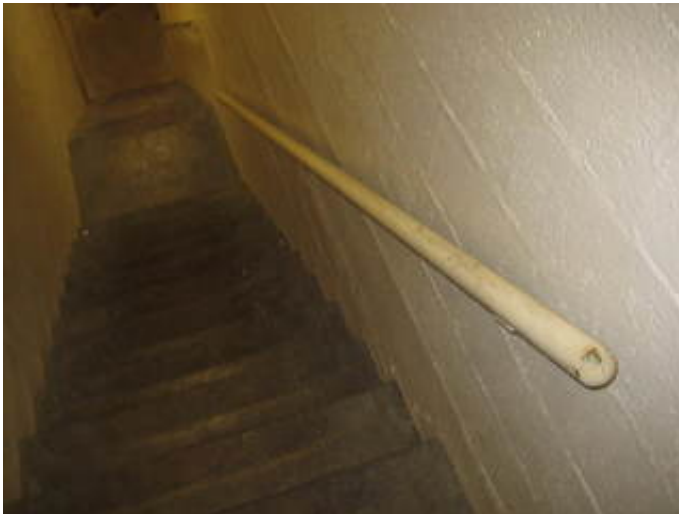
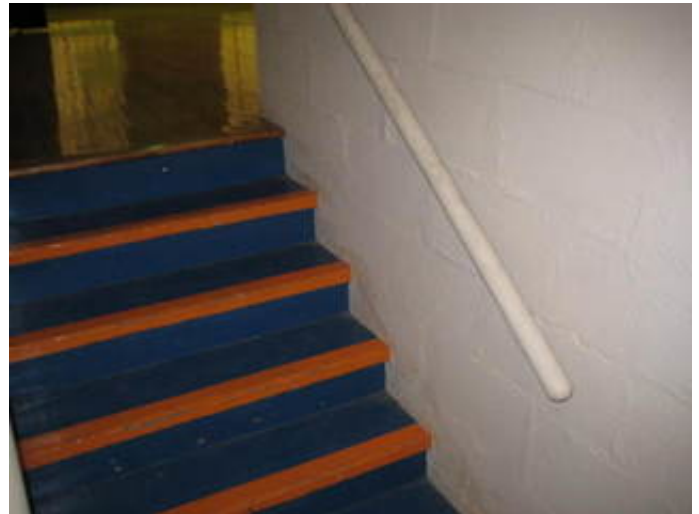
Mechanical Room Handrail

Stage Handrail

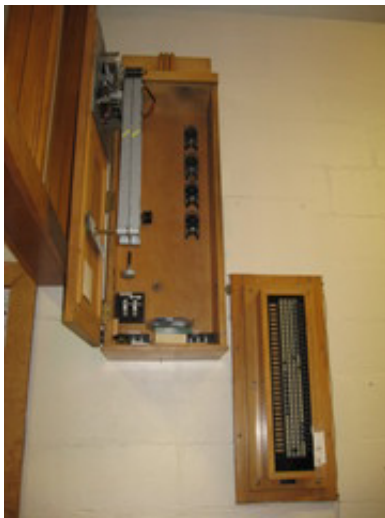
Outdated Centralized Clock System
