**Building Information - Cuyahoga Falls City (43836) - Roberts Middle**

Gilbert Roberts Middle School, which is not on the National Register of Historic Buildings, and originally constructed in 1968, is a 2 story, 75,249 square foot brick school building located in a suburban residential setting. The existing facility features a conventionally partitioned design, and does not utilize modular buildings. The structure of the overall facility contains a brick veneer on a masonry bearing wall type exterior wall construction and interior steel frame, with concrete masonry units and metal stud framed partitions with gypsum board type wall construction in the interior. The base floor system consists of concrete slab-on-grade type construction. The floor system of the second floor consists of metal form deck with concrete topping on steel beam type construction. The roof structure, except over the Gymnasium, is metal form deck on steel joist type construction. The roof structure over the Gymnasium is metal form deck on steel truss type construction. The roofing system of the overall facility is an asphalt built-up roof with gravel wear coat that was installed in 1999. The ventilation syst

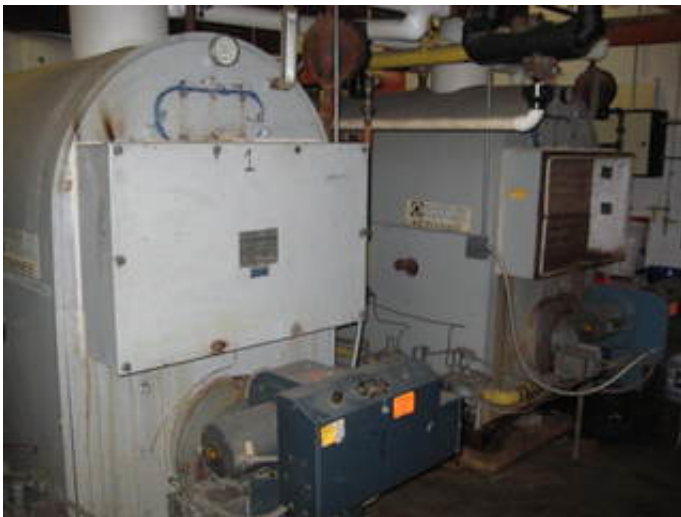
**Description:** The existing system for the overall facility is a natural gas fired heated water boiler type system and a ducted packaged roof top HVAC unit type system, installed in 1968 with upgrades in 1999, and is in fair condition. 2-pipe vs. 4-pipe designations are not applicable in this facility, as no central air conditioning is provided. The two (2) Kewanee square heat generator boilers, manufactured by American Standard, were installed in 1968 and are in poor condition. Heating water is distributed to terminal units consisting of unit ventilators, cabinet heaters, unit heaters, and air handlers. The terminal equipment was installed in 1968 with some upgrades in 1999 and is in fair condition. The facility is also equipped with ducted packaged roof top HVAC units, manufactured by Seasons-4, Inc., provide heated air to the interior rooms of the facility. The system does not comply with the 15 CFM per person fresh air requirements of the Ohio Building Code mechanical code and Ohio School Design Manual. The pneumatic type system temperature controls were installed in 1968 with upgrades in 1999 and are in fair to poor condition. The system does not feature individual temperature controls in all spaces required by the OSDM. The overall system does not feature any central energy recovery systems. The facility is partially equipped with louvered interior doors to facilitate Corridor utilization as return air plenums. See Items J and O for replacement of doors. The existing system is ducted, but the ductwork cannot be integrated into a possible future system due to arrangement, air volume, and routing of existing ductwork. The overall heating system is evaluated as being in safe but inefficient working order, and long term life expectancy of the existing system is not anticipated. The structure is equipped with a central air conditioning system, except for the Gymnasium and Locker Rooms. The site does contain underground fuel tanks.

**Rating:** 3 Needs Replacement

Natural Gas Fired Heated Water Boilers

**Recommendations:** Provide new overall heating, ventilating, and air conditioning system to achieve compliance with Ohio Building Code and Ohio School Design Manual standards. Replace existing ductwork in the overall facility to facilitate efficient exchange of conditioned air with pricing included in conversion to ducted system replacement.

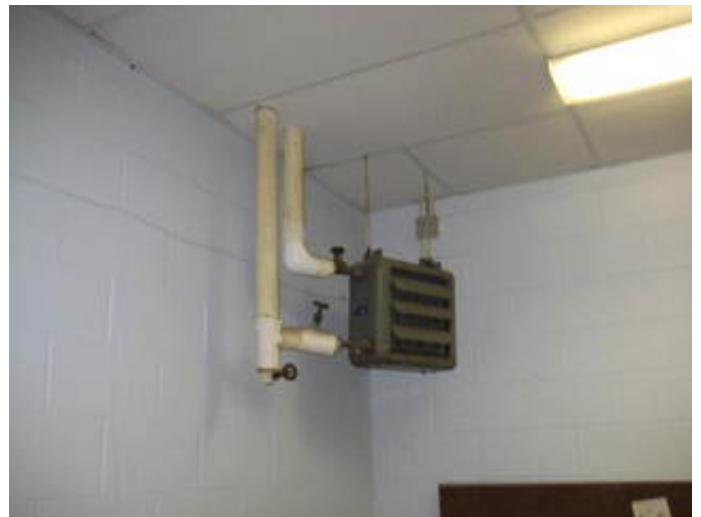
Heating Water Unit Heater

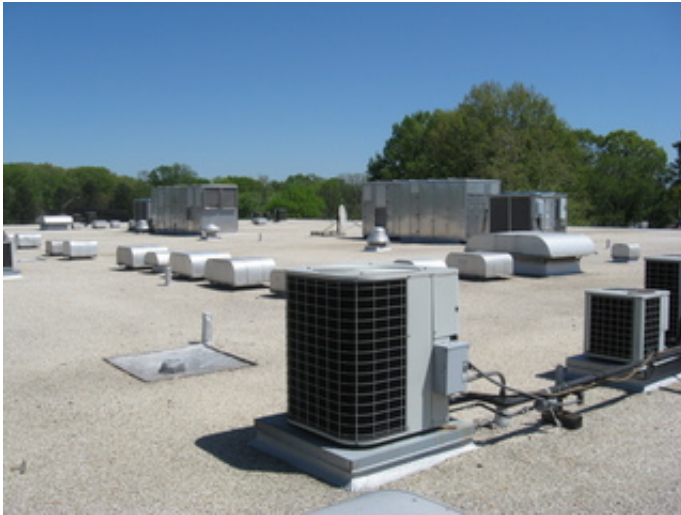
**Description:** The roof over the overall facility is an asphalt built-up roof with gravel wear coat that was installed in 1999, and is in fair condition. There are District reports of current leaking. Signs of past leaking were observed during the physical assessment. Access to the roof was gained by access roof hatch and interior access ladder that are in good condition. Fall safety protection cages are not required, and are not provided. There were no observations of standing water on the roof. Metal cap flashings are in good condition. Roof storm drainage is addressed through a system of roof drains, which are properly located, and in good condition. The roof is not equipped with overflow roof drains though they are needed on the roof over the Gymnasium. No problems requiring attention were encountered with any roof penetrations. There are not any covered walkways attached to this structure. 06-22-18 Assessment Update: Additional roof insulation required to meet LEED energy efficiency requirements.

**Rating:** 3 Needs Replacement

Typical Asphalt Built-Up Roof

**Recommendations:** The roof over the overall facility requires replacement to meet Ohio School Design Manual guidelines due to condition. Provide 4 new overflow roof drains on the roof over the Gymnasium. 06-22-18 Assessment Update: Provide for additional roof insulation to meet LEED energy efficiency requirements.

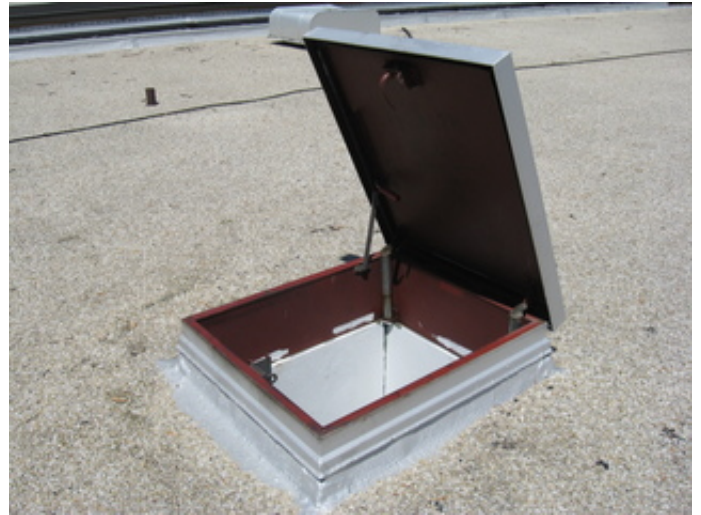
Roof Hatch

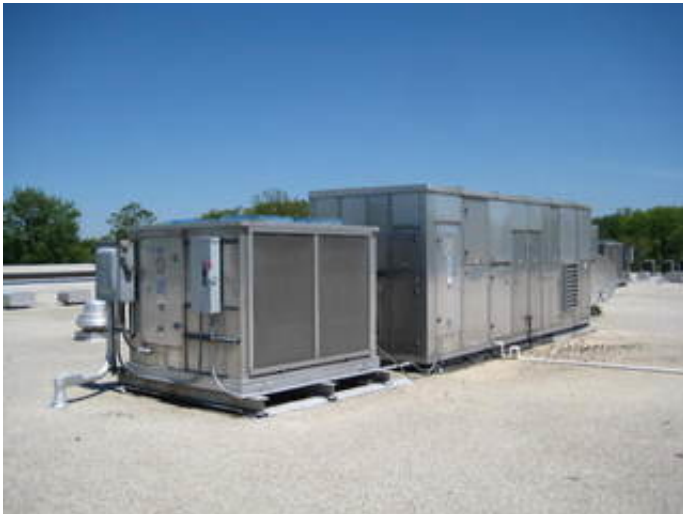
**Description:** The interior rooms of the overall facility are equipped with a ducted packaged roof top HVAC unit type central air conditioning system, which was installed in 1968 with upgrades in 1999, and is in fair condition. The two (2) ducted packaged roof top HVAC units were installed in 1999 and are in fair condition. The remainder of the overall facility, except for the Gymnasium and Locker Rooms, is equipped with isolated room systems. The Gymnasium and Locker Rooms are not equipped with a central air conditioning system. Isolated room systems consisting of ductless split HVAC units (with the condensing unit located on the roof and the unit ventilator / evaporator coils located in the rooms) are provided in all perimeter room locations of the overall facility. The overall facility is not equipped with any window units. The ventilation system in the overall facility consists of unit ventilators, ducted packaged roof top HVAC units, and air handlers, installed in 1999 and in fair condition, providing fresh air to Classrooms, and other miscellaneous spaces such as the Gymnasium, Student Dining, and Media Center. Relief air venting is provided by louvered interior doors, unit ventilators, air handlers, ducted packaged roof top HVAC units, and central relief fans. The ventilation system does not meet the Ohio Building Code 15 CFM per occupant fresh air requirement. The overall system is not compliant with Ohio Building Code and Ohio School Design Manual requirements. Dust collection systems are not required in this facility. Exhaust systems for Restrooms, Storage Rooms, Custodial Closets, Telecommunications Rooms, Maintenance Workrooms, Locker Rooms, Kitchen Dry Food Storage, P.E. Workroom & Storage, Art Material Storage, Art Rooms, Project Laboratories, and Science Classrooms are inadequately placed, and in fair to poor condition. The Art Program is equipped with a kiln, and the existing kiln ventilation system is adequate. 06-22-18 Assessment Update: General building exhaust is included in Item A and should not be included in this line item.

Ducted Packaged Roof Top HVAC Unit

**Recommendations:** Provide an air conditioning system to meet with Ohio Building Code and Ohio School Design Manual requirements. Pricing included in Item A. Replace the existing general building exhaust system. 06-22-18 Assessment Update: Delete general building exhaust.

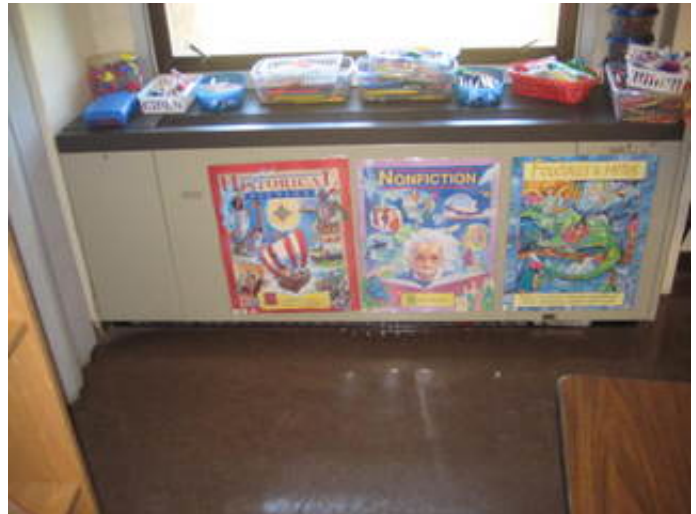
HVAC Unit Ventilator

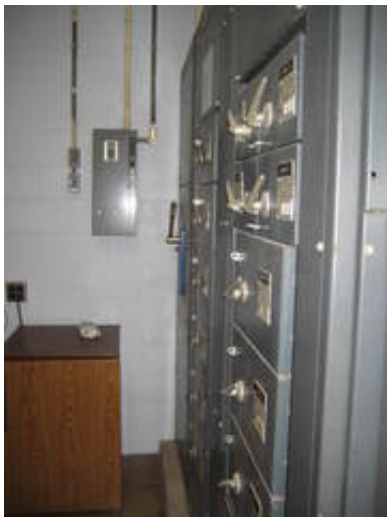
**Description:** The electrical system provided to the overall facility is a 240 volts, 1600 amp, 3 phase and 4 wire system installed in 1968, and is in fair condition. Power is provided to the school by a single City of Cuyahoga Falls owned, pad-mounted transformer located outside the Mechanical Room, and in good to fair condition. The panel system, installed in 1968, is in fair condition, and cannot be expanded to add additional capacity. The Classrooms are not equipped with adequate electrical outlets. The typical Classroom contains four (4) general purpose outlets, zero (0) dedicated outlets for each Classroom computer, and one (1) dedicated outlet for each Classroom television. Some Classrooms are equipped with as many as six (6) general purpose outlets, while others are equipped with as few as three (3) general purpose outlets. There are not any spaces that have no electrical outlets. The Corridors are not equipped with adequate electrical outlets for servicing. Adequate GFI protected exterior outlets are not provided around the perimeter of the building. The facility is not equipped with an emergency generator. Lightning protection safeguards are not provided. The facility is not equipped with Stage spaces. The overall electrical system does not meet Ohio School Design Manual requirements in supporting the current needs of the school, and will be inadequate to meet the facility's future needs.

**Rating:** 3 Needs Replacement

Main Electrical Distribution Panel

**Recommendations:** The entire electrical system requires replacement to meet Ohio School Design Manual guidelines for overall capacity and Classroom capacity due to age, condition, lack of OSDM-required features, and to accommodate the addition of an air conditioning system. Provide an emergency generator, with funding included in the electrical system replacement. Provide adequate lightning protection safeguards in the overall facility, including associated grounding system, with funding included in the electrical system replacement. Provide control panel, dimmers, and breakers to support a new Stage lighting system, with funding included in the electrical system replacement.

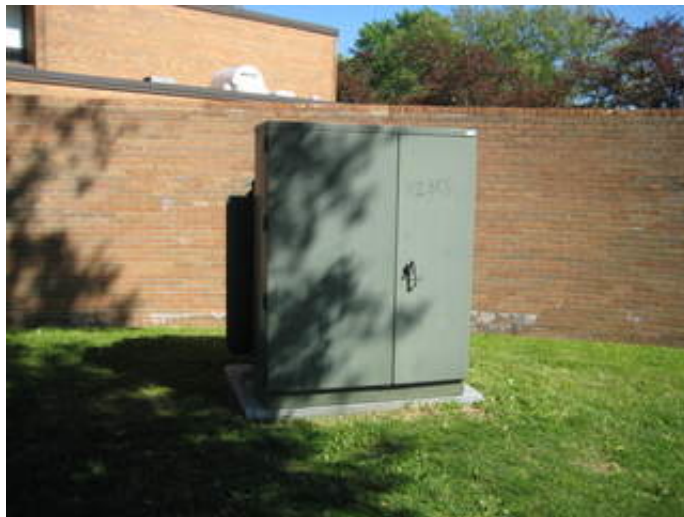
Pad Mounted Transformer

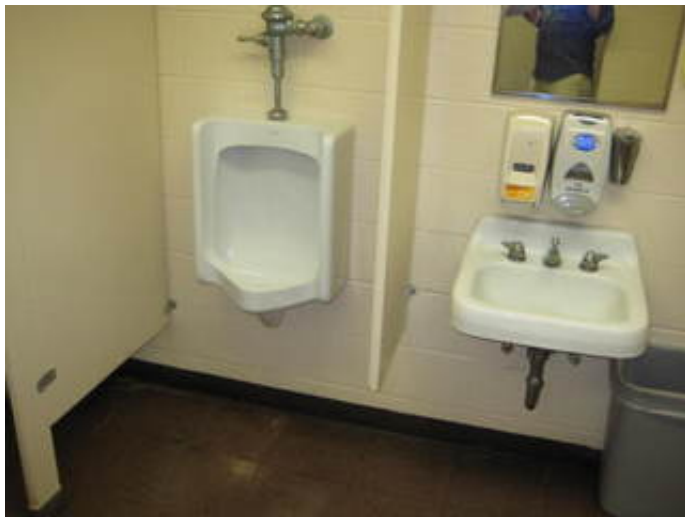
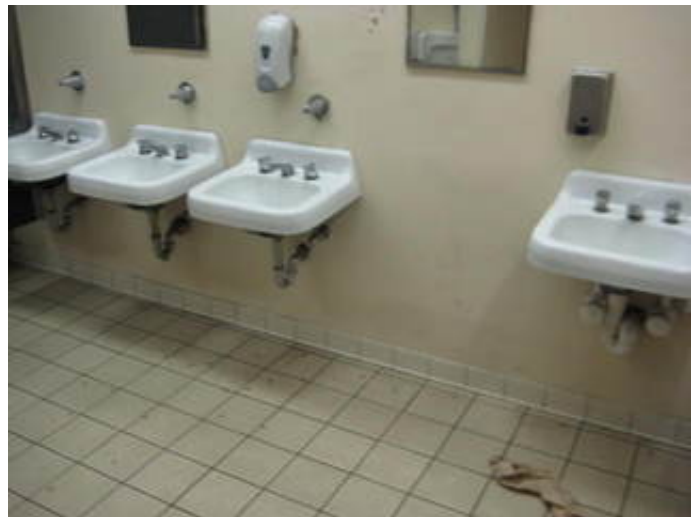
The service entrance is not equipped with a reduced pressure backflow preventer. A water treatment system is not provided, though none is needed. The domestic water supply piping in the overall facility is galvanized and copper, was installed in 1968, and is in fair condition. The waste piping in the overall facility is cast iron and galvanized, was installed in 1968, and is in fair condition. The facility is equipped with one (1) A.O. Smith Burkay Copper Coil natural gas water heater in poor condition, with one (1) separate Rudd 200 gallon storage tank in good to fair condition. The overall facility contains 2 Large Group Restrooms for boys, 2 Large Group Restrooms for girls, 1 Locker Room Restroom for boys, 1 Locker Room Restroom for girls, 0 Locker Room Restrooms for staff, 1 Kitchen Restroom, 1 Health Clinic Restroom, 0 Restrooms associated with Specialty Classrooms, and 3 Restrooms for staff. Boys' Large Group Restrooms contain 2 ADA and 10 non-ADA wall mounted flush valve toilets, 2 ADA and 4 non-ADA wall mounted flush valve urinals, as well as 7 non-ADA wall mounted lavatories. Girls' Large Group Restrooms contain 2 ADA and 8 non-ADA wall mounted flush valve toilets, as well as 8 non-ADA wall mounted lavatories. Boys' Locker Room Restrooms contain 1 non-ADA wall mounted flush valve toilet, 1 non-ADA wall mounted flush valve urinal, 2 non-ADA wall mounted lavatories, as well as 10 non-ADA showers. Girls' Locker Room Restrooms contain 2 non-ADA wall mounted flush valve toilets, 2 non-ADA wall mounted lavatories, as well as 12 non-ADA showers. Staff Restrooms contain 3 non-ADA wall mounted flush valve toilets, 1 non-ADA wall mounted flush valve urinal, as well as 3 non-ADA wall mounted lavatories. Condition of fixtures is fair. The facility is equipped with 2 non-ADA drinking fountains, as well as 6 ADA and 2 non-ADA electric water coolers, in good to fair condition. Due to existing grade configuration, there are no Elementary Classrooms. Special Education Classroom is not equipped with the required Restroom facilities. Kitchen is equipped with the required Restroom which contains 1 non-ADA wall mounted flush valve toilet, as well as 1 non-ADA wall mounted lavatories, and fixtures are in fair to poor condition. Health Clinic is equipped with the required Restroom which contains 1 ADA wall mounted flush valve toilet, as well as 2 non-ADA wall mounted lavatories, and fixtures are in fair condition. Due to existing grade configuration, there are no Kindergarten / Pre-K Classrooms. Kitchen fixtures consist of one (1) dishwashing unit, two (2) disposal units, one (1) double-compartment sink, and one (1) handsink, which are in fair condition. The Kitchen is not equipped with a grease interceptor. The Kitchen is not provided the required 140 degree hot water supply. The school meets the OBC requirements for fixtures. Per OBC and OSDM requirements this facility should be equipped with 14 toilets, 4 urinals, 14 lavatories, and 5 electric water coolers, and at present it is equipped with 30 toilets, 8 urinals, 25 lavatories, and 8 electric water coolers. ADA requirements are not met for fixtures and drinking fountains (see Item O). Custodial Closets are properly located and are adequately provided with required service sink or floor drain sink, which is in fair to poor condition. Science Classrooms / Labs are equipped with required utility sink and gas connections in good to fair condition, but are not equipped with the required compressed air connections and safety shower / eyewash. Due to existing grade configuration, no Biology or Chemistry Classroom acid waste systems are required. Adequate exterior wall hydrants are provided. 06-22-18 Assessment Update: Both domestic water heaters have exceeded their useful life and need replaced. In an effort to meet LEED requirements, the existing shower fixtures should be replaced with water saving fixtures. Science rooms are not equipped with safety eyewash/showers

3 Needs Replacement

Non-ADA Wall Hung Flush Valve Urinal and Wall Hung Lavatory

Non-ADA Wall Hung Lavatories

Replace galvanized water supply piping in the overall facility with copper piping due to age and condition. Replace sanitary waste piping in the overall facility due to age and condition. Due to age, condition, and OSFC standards, replace 25 lavatories, 30 toilets, 8 urinals, and 5 electric water coolers. See Item O for replacement of fixtures related to ADA requirements. See Item J for provisions on Kitchen related equipment. Provide the service entrance with a reduced pressure back flow preventer. Replace the domestic hot water heater due to age and condition. Provide the Kitchen with a grease trap interceptor. Provide the Kitchen with a water booster heater. Provide the Science Classrooms with the required compressed air connection. Provide the Science Classrooms with the required safety shower / eyewash station. Replace the existing Custodial Closet service sinks due to age and condition. 06-22-18 Assessment Update: Revise domestic water heaters replacement quantity from 1 to 2. Replace shower fixtures with water saving fixtures to meet LEED energy requirements. Provide 2 eyewash/shower stations.

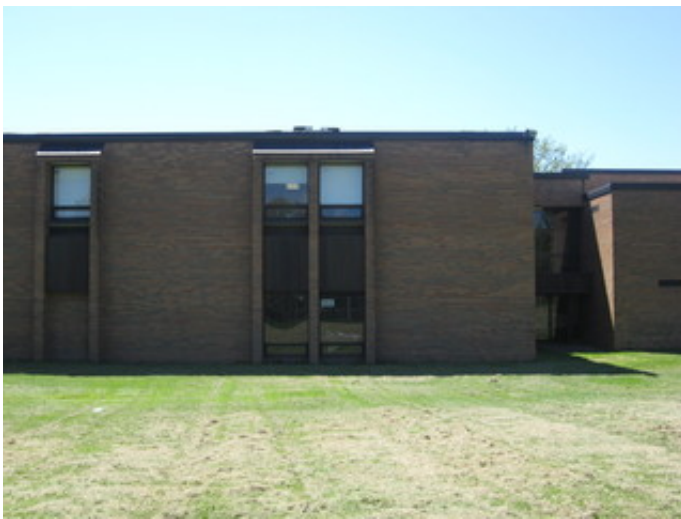
Typical masonry projection

**Description:** The overall facility has a brick veneer on a masonry bearing wall system, and interior steel frame, and is in good to fair condition. The exterior masonry of facility includes minimum control joints primarily located at exterior Service Area screen walls. These brick screen walls show various levels of deterioration, including missing and loose brick at wall cap. One north facing elevation of Service Area screen wall contains mold. Control joints are not provided at lintel locations at doors and windows. The overall facility contains masonry projections which provide shading and screening of windows and unit ventilator louvers. These masonry projections contain steel lintels and exterior soffits which are in fair to poor condition. Horizontal caulk joints at lintel bearing are in poor condition or completely missing. Weep holes and vents are not provided on facility, which may be contributing to deterioration of steel lintels. The school does not contain expansion joints, and none are needed as there is no indication of exterior masonry cracking or separation. Architectural exterior accent materials consist of prefinished metal panels, located in masonry projections, which are in poor condition. The exterior masonry has not been cleaned and sealed in recent years, and contains some severe staining in some areas as a result of water runoff from metal accent and roof panels and trim. Interior walls are concrete masonry units and metal stud framed partitions with gypsum board and are in good condition. Interior masonry appears to have adequately spaced and caulked control joints in good condition. Soffits are in fair condition. The window sills are brick and are in fair condition. The exterior steel lintel are rusting and in poor condition. Chimneys are in good condition. Canopies over entrances are metal panel fascia or masonry extensions of the building and plaster finish ceilings, are in good to fair condition. The facility does not contain a loading dock or large opening access to take delivery of building supplies or foodstuffs. 06-22-18 Assessment Update: The service yard masonry screen walls are deteriorating and needs rebuilt. Steel lintels at stained glass walls are rested and delaminating and need replaces. Repainting of lintels can be reduced from 450 to 370.

**Rating:** 2 Needs Repair

**Recommendations:** Provide tuckpointing in all areas of mortar deterioration as required at Service Area brick screen walls. Replace loose brick at screen wall cap. Reset, replace loose/damaged brick adjacent at head of masonry projection openings. Infill new brick at existing through wall unit ventilator louvers to be removed in section A. Provide masonry cleaning, sealing, and caulking as required through the overall facility. Prep and paint exterior soffits. Prep and paint exposed steel lintels through the overall facility. Replace steel lintels as required through the overall facility. Replacement of sloped metal roofs at masonry projections are addressed in section I. 06-22-18 Assessment Update: Rebuild masonry screen walls at service yard. Replace steel lintels at stained glass walls. Revise quantity for scraping and repainting lintels from 450 to 370.

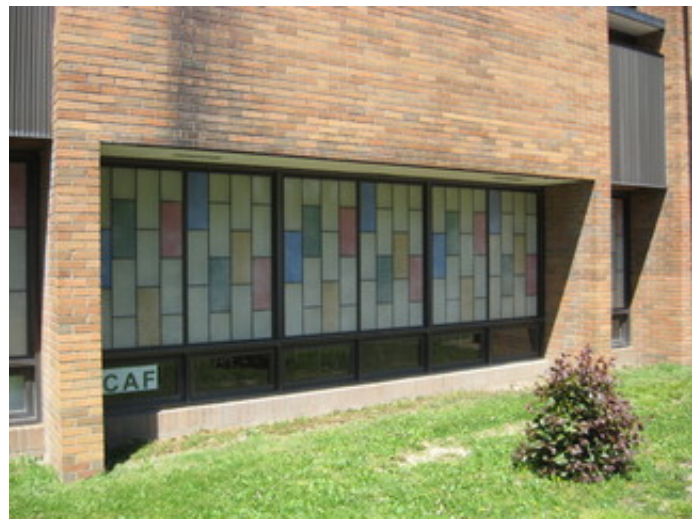
**Description:** The overall facility is equipped with non-thermally broken aluminum frame windows with single pane glazing type window system, which was installed in 1968, and is in fair condition. Several locations within the facility include insulated translucent panels within a non-thermally broken aluminum frame, which are in fair condition. Window system seals are in fair condition, with minimal air and water infiltration being experienced. Window system hardware is in fair condition. The window system features surface mounted blinds, which are in fair to poor condition. The window system is not equipped with insect screens on operable windows. This facility is not equipped with any curtain wall systems but contains some single glazed upper storefront at main circulation lobby, adjacent to Gymnasium. This facility does not feature any glass block windows. The exterior doors in the overall facility are non-thermally broken aluminum frame sidelights and transoms with single glazed non-insulated glazing, in fair condition. The school does not contain skylights. Window security grilles are not provided for ground floor windows. There is not a Greenhouse associated with this school. 06-22-18 Assessment Update: Interior classrooms have no natural lighting. While solutions are limited for the first floor, skylights can provide natural light to the 2nd floor bank of interior classrooms.

**Rating:** 3 Needs Replacement

Translucent panel window system at Cafeteria

**Recommendations:** Provide a new insulated window system with integral blinds to meet with Ohio School Design Manual requirements. Replace insulated translucent panels located in the Cafeteria and Home Education with new insulated window system. Replace window transoms / sidelights in exterior doors of the overall facility with approved insulated safety glass. Replace existing single pane glazing at gymnasium lobby storefront with thermally broke frame, insulated glazing. 06-22-18 Assessment Update: Provide skylights for 2nd floor interior classrooms.

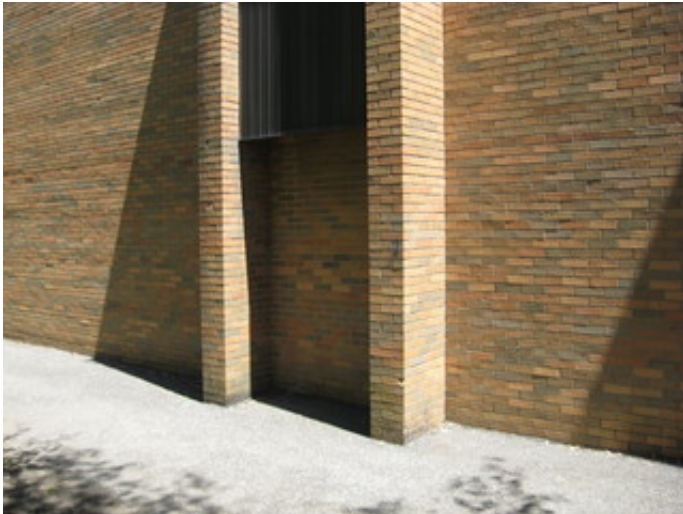
**Description:** The overall facility is equipped with concrete masonry unit foundation walls on concrete footings, which displayed no significant differential settlement, cracking, or leaking, and are in good condition. The District reports that there has been no past leaking. No grading or site drainage deficiencies were noted around the perimeter of the structure that are contributing or could contribute to foundation / wall structural deterioration.

Typical condition of Exterior Wall at Grade

**Recommendations:** Existing conditions require no renovation or replacement at the present time.

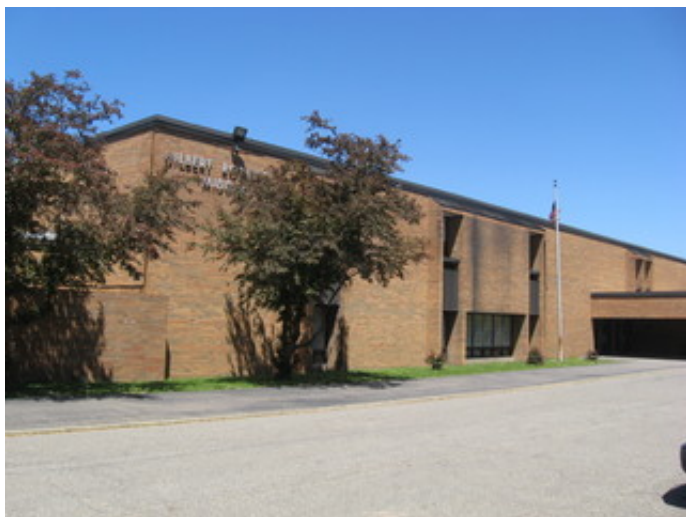
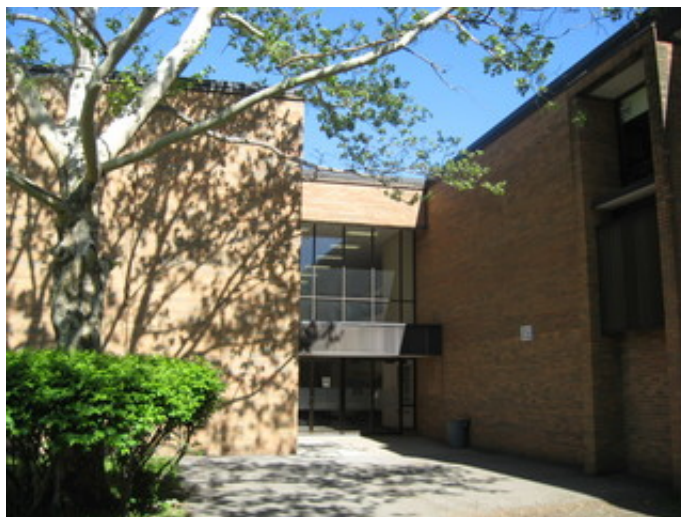
View Towards Main Entry

Entry to Gymnasium Lobby

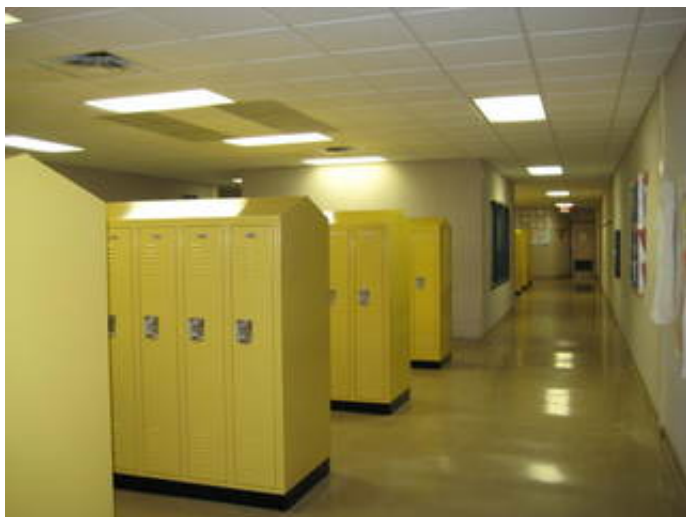
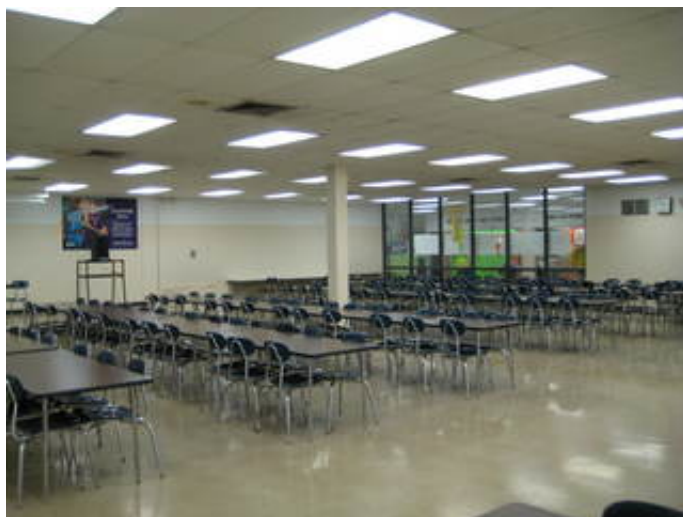
The overall facility features conventionally partitioned Classrooms with VCT flooring, acoustical tile ceilings, as well as painted block, gypsum board partitions, and operable partitions wall finishes, and they are in fair condition. The overall facility has Corridors with terrazzo flooring, acoustical tile ceilings, as well as epoxy coated block wall finishes, and they are in fair condition. The overall facility has Restrooms with ceramic tile flooring, gypsum board ceilings, as well as painted block wall finishes, and they are in fair to poor condition. Toilet partitions are phenolic resin in good condition, and metal in poor condition. Classroom casework in the overall facility is wood type construction with plastic laminate or wood tops, is inadequately provided, and in poor condition. The typical Classroom contains 16 lineal feet of casework, and Classroom casework provided ranges from 0 to 16 feet. Classrooms are provided adequate chalkboards, markerboards, and tackboards, which are in fair condition. The lockers, located in the Corridors, are adequately provided, and in good condition. The Art program is equipped with a kiln in good condition, and existing kiln ventilation is adequate. The facility is equipped with wood louvered and non-louvered interior doors that are recessed without proper ADA hardware and clearances, and in fair condition. The Gymnasium spaces have wood flooring, exposed metal deck ceilings, as well as painted block wall finishes, and they are in fair condition. Wood Gymnasium flooring has been well maintained, will accommodate one future sanding and refinishing, and is rated at an advanced stage of its product lifecycle. Gymnasium telescoping stands are wood type construction in fair condition. Gymnasium basketball backboards are manually operated type, and are in fair condition. The Media Center, located on the second floor, has carpet flooring, acoustical tile ceilings, as well as gypsum board wall finishes, and they are in fair condition. Student Dining, has VCT flooring, acoustical tile ceilings, as well as painted block wall finishes, and they are in fair to poor condition. The existing Kitchen is full service, is undersized based on current enrollment, and the existing Kitchen equipment, installed in 1968, is in poor condition. The Kitchen hood is in poor condition, and is not equipped with the required UL 300 compliant wet chemical fire suppression system. The required 6" overhang on all three exposed sides of the cooking equipment is not provided by the hood. Kitchen hood exhaust ductwork is not of proper construction material and/or installed as required by the OSDM and OBMC. Walk-in coolers and freezers are located within the Kitchen spaces, and are in fair condition.

06-22-18 Assessment Update: The 2nd floor classrooms have modular walls and those walls do not extent up to roof deck allowing excessive noise transfer between classrooms and corridors. The gymnasium floor is worn and should be sanded and refinished and striped. The operable walls on the 2nd floor are worn and do not open or close properly and should be replaced. The terrazzo has some cracking throughout the main corridor and should be repaired. The exterior wall design did not provide for a cavity wall construction with adequate insulation and to meet LEED energy requirements additional insulation required. The ceramic floor and wall tile in the locker rooms are damaged and need repairs.

3 Needs Replacement

Lockers and Corridor Finishes

Student Dining

Provide complete replacement of finishes and casework due to installation of systems outlined in Items A, C, D, E, I, K, L, M, N, T, U, and condition. Provide for the replacement of interior doors due to condition, with funding provided in Item O. Provide for the replacement of Kitchen equipment due to age and condition. Provide for the replacement of the Kitchen exhaust hood due to age and condition. Provide for the replacement of toilet partitions due to condition. Provide for the replacement of toilet accessories due to condition. Provide for the replacement of Gymnasium seating due to condition. Provide for the replacement of interior storefront due to lack of safety glass. 06-22-18 Assessment Update: Provide batt insulation above the ceilings at the 2nd floor classrooms to eliminate noise transmission from room o room and corridor to rooms. Sand, refinish and restripe gymnasium wood floor. Replace operable partition walls at 2nd floor classrooms. Provide for terrazzo floor repairs at main corridor. Provide exterior wall insulation to achieve LEED energy requirements. Repair/replace ceramic floor and wall tile in the locker rooms.

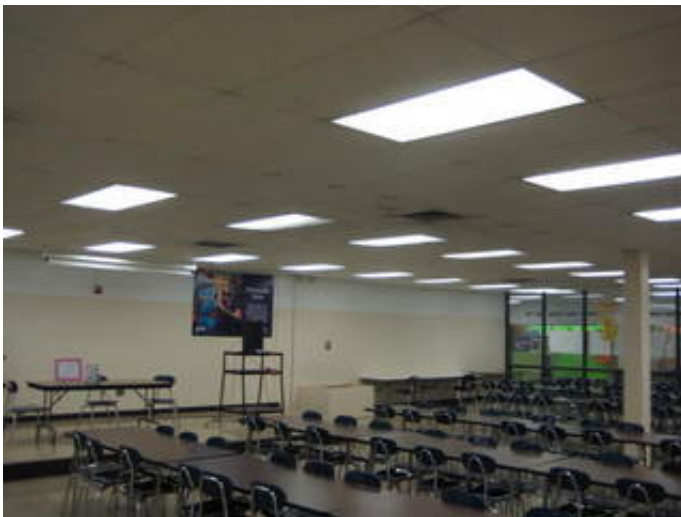
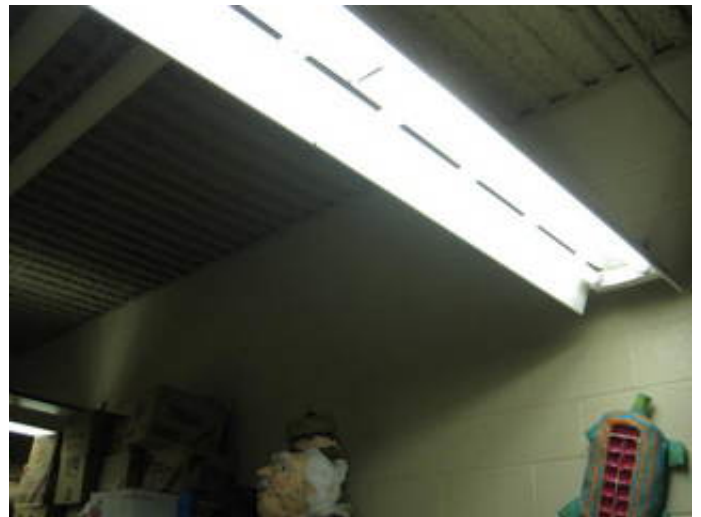
The typical Classrooms in the overall facility are equipped with T-8 1x4 surface mount and T-12 1x4 suspended fluorescent fixtures with single level switching. Classroom fixtures are in fair condition, providing an average illumination of 46 FC, which is less than the 50 FC recommended by the OSDM. The typical Corridors in the overall facility are equipped with T-8 2x4 lay-in direct fluorescent fixtures with single level switching. Corridor fixtures are in fair to poor condition, providing an average illumination of 12 FC, which is less than the 20 FC recommended by the OSDM. The Gymnasium spaces are equipped with pendant metal halide type lighting, in fair condition, providing an average illumination of 37 FC, which is less than the 50 FC recommended by the OSDM. The Media Center is equipped with T-8 2x4 lay-in direct fluorescent fixture type lighting in fair condition, providing an average illumination of 55 FC, thus complying with the 50 FC recommended by the OSDM. The Student Dining spaces are equipped with T-8 2x4 lay-in direct fluorescent fixture type lighting with single level switching. Student Dining fixtures are in good to fair condition, providing an average illumination of 61 FC, thus complying with the 50 FC recommended by the OSDM. The Kitchen spaces are equipped with T-8 1x4 surface mount fluorescent fixture type lighting with single level switching. Kitchen fixtures are in fair condition, providing an average illumination of 69 FC, which is less than the 75-80 FC recommended by the OSDM. The Service Areas in the overall facility are equipped with T-8 1x4 suspended fluorescent fixture type lighting in fair condition, providing inadequate illumination. The typical Administrative spaces in the overall facility are equipped with T-8 1x4 surface mount fluorescent fixture type lighting in fair to poor condition, providing inadequate illumination based on OSDM requirements. The overall lighting systems of the facility are not compliant with Ohio School Design Manual requirements due to age, condition, inadequate lighting levels, lack of multi-level switching, the utilization of incandescent fixtures, and the utilization of T-12 fluorescent fixtures.

3 Needs Replacement

Student Dining Fluorescent Light Fixtures

Classroom T-12 Fluorescent Light Fixture

Provide complete replacement of lighting system due to age, condition, inadequate lighting levels, lack of multilevel switching, the utilization of incandescent fixtures, the utilization of T-12 fixtures, and installation of systems outlined in Items A, C, J, and U.

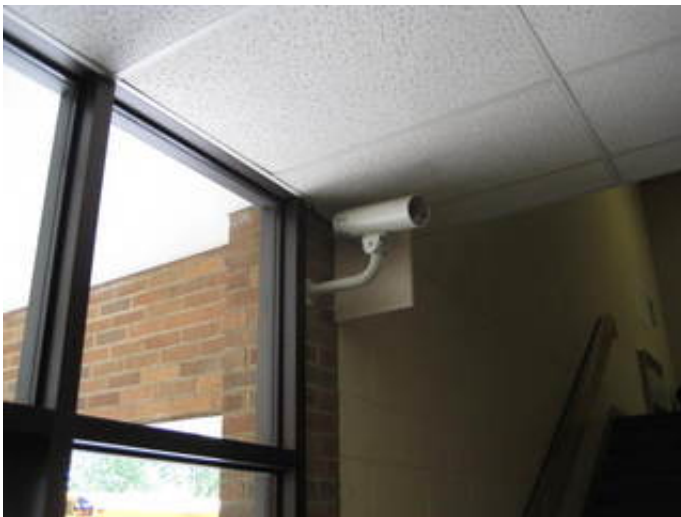
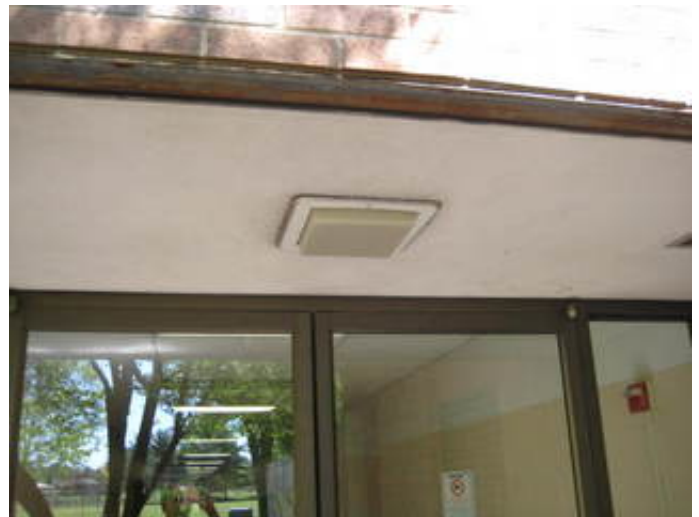
**Description:** The overall facility contains a Radionics CCTV camera, motion sensor, and door contact type security system in fair to poor condition. Motion detectors are inadequately provided in main entries, central gathering areas, offices, main Corridors, and spaces where 6 or more computers are located. Exterior doors are inadequately equipped with door contacts. An automatic visitor control system is not provided. Compliant color CCTV cameras are inadequately provided at main entry areas, parking lots, central gathering areas, and main Corridors. CCTV is monitored in Administrative Area with the use of TV, VCR, and multiplexer. A compliant computer controlled access control system integrating alarms and video signals, with appropriate UPS backup, is not provided. The system is not equipped with card / biometric readers. The security system is inadequately provided throughout, and the system is is not fully compliant with Ohio School Design Manual guidelines. Existing playground fencing is not fully compliant with Ohio School Design Manual guidelines. The exterior site lighting system is equipped with recessed and surface mounted HID high pressure sodium and mercury vapor entry lights in fair to poor condition. Pedestrian walkways and parking and bus pick-up / drop off areas are illuminated by pole mounted HID mercury vapor fixtures in fair to poor condition. The exterior site lighting system provides inadequate coverage.06-22-18 Assessment Update: The main office is adjacent to the main entrance interior but the entry is not a secure vestibule entry. Modifications are required to achieve a secure main entrance into the building.

**Rating:** 3 Needs Replacement

Security System CCTV Camera

Recessed HID High Pressure Sodium Entry Light Fixture

**Recommendations:** Provide complete replacement of security system to meet Ohio School Design Manual guidelines. Provide complete replacement of exterior site lighting system to meet Ohio School Design Manual guidelines. Provide additional playground fencing to meet Ohio School Design Manual guidelines, funding included in complete replacement of security system.06-22-18 Assessment Update: Provide for modifications on existing main entrance to provide for a security vestibule.

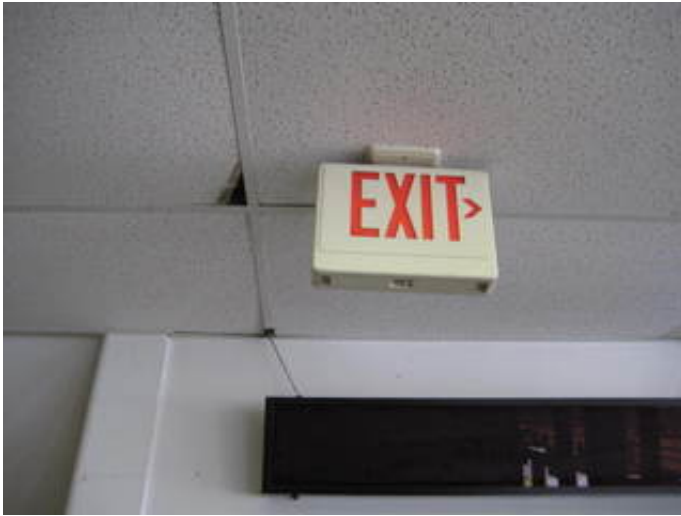
**Description:** The overall facility is equipped with an emergency egress lighting system consisting of non compliant incandescent and plastic construction exit signs, as well as OSDM compliant red lettered, cast aluminum construction, and LED illuminated exit signs and the system is in fair to poor condition. The facility is not adequately equipped with emergency egress floodlighting, and the system is in fair condition. The system is not provided with appropriate battery backup or emergency generator on separate circuits. The system is inadequately provided throughout, and does not meet Ohio School Design Manual and Ohio Building Code requirements.

**Rating:** 3 Needs Replacement

Non-Compliant Plastic Construction Illuminated Exit Sign

**Recommendations:** Provide complete replacement of emergency / egress lighting system to meet Ohio School Design Manual guidelines.

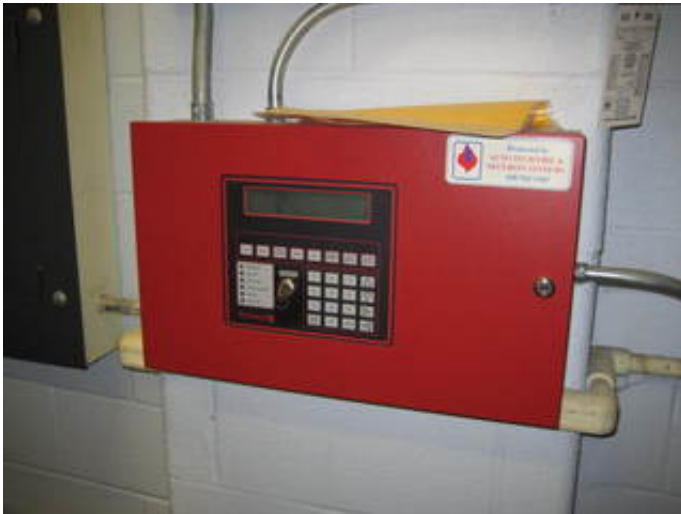
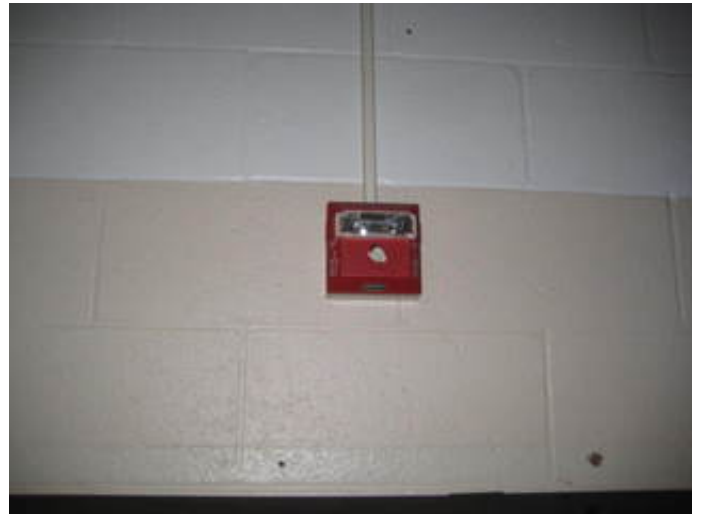
**Description:** The overall facility is equipped with an addressable Gamewell Flex 610 fire alarm system, installed in 1999, and in fair condition, consisting of manual pull stations, smoke detectors, and horn and strobe indicating devices. The system is automatic and is monitored by a third party. The system is not equipped with sufficient audible horns, strobe indicating devices, smoke detectors, and heat sensors. The system is not equipped with any flow switches, tamper switches, or heat sensors. The system thus will not support future fire suppression systems. The system is not adequately provided throughout, and does not have additional zone capabilities. The system is not fully compliant with Ohio Building Code, NFPA, and Ohio School Design Manual requirements.

**Rating:** 3 Needs Replacement

Fire Alarm System Control Panel

Fire Alarm System Horn and Strobe Indicating Device

**Recommendations:** Provide complete replacement of fire alarm system to meet OBC, NFPA, and Ohio School Design Manual guidelines.

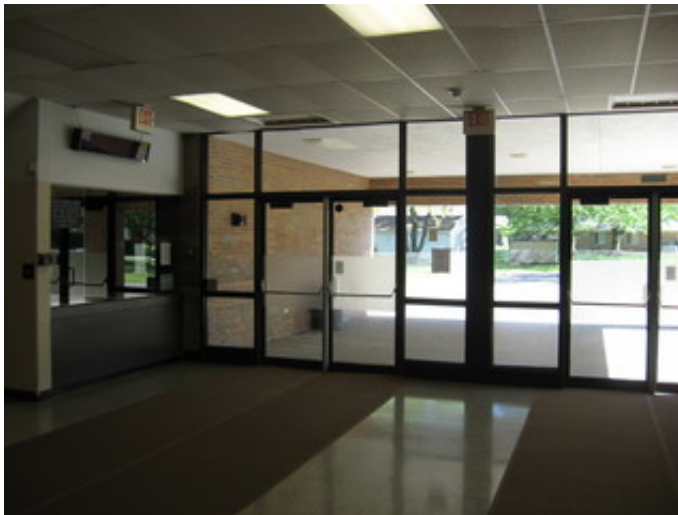
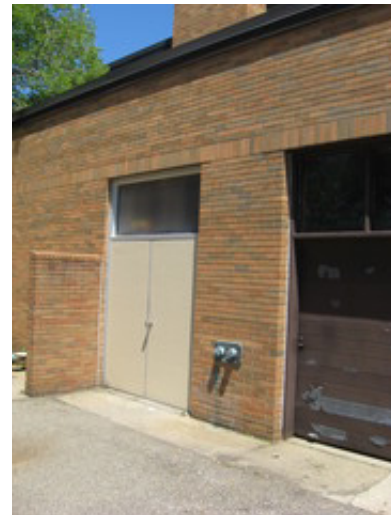
2 Needs Repair

View to Exterior of Main Entry Doors.

Exterior View of Service Area Doors.

Prep and paint all Hollow Metal doors and frames. Replace single glazed aluminum entry doors. Replacement of vision panels, transoms, and sidelights as addressed in Item F. Replace existing overhead door and transom system with new insulated metal overhead door system. Remove existing rolling metal shutter door at Art Room. Replace with window system as part of Section F. 06-22-18 Assessment Update: Revise door replacement quantity from 12 to 22. Revise replace overhead door from 1 to 2. Delete prep and paint exterior doors.

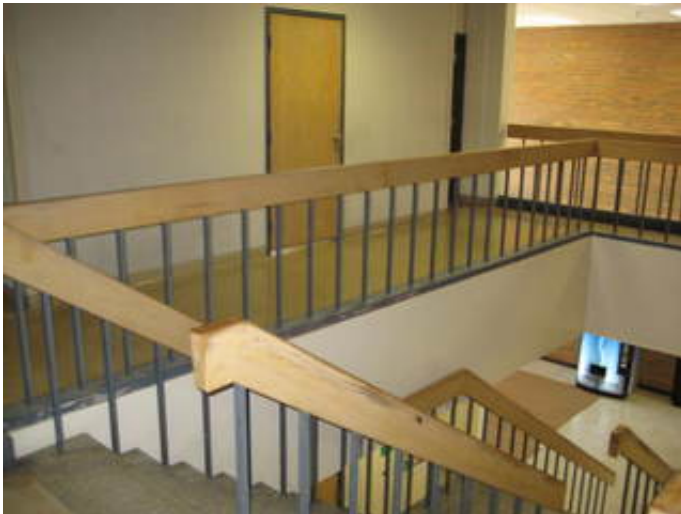
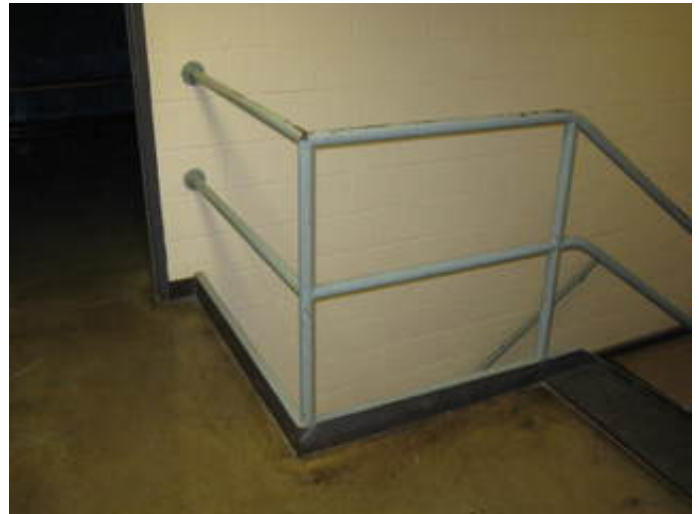
Non-Compliant Guardrail

Provide new automated fire suppression system to meet Ohio School Design Manual guidelines. Provide increased water service of a capacity sufficient to support the fire suppression system, with funding included in fire suppression funding. Provide new emergency generator, with funding provided via complete replacement of electrical system in Item D. Provide new handrails to meet the requirements of the Ohio Building Code. Provide new guardrails to meet the requirements of the Ohio Building Code. Provide fire-rated enclosure around existing stair towers. Provide the new Kitchen hood with a UL 300 compliant wet chemical fire suppression system, with funding provided in Item J. Provide the interlock to de-energize cooking equipment upon discharge of the new Kitchen hood fire suppression system, with funding provided in Item J. 06-22-18 Assessment Update: Add a backflow preventer to support new fire line service for fire suppression system. Provide supplemental budget for handrails.
