Building Information - Cuyahoga Falls City (43836) - Schnee Learning Center

Schnee Elementary School, which is not on the National Register of Historic Buildings, and originally constructed in 1961, is a two story, 40,724 square foot brick school building located in a suburban residential setting. The existing facility features a conventionally partitioned design, and does not utilize modular buildings. The structure of the overall facility contains a reinforced concrete structural frame with a folded plate roof structure and a brick veneer on masonry infill wall type exterior wall construction, with concrete masonry units and glazed block type wall construction in the interior. The floor system of the base floor of the overall facility consists of concrete slab-on-grade type construction. The floor system of the first floor of the elevated west Classroom wing of the overall facility consists of a reinforced cast-in-place two-way concrete slab with concrete topping type construction. The roof structure of the overall facility, except at the Multipurpose space and canopies, is precast reinforced concrete planks with concrete topping type construction. The roof structure of the over

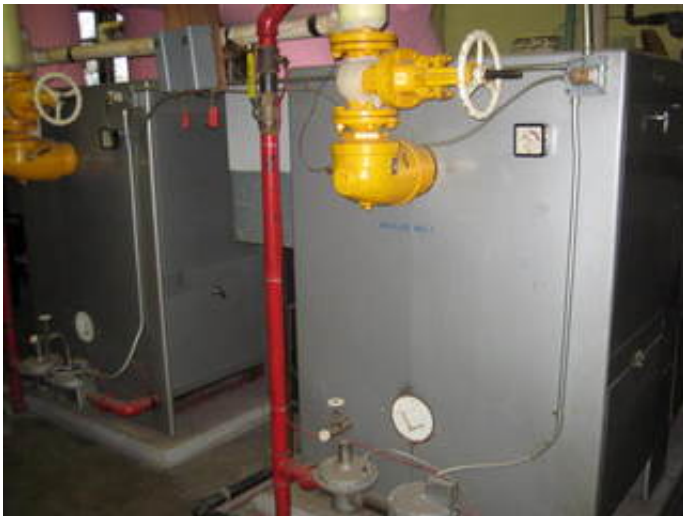
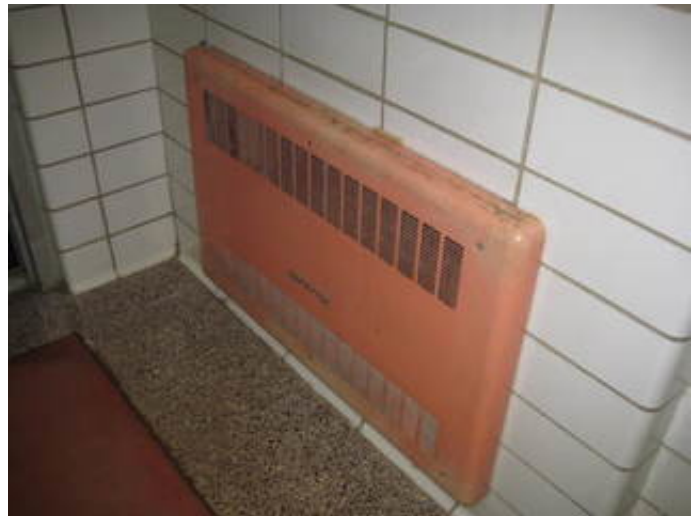
Description: The existing system for the 1961 Original Construction is a natural gas fired heated water boiler type system, installed in 1961, and is in poor condition. The system in the 1961 Board Offices is an extension of that found in the 1961 Original Construction. 2-pipe vs. 4-pipe designations are not applicable in this facility, as no central air conditioning is provided. The two (2) cast iron boilers, manufactured by American Standard, were installed in 1961 and are in fair to poor condition. Heating water is distributed to terminal units consisting of unit ventilators, cabinet heaters, unit heaters, fin tubes, and air handlers. The terminal equipment was installed in 1961 and is in fair to poor condition. The system does not comply with the 15 CFM per person fresh air requirements of the Ohio Building Code mechanical code and Ohio School Design Manual. The pneumatic type system temperature controls were installed in 1961 and are in fair condition. The system does not feature individual temperature controls in all spaces required by the OSDM. The overall system does not feature any central energy recovery systems. The facility is not equipped with louvered interior doors to facilitate Corridor utilization as return air plenums. The existing system is not ducted, and floor to structural deck heights will not accommodate the installation of properly sized ductwork for a future Ohio School Design Manual approved system. The overall heating system is evaluated as not being in safe and efficient working order, and long term life expectancy of the existing system is not anticipated. The structure is not equipped with a central air conditioning system. The site does not contain underground fuel tanks.

Rating: 3 Needs Replacement

Natural Gas Fired Heated Water Boilers

Heating Water Cabinet Heater

Recommendations: Provide new overall heating, ventilating, and air conditioning system to achieve compliance with Ohio Building Code and Ohio School Design Manual standards. Convert the overall facility to a ducted system to facilitate efficient exchange of conditioned air. Provide architectural soffits to accommodate the installation of ductwork, with funding provided in conversion to ducted system replacement.

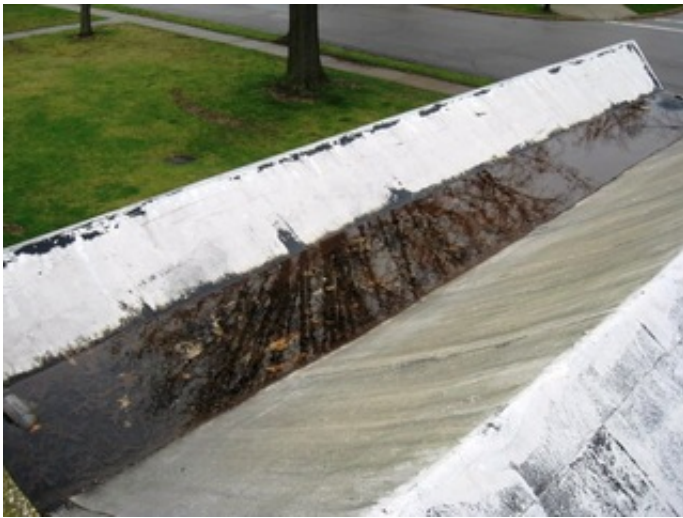
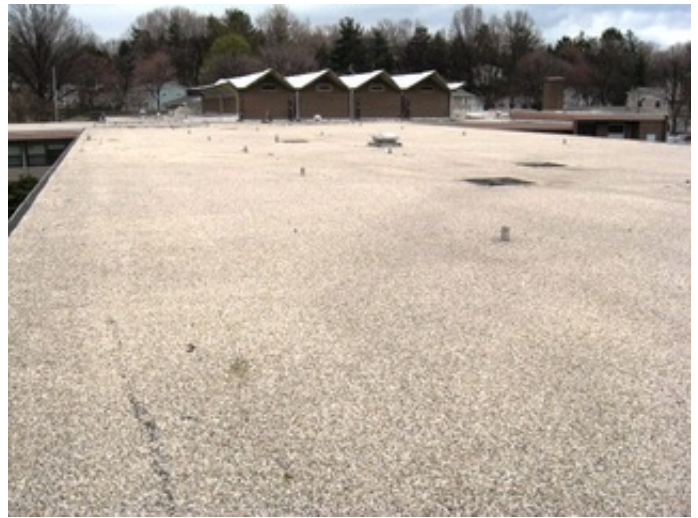
Description: The roof over the overall facility, except for the sloped roof areas, is an asphalt built-up roof with gravel wear coat system that was installed in 1999, and is in fair condition. The roof over the sloped roof areas of the overall facility is a granulated asphalt rolled roofing system that was installed in 1999, and is in fair condition. There are District reports of current leaking in the north Corridor and west Corridor. Signs of past leaking were also observed during the physical assessment. Access to the roof was gained by a roof access hatch that is in poor condition and interior access ladder that is in good condition. Fall safety protection cages are not required, and are not provided. The roof over the Multipurpose space was inaccessible during the physical assessment due to a missing exterior roof access ladder. There were observations of standing water on the roof. Metal cap flashings are in good condition and concrete copings are in poor condition. Roof storm drainage is addressed through a system of roof drains, downspouts and through-wall drains, which are properly located, and in fair condition. The roof is not equipped with overflow roof drains though they are not required on this building. No problems requiring attention were encountered with any roof penetrations. There are no covered walkways attached to this structure, however an elevated west Classroom wing covers a large plaza below. 11-19-18 Assessment Update: It was reported by district personnel, and observed, the original roof area was not removed prior to installing the current roof system. Therefore, additional tear-off costs required. Additional roof insulation required to meet LEED energy efficiency requirements.

Rating: 2 Needs Repair

Roof Canopy Over The Main Entrance

Roof Over The West Classroom Wing

Recommendations: The roof over the overall facility requires replacement to meet Ohio School Design Manual guidelines due to condition. Replace all roof drains, drain pans, and drain guards. Replace existing roof access hatch. Provide new downspouts at missing locations serving the roof over the Multipurpose space. Provide new exterior roof access ladder for access to the roof over the Multipurpose space. 11-19-18 Assessment Update: Provide for additional roof tear-off due to recovery roof system installed over existing roof. Provide for additional roof insulation to meet LEED energy efficiency requirements.

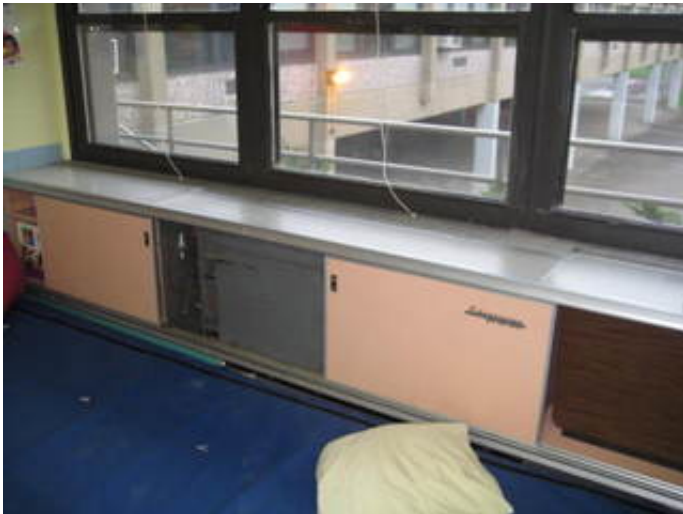
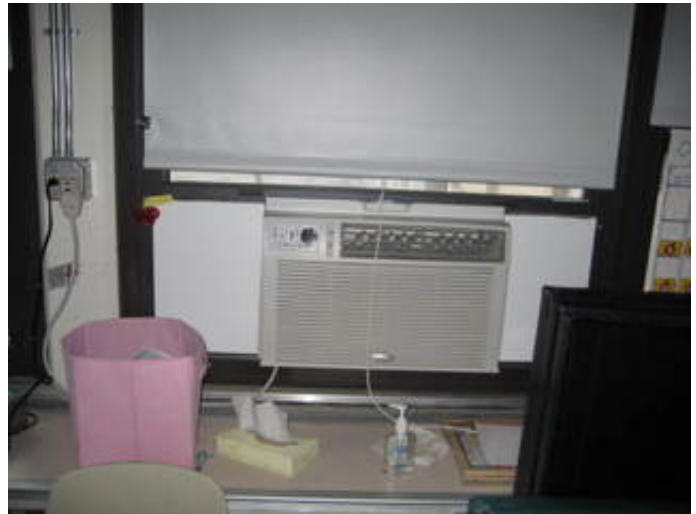
Description: The overall facility is not equipped with a central air conditioning system. Window units are provided in the 1961 Board Offices, Classrooms, Administrative Offices, and Principal's Office locations. The ventilation system in the overall facility consists of unit ventilators, installed in 1961 and in fair condition, providing fresh air to Classrooms, and air handlers, installed in 1961 and in poor condition, providing fresh air to other miscellaneous spaces such as the Multi-Purpose Room (Student Dining / Gymnasium). Relief air venting is provided by unit ventilators, air handlers, and ceiling plenums. The ventilation system does not meet the Ohio Building Code 15 CFM per occupant fresh air requirement. The overall system is not compliant with Ohio Building Code and Ohio School Design Manual requirements. Dust collection systems are not required in this facility. Exhaust systems for Restrooms, Storage Rooms, Custodial Closets, Telecommunications Rooms, Maintenance Workrooms, Kitchen Dry Food Storage, and P.E. Workroom & Storage are inadequately placed, and in fair to poor condition. The Art Program is not equipped with a kiln. 11-19-18 Update: The educational curriculum no longer includes chemistry lab work.

Unit Ventilator

Window AC Unit

Recommendations: Provide an air conditioning system to meet with Ohio Building Code and Ohio School Design Manual requirements. Pricing included in Item A. Replace the existing general building exhaust system. Provide the existing Art Program the required kiln ventilation system, with kiln pricing to be included in Item J. 11-19-18 Update: Delete Safety Shower, Utility Sink, Natural Gas Connections, Compressed Air Connections and Acid Waste System & Neutralization Tank.

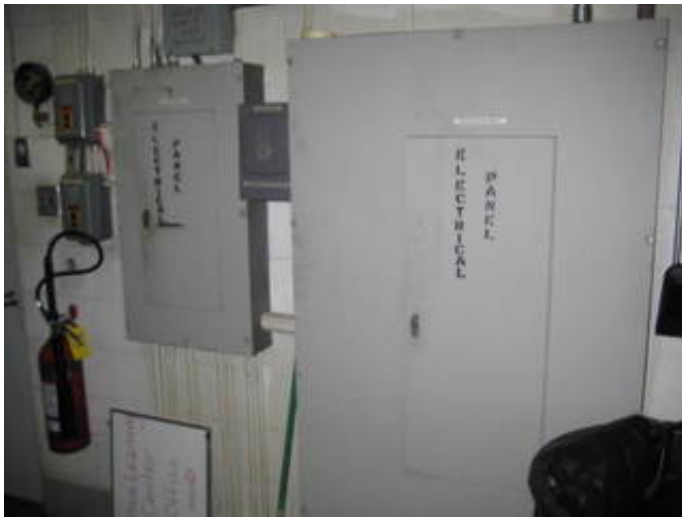
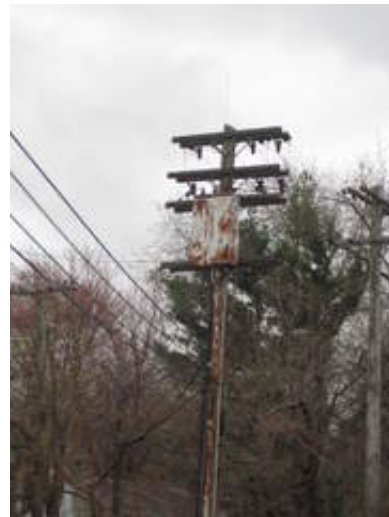
Description: The electrical system provided to the 1961 Original Construction is a 120/208 volts, 600 amp, 3 phase and 4 wire system installed in 1961, and is in fair to poor condition. The system in the 1961 Board Offices is an extension of that found in the 1961 Original Construction. Power is provided to the school by a single City of Cuyahoga Falls owned, pole-mounted transformer located in the main parking lot, and in poor condition. The panel system, installed in 1961, is in poor condition, and cannot be expanded to add additional capacity. The Classrooms are not equipped with adequate electrical outlets. The typical Classroom contains four (4) general purpose outlets, one (1) dedicated outlet for each Classroom computer, and zero (0) dedicated outlets for each Classroom television. Some Classrooms are equipped with as many as five (5) general purpose outlets, while others are equipped with as few as two (2) general purpose outlets. There are not any spaces that have no electrical outlets. The Corridors are not equipped with adequate electrical outlets for servicing. Adequate GFI protected exterior outlets are not provided around the perimeter of the building. The facility is not equipped with an emergency generator. Adequate lightning protection safeguards are not provided. Stage lighting power system including control panel, breakers, and dimmers is inadequately provided, in fair to poor condition and does not meet OSDM requirements. The overall electrical system does not meet Ohio School Design Manual requirements in supporting the current needs of the school, and will be inadequate to meet the facility's future needs.

Rating: 3 Needs Replacement

Main Electrical Distribution Panel

Pole Mounted Transformer

Recommendations: The entire electrical system requires replacement to meet Ohio School Design Manual guidelines for overall capacity and Classroom capacity due to age, condition, lack of OSDM-required features, and to accommodate the addition of an air conditioning system. Provide new transformer due to age and condition, with funding to be coordinated with the utility company. Provide an emergency generator, with funding included in the electrical system replacement. Provide adequate lightning protection safeguards in the overall facility, including associated grounding system, with funding included in the electrical system replacement. Provide control panel, dimmers, and breakers to support the Stage lighting system, with funding included in the electrical system replacement.

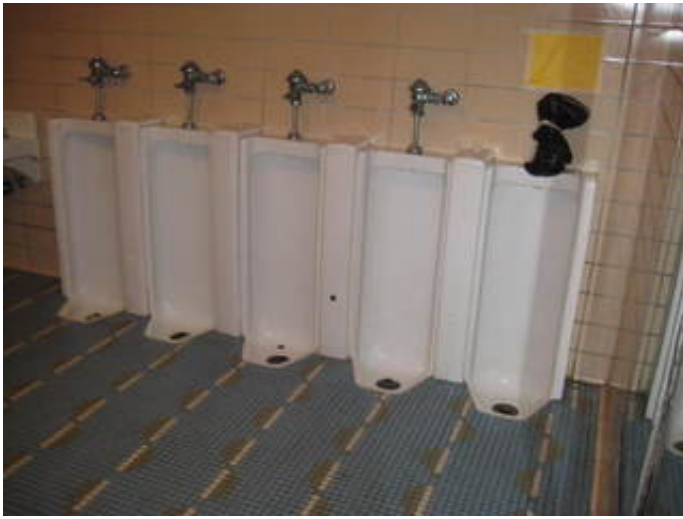
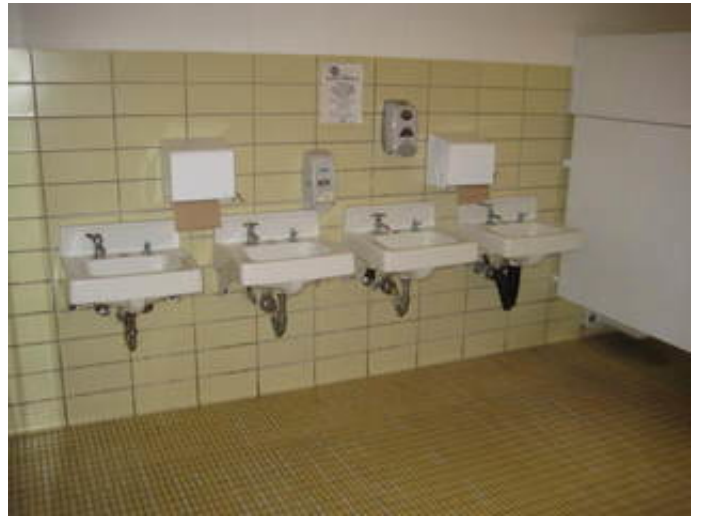
Description: The service entrance is not equipped with a reduced pressure backflow preventer. A water treatment system is not provided, though none is needed. The domestic water supply piping in the overall facility is galvanized and copper, was installed in 1961, and is in fair condition. The waste piping in the overall facility is cast iron and galvanized, was installed in 1961, and is in fair condition. The facility is equipped with one (1) Rudd Multi-coil natural gas domestic water boiler, installed in 1961, in fair to poor condition, with one (1) separate A.O. Smith 350 gallon storage tank, installed in 1988, and in good to fair condition. The overall facility contains 3 Large Group Restrooms for boys, 3 Large Group Restrooms for girls, 0 Locker Room Restrooms for boys, 0 Locker Room Restrooms for girls, 0 Locker Room Restrooms for staff, 1 Kitchen Restroom, 0 Health Clinic Restrooms, 0 Restrooms associated with Kindergarten / Pre-K Classrooms / Specialty Classrooms, and 2 Restrooms for staff. Boys' Large Group Restrooms contain 5 non-ADA wall mounted flush valve toilets, 10 non-ADA floor mounted flush valve urinals, as well as 9 non-ADA wall mounted lavatories. Girls' Large Group Restrooms contain 11 non-ADA wall mounted flush valve toilets, as well as 9 non-ADA wall mounted lavatories. Staff Restrooms contain 3 non-ADA wall mounted flush valve toilets, 1 non-ADA floor mounted flush valve urinal, as well as 3 non-ADA wall mounted lavatories. Condition of fixtures is fair to poor. The facility is equipped with 4 ADA electric water coolers, in fair condition. Elementary Classrooms are equipped with required lavatory mounted type drinking fountains, which are not ADA compliant, and are in fair condition. Special Education Classroom is not equipped with the required Restroom facilities. Kitchen is equipped with the required Restroom which contains 1 non-ADA floor mounted flush valve toilet, as well as 1 non-ADA wall mounted lavatory, and fixtures are in fair to poor condition. Health Clinic is not equipped with the required Restroom facilities. Kindergarten / Pre-K Classrooms are not equipped with the required Restroom facilities. Kitchen fixtures consist of one (1) double-compartment sink, one (1) disposal unit, and one (1) dishwashing unit with built-in Hatco water booster heater, which are in fair to poor condition. The Kitchen is equipped with an unsatisfactory grease interceptor due to age, condition, and insufficient capacity. The Kitchen is not provided the required 140 degree hot water supply. The school meets the OBC requirements for fixtures. Per OBC and OSDM requirements this facility should be equipped with 12 toilets, 6 urinals, 12 lavatories, and 4 electric water coolers, and at present it is equipped with 20 toilets, 11 urinals, 22 lavatories, and 4 electric water coolers. ADA requirements are not met for fixtures and drinking fountains (see Item O). Custodial Closets are properly located and are adequately provided with required service sink or floor drain sink, which is in fair to poor condition. Science Classroom / Lab utility sinks, gas connections, compressed air connections, and safety shower / eyewash are not provided, but are required due to existing grade configuration. Biology or Chemistry Classroom acid waste systems are not provided, but are required due to existing grade configuration. Adequate exterior wall hydrants are not provided.

Rating: 3 Needs Replacement

Floor Mounted Flush Valve Urinals

Non-ADA Wall Mounted Lavatories

Recommendations: Replace galvanized water supply piping in the overall facility with copper piping due to age and condition. Replace sanitary waste piping in the overall facility due to age and condition. Due to age, condition, and OSFC standards, replace 5 lavatory mounted type drinking fountains, 22 lavatories, 20 toilets, 11 urinals, and 2 electric water coolers. See Item O for replacement of fixtures related to ADA requirements. See Item J for provisions on Kitchen related equipment. Provide the service entrance with a reduced pressure back flow preventer. Replace the Rudd multi-coil domestic water boiler due to age and condition. Replace the Kitchen grease trap interceptor due to age, condition, and insufficient capacity. Provide the Kitchen with a water booster. Provide 2 additional exterior wall hydrants. Replace the existing Custodial Closet service sinks due to age and condition. Provide the Science Classrooms with the required gas connection. Provide the Science Classrooms with the required compressed air connection. Provide the Science Classrooms with the required safety shower / eyewash station. Provide the Science Classrooms with the required utility sink. Provide the Biology / Chemistry Classroom with the required acid waste systems.

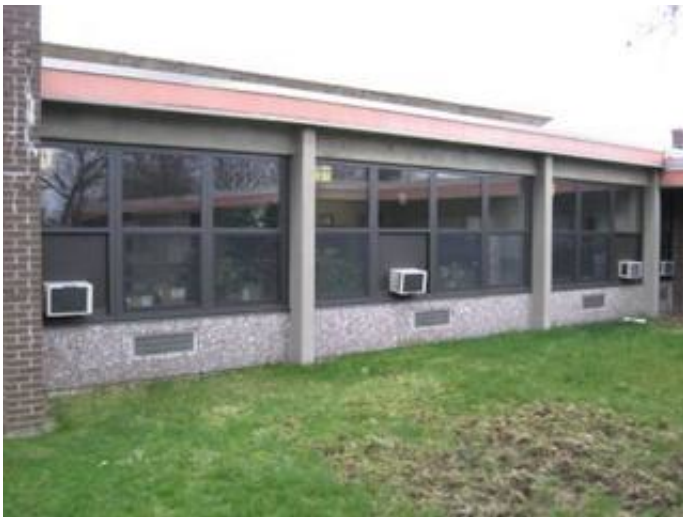
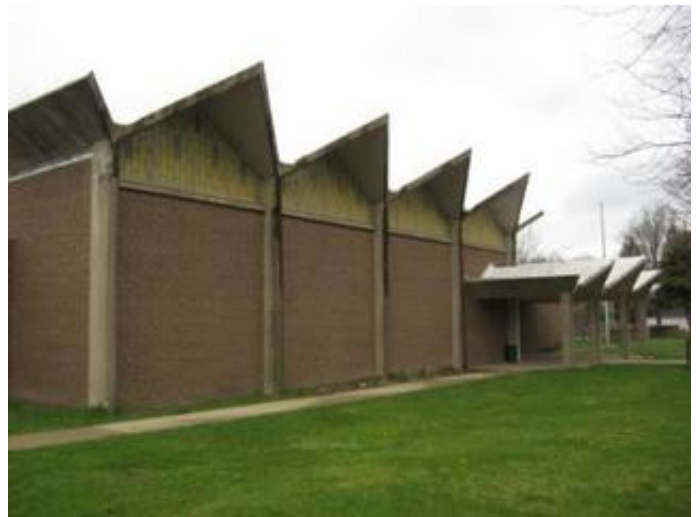
Description: The overall facility is equipped with thermally broken aluminum frame windows with double glazed insulated glazing type window system, which was installed in 2003, and is in good condition. There are insulated translucent fiberglass clerestory panels in the Gymnasium, which were installed in 1961, and are in fair condition. Window system seals are in good condition, with no air and water infiltration being experienced. Window system hardware is in good condition. The window system features surface mounted shades, which are in good condition. The window system is equipped with insect screens on operable windows, which are in good condition. This facility is not equipped with any curtain wall systems. This facility does not feature any glass block windows. The main entry doors in the 1961 Original Construction are equipped with non thermal aluminum frame sidelights and transoms with single glazed glazing, in fair condition. The school does contain two acrylic bubble type skylights on aluminum frames, in good condition. Window security grilles are not provided for ground floor windows. There is not a Greenhouse associated with this school.

Rating: 3 Needs Replacement

Typical Classroom Windows

Clerestory Windows in Multi-Purpose Room

Recommendations: Replace single pane glazed transoms and sidelights at the main entry doors of the 1961 Original Construction with approved insulating safety glass. Replace single pane glazed vision panels as required in exterior doors of the overall facility. Replace translucent fiberglass clerestory panels.

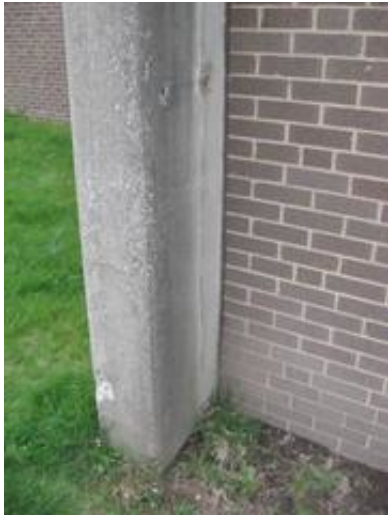
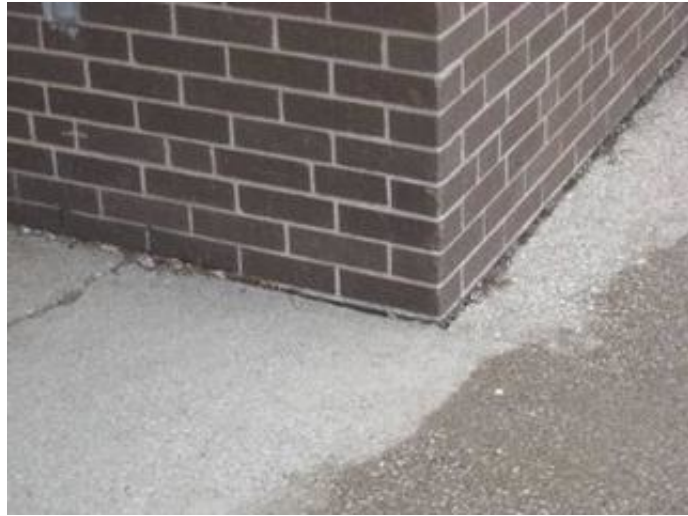
Description: The overall facility is equipped with concrete foundation walls on concrete footings, which displayed locations of differential settlement and cracking at two exterior wall locations and are in good to fair condition. The District reports that there has been no past leaking due to foundation issues. No grading or site drainage deficiencies were noted around the perimeter of the structure that are contributing or could contribute to foundation / wall structural deterioration. 11-19-18 Update: The budget allocate to address foundation settlement issues is not adequate.

Rating: 2 Needs Repair

Condition of Exterior Wall and Concrete Column at Grade

Condition of Exterior Wall Adjacent to Pavement

Recommendations: Address foundation settlement issues at two exterior wall locations. 11-19-18 Update: Increase budget allocate to address foundation settlement issues.

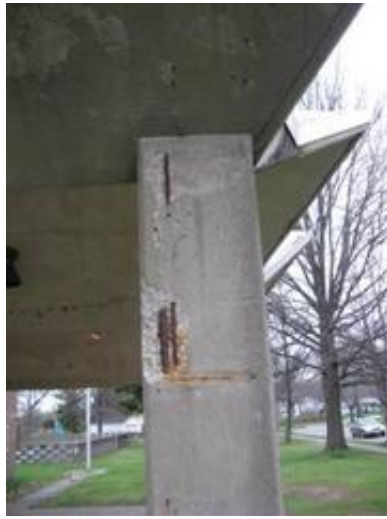
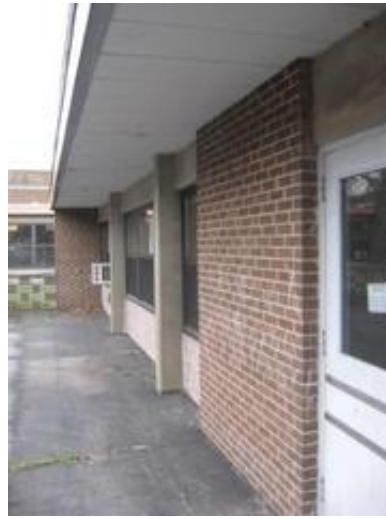
Description: The overall facility has a reinforced concrete structural frame with a folded plate roof structure and a brick veneer on masonry infill wall system, which displayed locations of deterioration, and is in fair to poor condition. The exterior masonry appears to have appropriately spaced and inadequately caulked control joints in fair to poor condition. Control joints are not provided at lintel locations at doors and windows. The school does have sufficient expansion joints, and they are in fair condition. The exterior masonry has not been cleaned and sealed in recent years; shows evidence of mortar deterioration and has locations of efflorescence, staining and graffiti. Architectural exterior accent material consists of precast concrete panels and exposed cast in place concrete, which is in fair to poor condition. Interior walls are concrete masonry units and glazed block, and are in good to fair condition. Interior masonry appears to have adequately spaced and caulked control joints in good condition. Exterior soffits are painted concrete type construction, and in fair condition. Exterior fascias are corrugated metal type, and in fair to poor condition. The window sills are an element of the aluminum window system, and are in good condition. The exterior lintels are exposed reinforced concrete, and are in fair condition. The chimney is in fair condition, and requires masonry repair work. The canopy at the main building entrance is a concrete folded plate type construction, and is fair to poor condition. A loading dock has not been provided to facilitate unloading of trucks and receipt of product / supplies / foodstuffs. 11-19-18 Update: The budget allocate to address spalling concrete at entry canopy if inadequate.

Rating: 2 Needs Repair

Concrete Column Support for Entry Canopy

Typical Exterior Wall and Soffit

Recommendations: Provide tuckpointing in all areas of mortar deterioration as required through the overall facility. Provide masonry cleaning, sealing and caulking as required through the overall facility. Provide masonry repairs as required through the overall facility. Recaulk existing control joints. Recaulk existing expansion joints through the overall facility. Repair and paint concrete soffits through the overall facility. Repair concrete canopy at the main entry to the 1961 Original Construction. Repair masonry wall at outdoor play area as required. Replace ceiling over lower covered outdoor play area. Repair exposed concrete structure as required through the overall facility. Repair chimney masonry as required. Repair metal fascia as required. 11-19-18 Update: Increase the budget allocate to address spalling concrete at entry canopy.

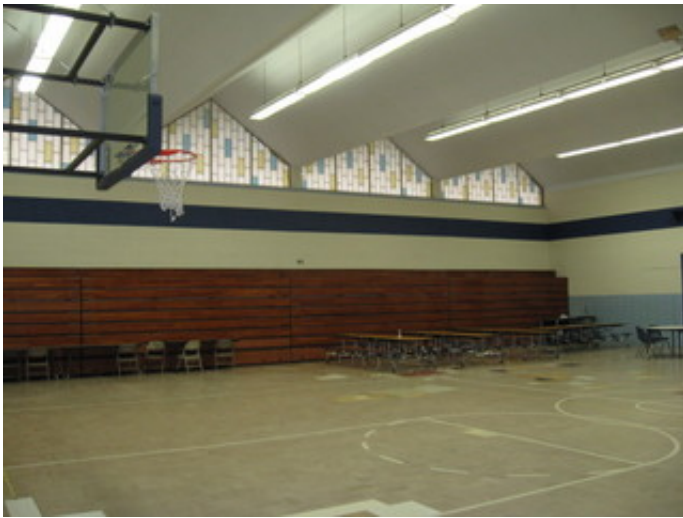
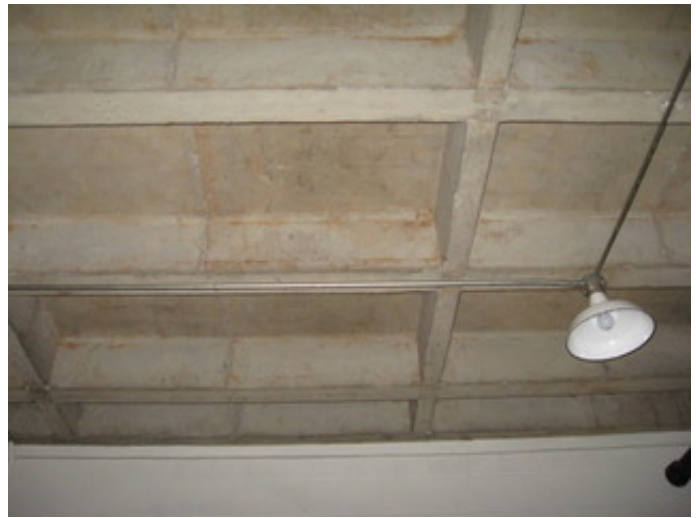
Description: The floor construction of the base floor of the overall facility is concrete slab-on-grade type construction, and is in good condition. The floor construction of the first floor of the elevated west Classroom wing of the overall facility is reinforced cast-in-place two-way concrete slab with concrete topping type construction, and is in good condition. There is no crawl space. There are no intermediate floors in this single story structure. Ceiling to structural deck spaces are insufficient to accommodate HVAC, electrical, and plumbing scopes of work in required renovations. Architectural soffits will be required since the current ceiling and structure elevations will not accommodate new work. The roof construction of the overall facility, except at the Multi-Purpose Room and canopies, is precast reinforced concrete planks with concrete topping type construction, and is in good condition. The roof construction of the overall facility at the Multi-Purpose Room and canopies are reinforced cast-in-place concrete folded plate type construction, and is in fair condition due to spalling on the areas exposed to weather.

Folded Plate Concrete Roof Structure Over the Multi-Purpose Space

Reinforced Cast-In-Place Two-Way Concrete Slab Floor Of Elevated Classroom Wing

Recommendations: Existing conditions of the reinforced cast-in-place concrete folded plate type construction require patching and restoration to protect the reinforcing from further deterioration with funding provided in Item H. Refer to Item A for funding of architectural soffits to accommodate HVAC, electrical, and plumbing scopes of work.

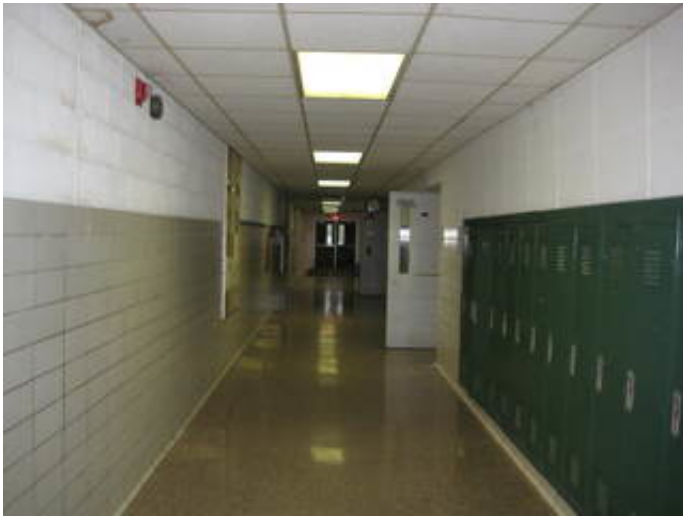
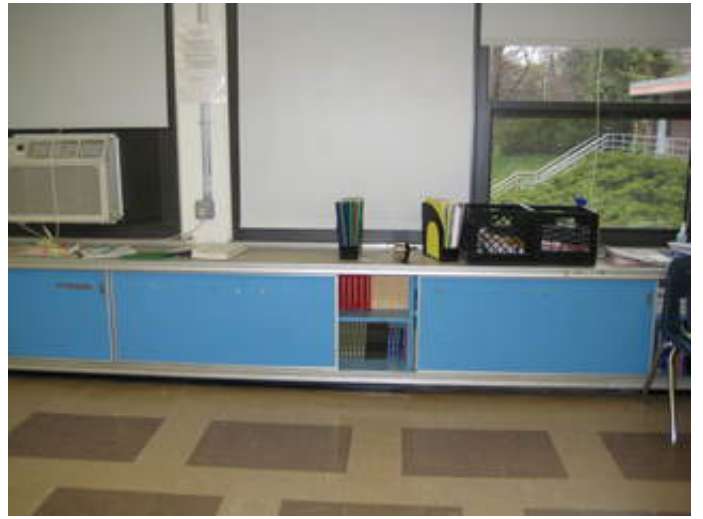
Description: The overall facility features conventionally partitioned Classrooms with VAT and carpet flooring, acoustical tile ceilings, as well as glazed and painted block wall finishes, and they are in fair to poor condition. The overall facility has Corridors with terrazzo flooring, acoustical tile ceilings, as well as glazed and painted block wall finishes, and they are in fair to poor condition. The overall facility has Restrooms with ceramic tile flooring, plaster ceilings, as well as glazed block wall finishes, and they are in poor condition. Toilet partitions are metal and wood, and are in poor condition. Classroom casework in the overall facility is wood or metal type construction with plastic laminate tops, is inadequately provided, and in poor condition. The typical Classroom contains 24 lineal feet of casework, and Classroom casework provided ranges from 12 to 30 feet. Classrooms are provided adequate chalkboards, markerboards, tackboards, which are in fair condition. The lockers, located in the Corridors, are inadequately provided, and in poor condition. The Art program is not equipped with a kiln. The facility is equipped with metal non-louvered interior doors that are flush mounted and partially recessed without proper ADA hardware and clearances, and in fair to poor condition. The Gymnasium spaces have VAT flooring, acoustical tile ceilings, as well as glazed and painted wall finishes, and they are in fair to poor condition. Gymnasium telescoping stands are wood type construction in fair condition. Gymnasium basketball backboards are fixed type, and are in good condition. The Resource Room, located in the 1961 Original Construction, has carpet flooring, acoustical tile ceilings, as well as glazed and painted block wall finishes, and they are in fair condition. Student Dining shares the Gymnasium space. OSDM-required fixed equipment for Stage is inadequately provided, and in poor condition. The existing Kitchen is full service, is oversized based on current enrollment, and the existing Kitchen equipment, installed in 1961, is in poor condition. The Kitchen hood is in poor condition, and is equipped with the required UL 300 compliant wet chemical fire suppression system. The required 6" overhang on all three exposed sides of the cooking equipment is not provided by the hood. Kitchen hood exhaust ductwork is not of proper construction material and/or installed as required by the OSDM and OBMC. Reach-in coolers and freezers are located within the Kitchen spaces, and are in fair to poor condition. 11-19-18 Update: Floor and Wall patch required following removal of floor mounted urinals. Additional wall insulation required to meet LEED Silver energy requirements. Bleacher capacity does not meet building capacity.

Rating: 3 Needs Replacement

Typical Corridor Finishes

Typical Classroom Casework

Recommendations: Provide complete replacement of finishes and casework due to installation of systems outlined in Items A, C, D, E, I, K, L, M, N, T, U, and condition. Provide for the replacement of interior doors due to condition. Other doors are funded in Item O due to opening expansion. Provide for the replacement of Kitchen equipment due to age and condition. Provide for the replacement of the Kitchen exhaust hood due to age and condition. Provide for replacement of reach-in cooler/freezer. Provide for the replacement of toilet partitions due to condition. Provide for the replacement of toilet accessories due to condition. Provide for the replacement of Gymnasium seating due to condition. Provide a kiln for the Art Program, with funding for ventilation provided in Item C. Provide for terrazzo repair as required in the 1956 Original Construction. 11-19-18 Update: Provided floor and wall patch following removal of floor mounted urinals. Provide additional wall insulation to meet LEED Silver energy requirements. Increase bleacher capacity to meet building capacity.

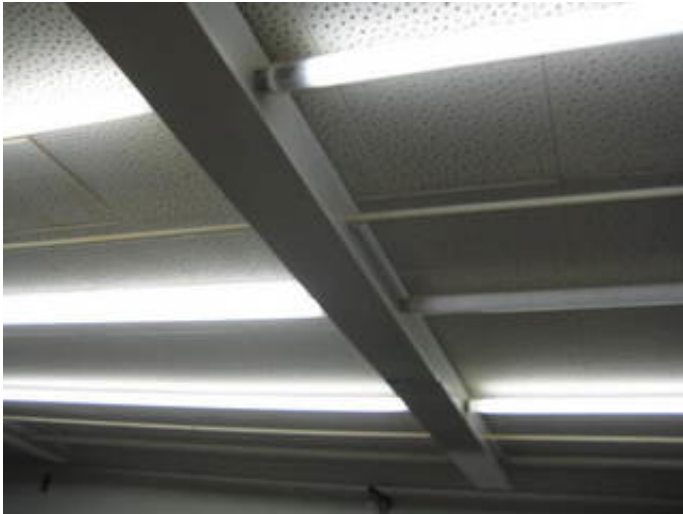
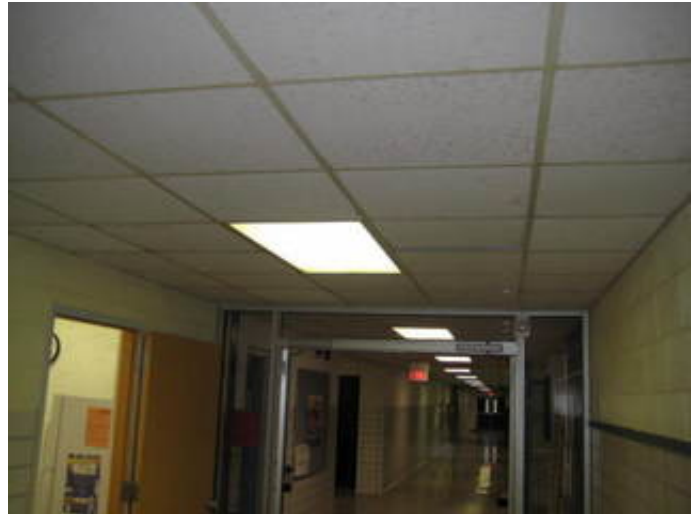
Description: The typical Classrooms in the overall facility are equipped with T-12 1x4 surface mount fluorescent fixtures with single level switching. Classroom fixtures are in fair condition, providing an average illumination of 33 FC, which is less than the 50 FC recommended by the OSDM. The typical Corridors in the overall facility are equipped with T-12 2x2 and 2x4 lay-in direct fluorescent fixtures with single level switching. Corridor fixtures are in fair to poor condition, providing an average illumination of 11 FC, which is less than the 20 FC recommended by the OSDM. The Multi-Purpose Room (Student Dining / Gymnasium) spaces are equipped with T-12 surface mount fluorescent fixture type lighting, in fair condition, providing an average illumination of 45 FC, which is less than the 60 FC recommended by the OSDM. The overall facility is not equipped with a Media Center. The Student Dining and Gymnasium spaces are combined and incorporated into the Multi-Purpose Room. The Kitchen spaces are equipped with T-12 1x4 surface mount fluorescent fixture type lighting with single level switching. Kitchen fixtures are in fair to poor condition, providing an average illumination of 50 FC, which is less than the 75-80 FC recommended by the OSDM. The Service Areas in the overall facility are equipped with pendant incandescent and T-121x4 suspended fluorescent fixture type lighting in fair to poor condition, providing inadequate illumination. The typical Administrative spaces in the overall facility are equipped with T-12 surface mounted and T-8 2x4 lay-in direct fluorescent fixture type lighting in good to fair condition, providing adequate illumination based on OSDM requirements. The overall lighting systems of the facility are not compliant with Ohio School Design Manual requirements due to age, condition, inadequate lighting levels, lack of multi-level switching, the utilization of incandescent fixtures, and the utilization of T-12 fluorescent fixtures.

Rating: 3 Needs Replacement

Typical Classroom Fluorescent Light Fixtures

Typical Corridor Fluorescent Light Fixtures

Recommendations: Provide complete replacement of lighting system due to age, condition, inadequate lighting levels, lack of multilevel switching, the utilization of incandescent fixtures, the utilization of T-12 fixtures, and installation of systems outlined in Items A, C, J, and U.

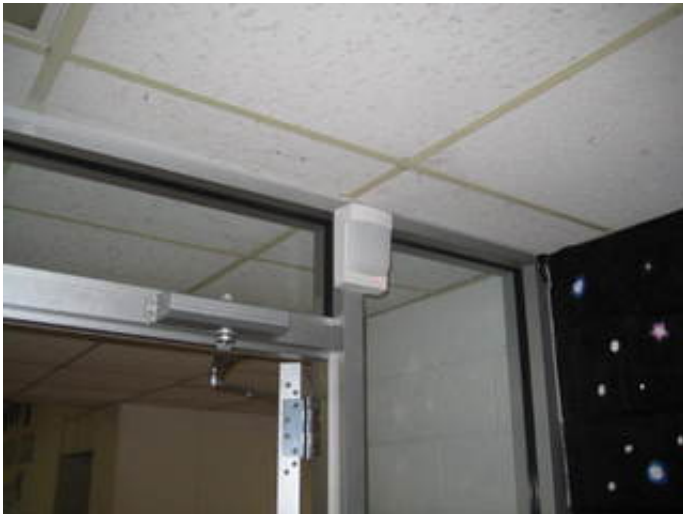
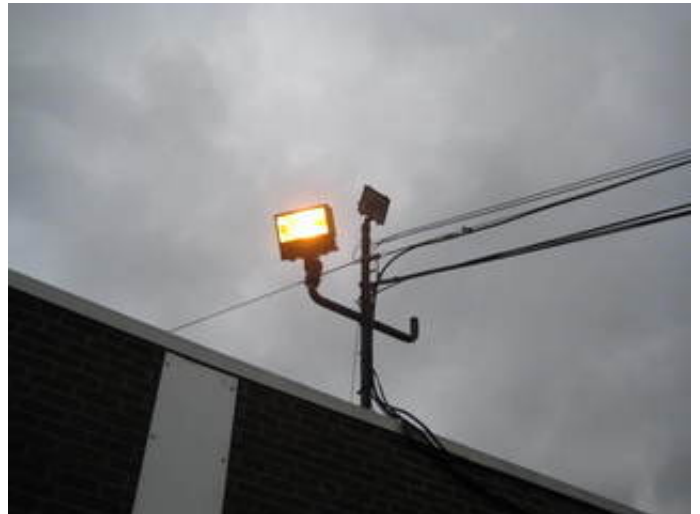
Description: The overall facility contains a motion sensor and door contact type security system in fair condition. Motion detectors are inadequately provided in main entries, central gathering areas, offices, main Corridors, and spaces where 6 or more computers are located. Exterior doors are equipped with door contacts. An automatic visitor control system is not provided. Compliant color CCTV cameras are not provided at main entry areas, parking lots, central gathering areas, and main Corridors. A compliant computer controlled access control system integrating alarms and video signals, with appropriate UPS backup, is not provided. The system is not equipped with card / biometric readers. The security system is inadequately provided throughout, and the system is not fully compliant with Ohio School Design Manual guidelines. Existing playground fencing is not fully compliant with Ohio School Design Manual guidelines. The exterior site lighting system is equipped with surface mounted HID high pressure sodium and mercury vapor entry lights in fair condition. Pedestrian walkways are not illuminated. Parking and bus pick-up / drop off areas are illuminated by surface mounted HID high pressure sodium fixtures in fair condition. The exterior site lighting system provides inadequate coverage. 11-19-18 Update: There is not security vestibule at main entry.

Rating: 3 Needs Replacement

Security System Motion Detection Device

Surface Mounted HID High Pressure Sodium Light Fixture

Recommendations: Provide complete replacement of security system to meet Ohio School Design Manual guidelines. Provide complete replacement of exterior site lighting system to meet Ohio School Design Manual guidelines. Provide additional playground fencing to meet Ohio School Design Manual guidelines, funding included in complete replacement of security system. 11-19-18 Update: Provide for security vestibule at main entry.

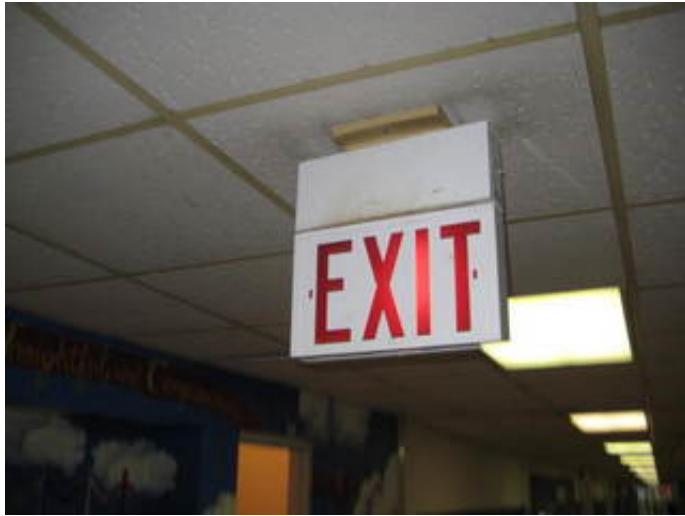
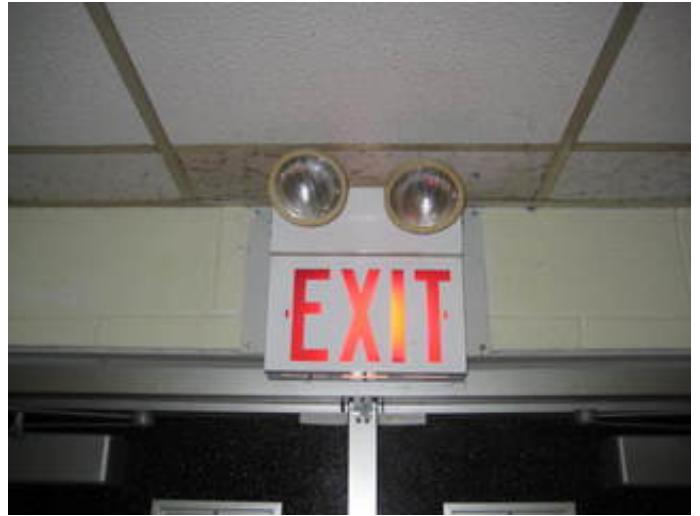
Description: The overall facility is equipped with an emergency egress lighting system consisting of non compliant incandescent and plastic construction exit signs, as well as OSDM compliant red lettered and LED illuminated exit signs and the system is in fair condition. The facility is not adequately equipped with emergency egress floodlighting, and the system is in fair condition. The system is not provided with appropriate battery backup and emergency generator on separate circuits. The system is inadequately provided throughout, and does not meet Ohio School Design Manual and Ohio Building Code requirements.

Rating: 3 Needs Replacement

Illuminated Exit Sign

Illuminated Exit Sign and Emergency Egress Light Fixture

Recommendations: Provide complete replacement of emergency / egress lighting system to meet Ohio School Design Manual guidelines.

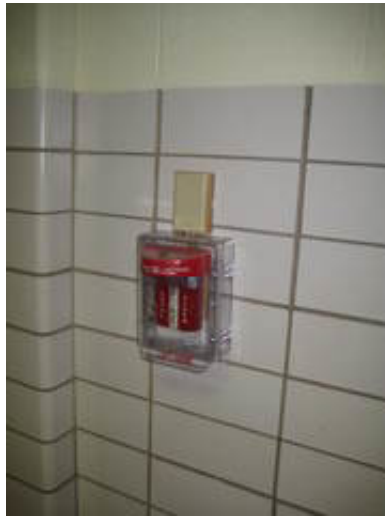
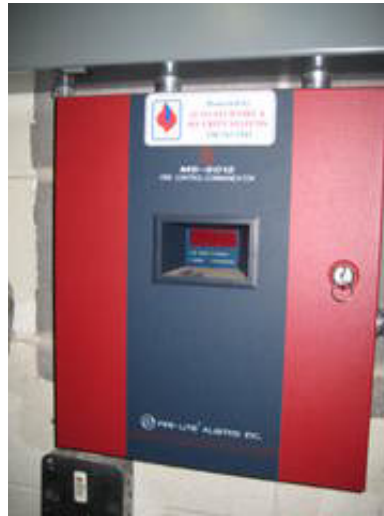
Description: The overall facility is equipped with an Ademco Fire-lite MS5012 addressable fire alarm system, installed in 1999, and in fair condition, consisting of manual pull stations and horn and strobe indicating devices. The system is not automatic but is monitored by a third party. The system is not equipped with sufficient audible horns and strobe indicating devices. The system is not equipped with any flow switches, tamper switches, smoke detectors, or heat sensors. The system thus will not support future fire suppression systems. The system is not adequately provided throughout, and does not have additional zone capabilities. The system is not fully compliant with Ohio Building Code, NFPA, and Ohio School Design Manual requirements.

Rating: 3 Needs Replacement

Fire Alarm Manual Pull Station

Fire Alarm System Control Panel

Recommendations: Provide complete replacement of fire alarm system to meet OBC, NFPA, and Ohio School Design Manual guidelines.

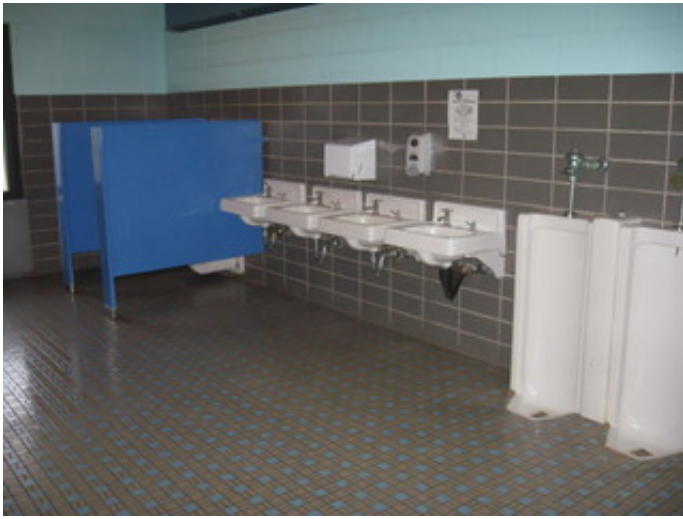
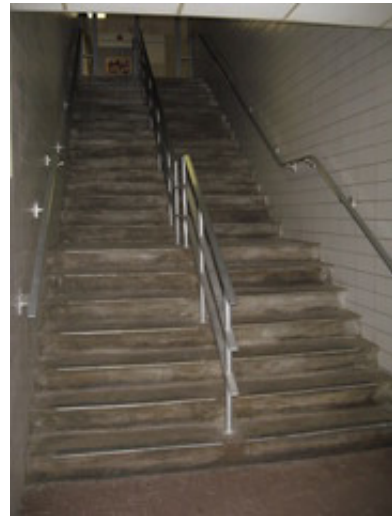
Rating: 2 Needs Repair

Typical Large Boy's Restroom

Non-Compliant Stair to Lower Level Classrooms

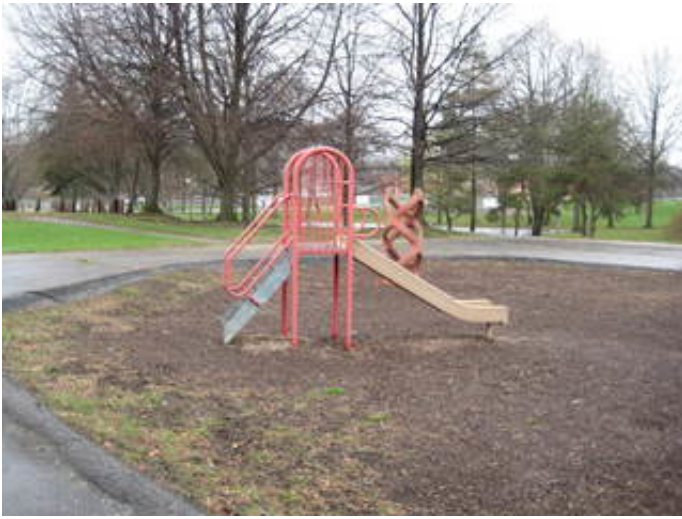
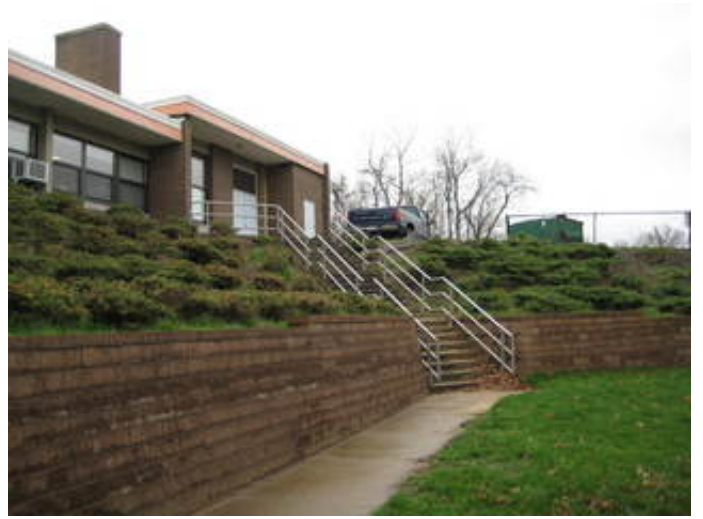
2 Needs Repair

Typical Playground Equipment

Retaining Wall

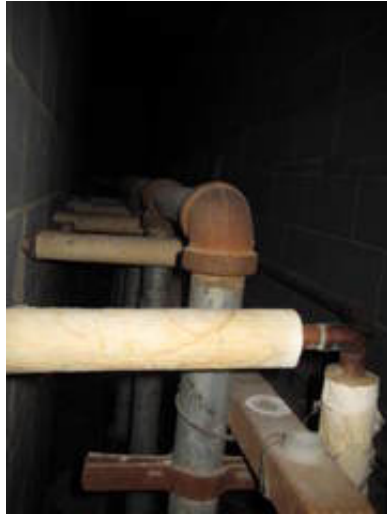
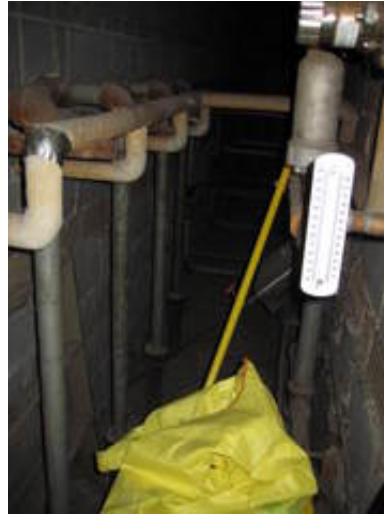
Rating: 3 Needs Replacement

Sanitary Waste Piping

Recommendations: Existing conditions require no renovation or replacement at the present time. 11-19-18 Assessment Update: Replace sanitary sewer main from building to street due to age and deterioration.

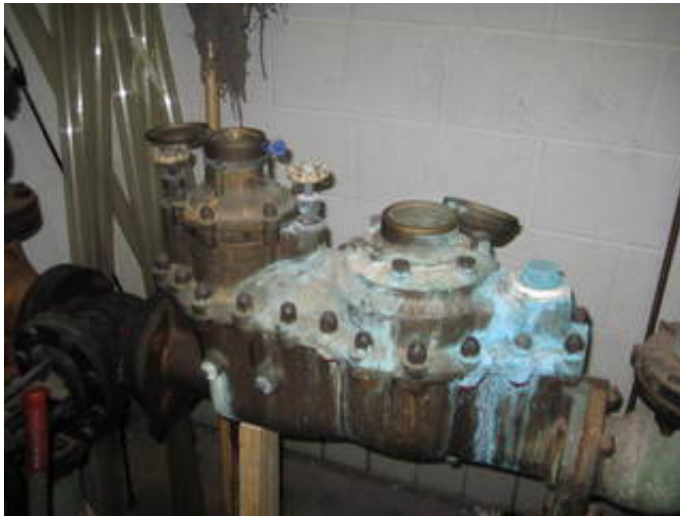
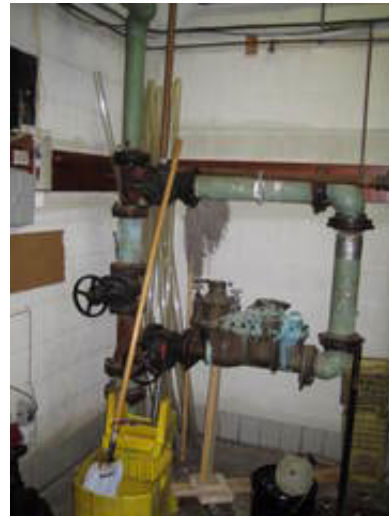
Incoming Domestic Water Service Meter

Incoming Domestic Water Service Line

Recommendations: Provide a new city water supply line of adequate capacity to support the existing needs of the facility, as well as a future automated fire suppression system. Funding provided in Item U.

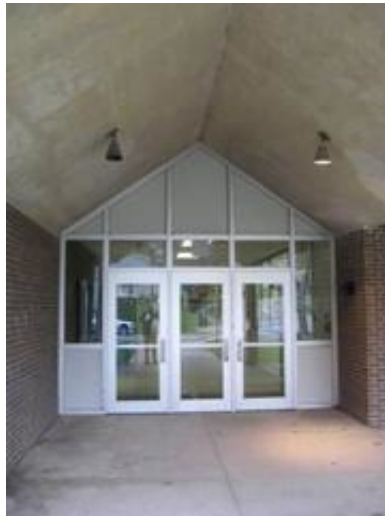
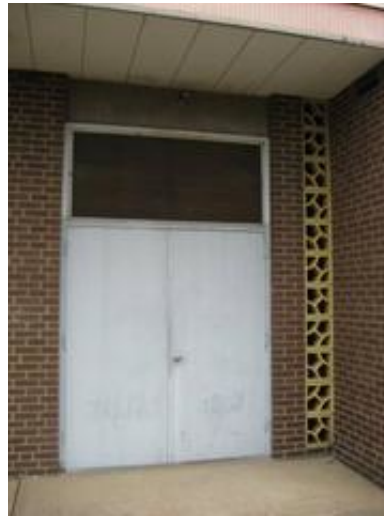
Rating: 3 Needs Replacement

Main Entry Doors

Typical Exterior Hollow Metal Doors

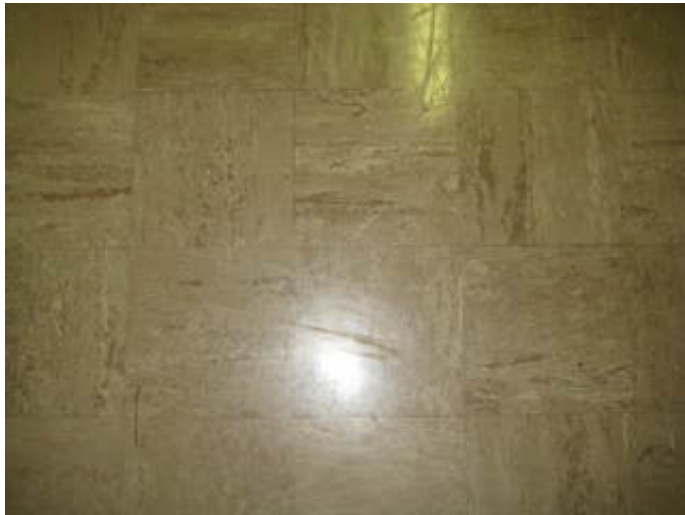
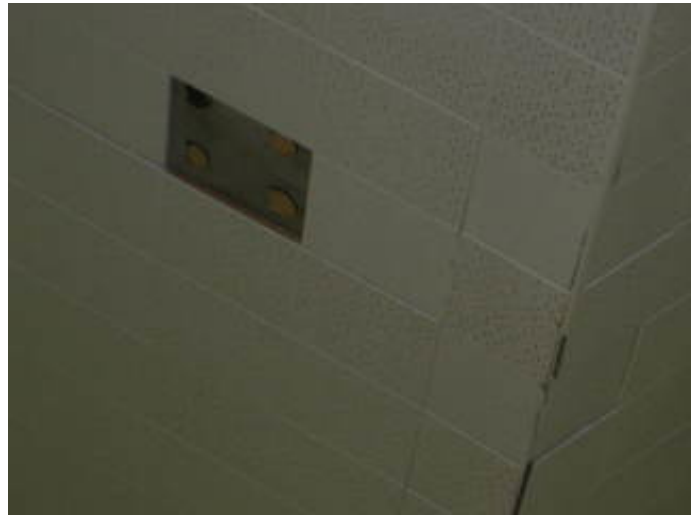
Rating: 3 Needs Replacement

VAT in the Classrooms

Acoustical Tile

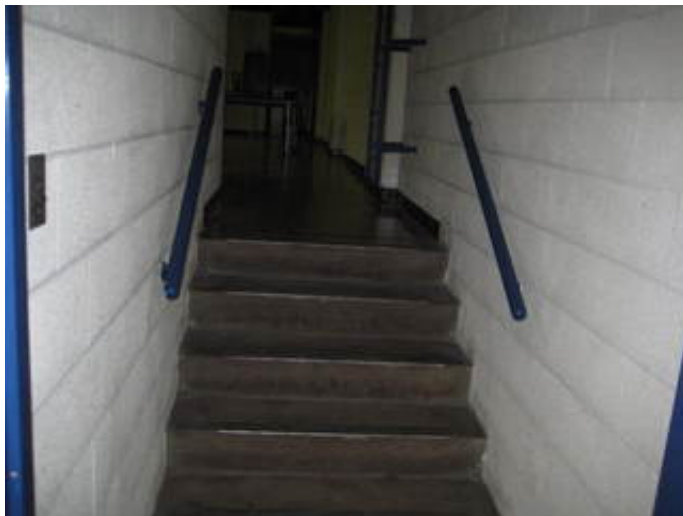
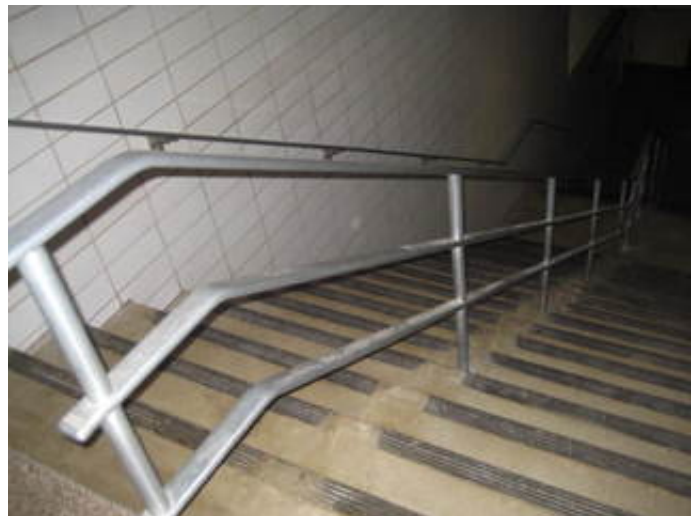
Non-Compliant Handrails
