Building Information - Cuyahoga Falls City (43836) - Schnee Learning Center

Schnee Elementary School, which is not on the National Register of Historic Buildings, and originally constructed in 1961, is a two story, 40,724 square foot brick school building located in a suburban residential setting. The existing facility features a conventionally partitioned design, and does not utilize modular buildings. The structure of the overall facility contains a reinforced concrete structural frame with a folded plate roof structure and a brick veneer on masonry infill wall type exterior wall construction, with concrete masonry units and glazed block type wall construction in the interior. The floor system of the base floor of the overall facility consists of concrete slab-on-grade type construction. The floor system of the first floor of the elevated west Classroom wing of the overall facility consists of a reinforced cast-in-place two-way concrete slab with concrete topping type construction. The roof structure of the overall facility, except at the Multipurpose space and canopies, is precast reinforced concrete planks with concrete topping type construction. The roof structure of the over

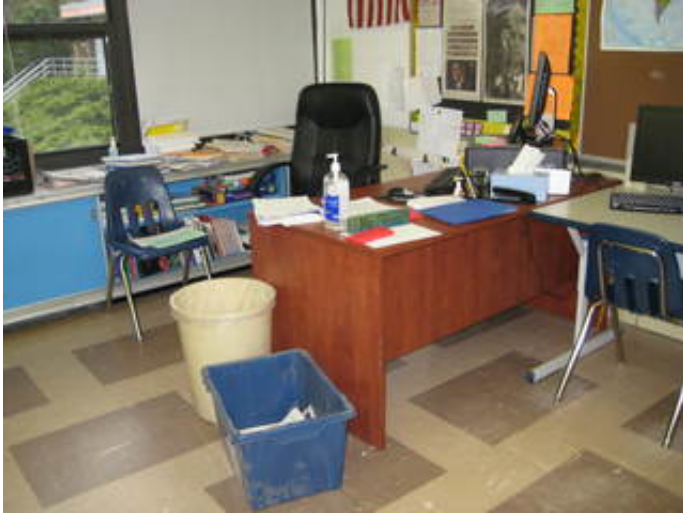
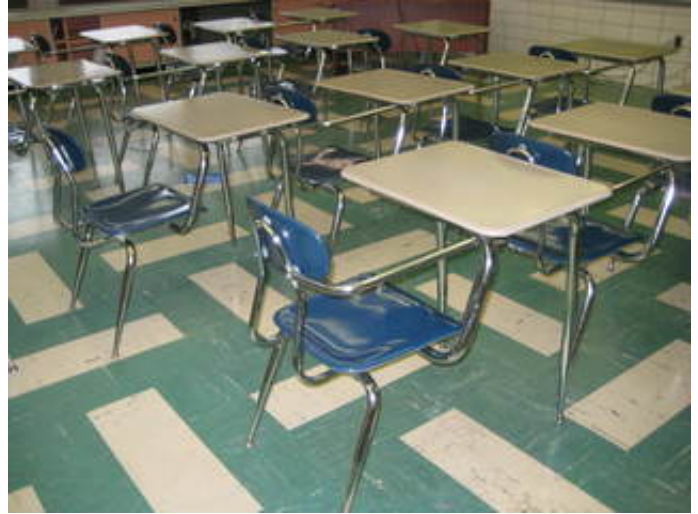
Typical Teacher's Desk

Typical Student Desk

Recommendations: Provide for replacement of outdated or inadequate furnishings.

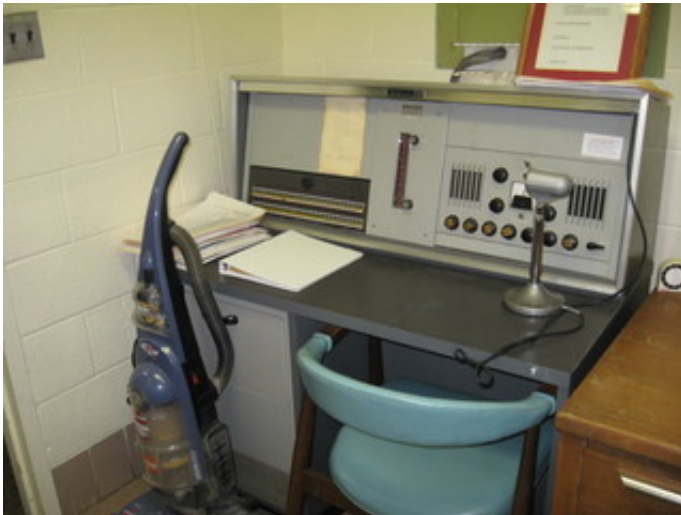
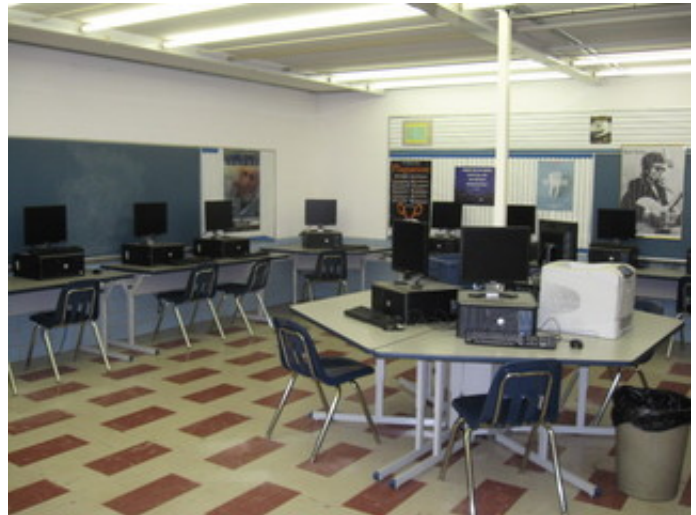
Outdated Building PA System

Typical Classroom In The Elevated West Classroom Wing
