**Building Information - Cuyahoga Falls City (43836) - Silver Lake Elementary**

**Building Construction Information - Cuyahoga Falls City (43836) - Silver Lake Elementary (34603)**

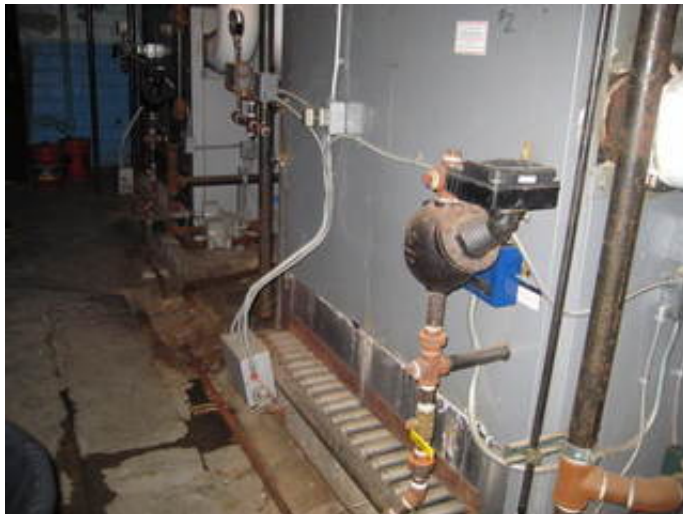
The existing system for the 1927 Original Construction is a natural gas fired steam boiler type system, installed in 1927, and is in fair to poor condition. The systems in the 1946, 1950, and 1956 Additions are an extension of that found in the 1951 Original Construction. 2-pipe vs. 4-pipe designations are not applicable in this facility, as no central air conditioning is provided. The two (2) cast iron boilers, manufactured by Peerless, were installed in 1999 and are in fair condition. Steam is distributed to terminal units consisting of unit ventilators, cabinet heaters, unit heaters, air handlers, radiators. The terminal equipment is original to each addition and is in fair to poor condition. The system does not comply with the 15 CFM per person fresh air requirements of the Ohio Building Code mechanical code and Ohio School Design Manual. The pneumatic type system temperature controls are original to each addition with incremental upgrades and are in fair condition. The system does not feature individual temperature controls in all spaces required by the OSDM. The overall system does not feature any central energy recovery systems. The facility is not equipped with louvered interior doors to facilitate Corridor utilization as return air plenums. The existing system in the Gymnasium is ducted, but the ductwork cannot be integrated into a possible future system due to arrangement, air volume, and routing of existing ductwork. The existing system in the remainder of the overall facility is not ducted, except for the Basement, and floor to structural deck heights will accommodate the installation of properly sized ductwork for a future Ohio School Design Manual approved system. The existing system in the Basement is not ducted, but floor to structural deck heights will not accommodate the installation of properly sized ductwork for a future Ohio School Design Manual approved system. The overall heating system is evaluated as not being in safe and efficient working order, and long term life expectancy of the existing system is not anticipated. The structure is not equipped with a central air conditioning system. The site does not contain underground fuel tanks.

Natural Gas Fired Steam Boilers

Provide new overall heating, ventilating, and air conditioning system to achieve compliance with Ohio Building Code and Ohio School Design Manual standards. Convert the overall facility, except for the Gymnasium to a ducted system to facilitate efficient exchange of conditioned air. Replace existing ductwork in the remainder of the overall facility to facilitate efficient exchange of conditioned air with pricing included in conversion to ducted system replacement. Provide architectural soffits in the Basement of the facility to accommodate the installation of ductwork, with funding provided in conversion to ducted system replacement.

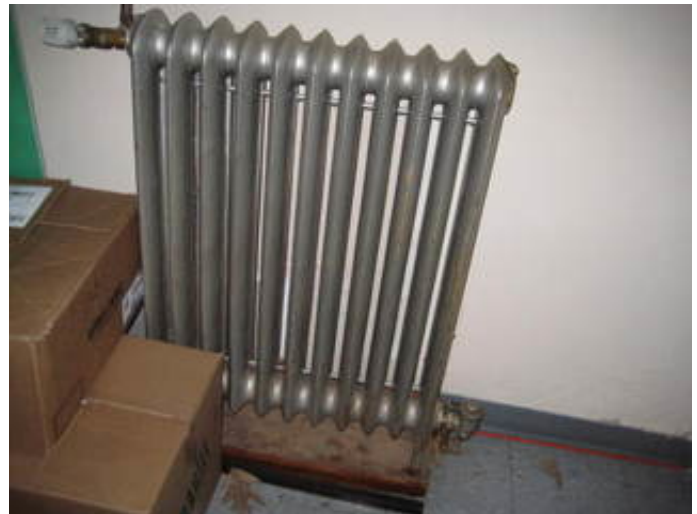
Steam Radiators

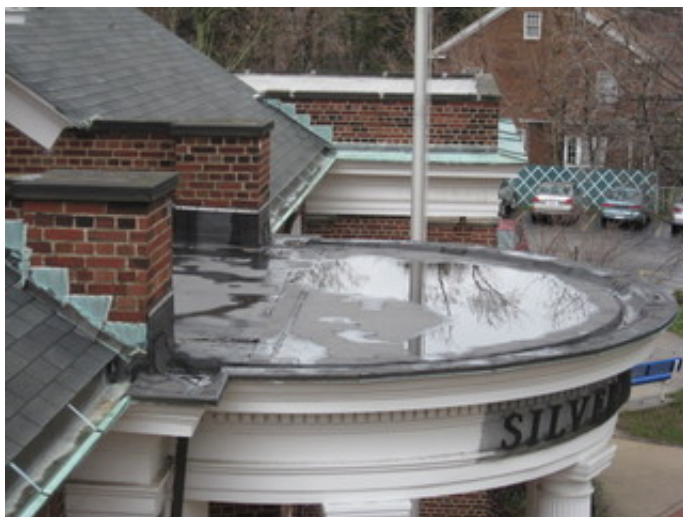
The roof over the 1927 Original Construction is a combination of a fully adhered EPDM roof over the entry portico, asphalt shingles on the sloped areas, and asphalt built-up roof with gravel wear coat system over the flat areas that was installed in 1999, and is in fair condition. The roof over the 1946, 1950, and 1956 Additions is an asphalt built-up roof with gravel wear coat system that was installed in 1999, and is in fair condition. There are no District reports of current leaking. Signs of past leaking were observed during the physical assessment. Access to the roof was gained by access roof hatch with access ladder and exterior access ladders that are in fair to poor condition. Fall safety protection cages are not required, and are not provided. There were observations of standing water on the roof. Metal and clay tile cap flashings and stone copings are in fair to poor condition. Roof storm drainage for the 1927 Original Construction is addressed through a system of gutters and downspouts, which are properly located, and in good to fair condition. Roof storm drainage for the 1946, 1950, and 1956 Additions is addressed through a system of roof drains and downspouts, which are properly located, and in good condition. The roof is equipped with overflow roof drains in sufficient quantity and in good condition. No problems requiring attention were encountered with any roof penetrations. There are not any covered walkways attached to this structure. It was reported by district personnel, and observed, the original roof area was not removed prior to installing the current roof system. Therefore, additional tear-off costs required. Additional roof insulation required to meet LEED energy efficiency requirements.

Asphalt Shingle and EPDM Roof Over the 1927 Original Construction

The roof over the overall facility requires replacement to meet Ohio School Design Manual guidelines due to condition. The roof access hatch and access ladders require replacement due to condition. 10-02-14 Update: Original assessment did not include roof replacement for the 1950 Addition. Revise to include replacing the roof on the 1950 Addition with built-up asphalt system. Provide for additional roof tear-off due to recovery roof system installed over existing roof. Provide for additional roof insulation to meet LEED energy efficiency requirements.

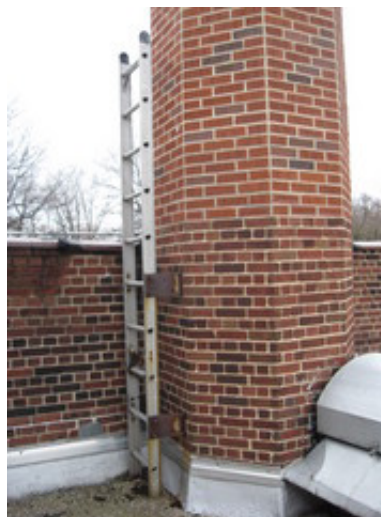
Non-Compliant Roof Ladder At the 1946 Addition

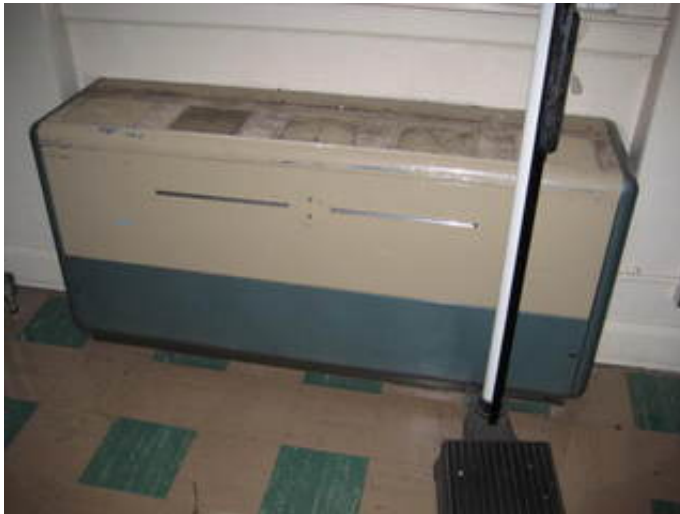
**Description:** The overall facility is not equipped with a central air conditioning system. Window units are provided in several Classroom locations. The ventilation system in the overall facility consists of unit ventilators, original to each addition and in fair to poor condition, providing fresh air to Classrooms, and unit ventilators and air handlers, original to each addition and in fair to poor condition, providing fresh air to other miscellaneous spaces such as the Gymnasium, Student Dining, and Media Center. Relief air venting is provided by transfer grilles to Corridors, unit ventilators, air handlers, and central relief fans. The ventilation system does not meet the Ohio Building Code 15 CFM per occupant fresh air requirement. The overall system is not compliant with Ohio Building Code and Ohio School Design Manual requirements. Dust collection systems are not required in this facility. Exhaust systems for Restrooms, Storage Rooms, Custodial Closets, Maintenance Workrooms, Kitchen Dry Food Storage, Locker Rooms, P.E. Workroom & Storage, and Art Rooms are inadequately placed, and in poor condition. The Art Program is equipped with a kiln, and the existing kiln ventilation system is inadequate. General building exhaust is included in Item A and should not be included in this line item.

Unit Ventilator

**Recommendations:** Provide an air conditioning system to meet with Ohio Building Code and Ohio School Design Manual requirements. Pricing included in Item A. Replace the existing general building exhaust system. Provide the existing Art Program the required kiln ventilation system. Delete general building exhaust.

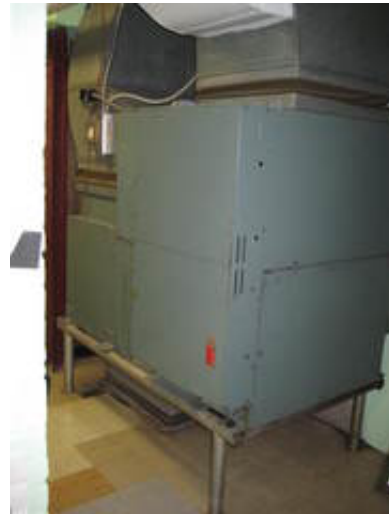
Air Handler Unit

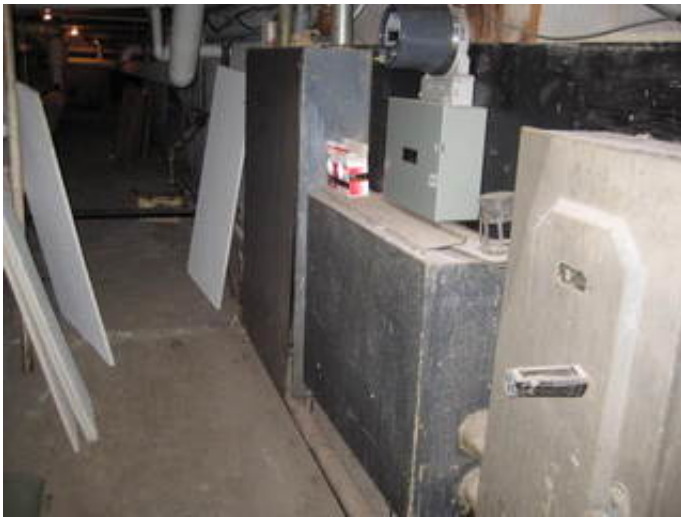
**Description:** The electrical system provided to the 1927 Original Construction is a 120/208 volts, 600 amp, 3 phase and 4 wire system installed in 1927, and is in poor condition. The systems in the 1946, 1950, and 1956 Additions are an extension of that found in the 1951 Original Construction. Power is provided to the school by a single City of Cuyahoga Falls owned, pole-mounted transformer located at the corner of the existing parking area, and in fair condition. The panel system, installed in 1927, with upgrades in 1999, is in fair condition, but cannot be expanded to add additional capacity. The Classrooms are not equipped with adequate electrical outlets. The typical Classroom contains four (4) general purpose outlets, zero (0) dedicated outlets for each Classroom computer, and zero (0) dedicated outlets for each Classroom television. Some Classrooms are equipped with as many as six (6) general purpose outlets, while others are equipped with as few as three (3) general purpose outlets. There are not any spaces that have no electrical outlets. The Corridors are not equipped with adequate electrical outlets for servicing. Adequate GFI protected exterior outlets are not provided around the perimeter of the building. The facility is not equipped with an emergency generator. Adequate lightning protection safeguards are not provided. Stage lighting power system including control panel, breakers, and dimmers is inadequately provided, in fair condition and does not meet OSDM requirements. The overall electrical system does not meet Ohio School Design Manual requirements in supporting the current needs of the school, and will be inadequate to meet the facility's future needs.

Main Electrical Distribution Panel

**Recommendations:** The entire electrical system requires replacement to meet Ohio School Design Manual guidelines for overall capacity and Classroom capacity due to age, condition, lack of OSDM-required features, and to accommodate the addition of an air conditioning system. Provide an emergency generator, with funding included in the electrical system replacement. Provide adequate lightning protection safeguards in the overall facility, including associated grounding system, with funding included in the electrical system replacement. Provide control panel, dimmers, and breakers to support the Stage lighting system, with funding included in the electrical system replacement.

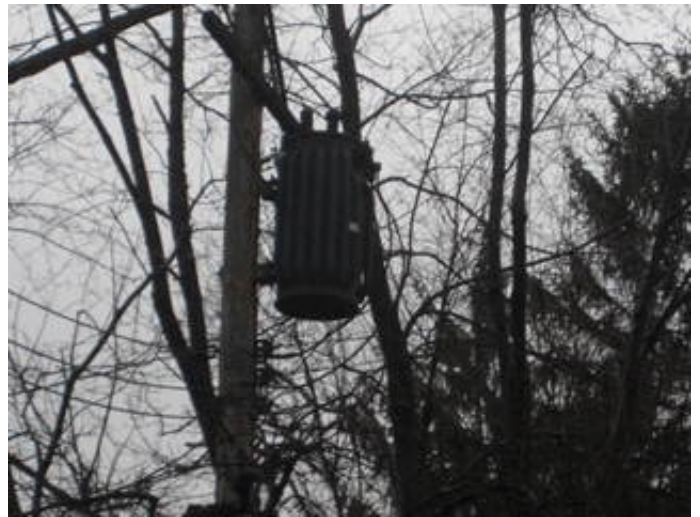
Pole Mounted Transformer

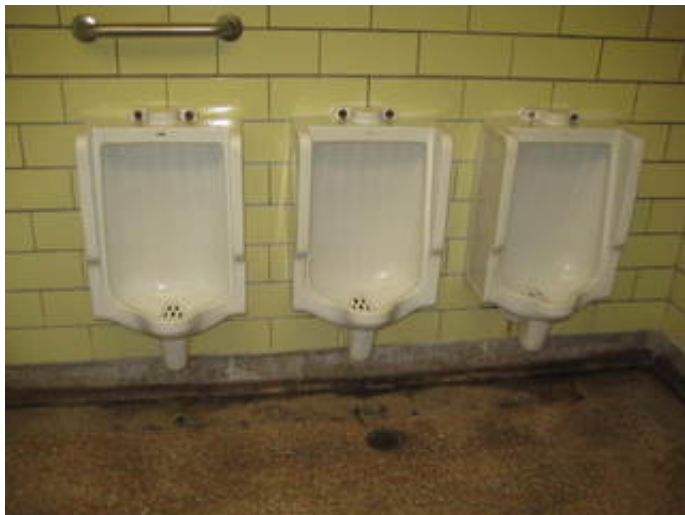
Wall Hung Central Flush Urinals

Replace galvanized water supply piping in the overall facility with copper piping due to age and condition. Replace sanitary waste piping in the overall facility due to age and condition. To facilitate the school's compliance with OBC and OSFC requirements, provide 16 lavatory mounted type drinking fountains. Due to age, condition, and OSFC standards, replace 18 lavatories, 26 toilets, 8 urinals, and 3 electric water coolers. See Item O for replacement of fixtures related to ADA requirements. See Item J for provisions on Kitchen related equipment. Provide the service entrance with a reduced pressure back flow preventer. Replace the Kitchen grease trap interceptors due to age, condition, and insufficient capacity. Provide the Kitchen with a water booster heater. Provide 2 additional exterior wall hydrants. Replace the existing Custodial Closet service sinks due to age and condition.

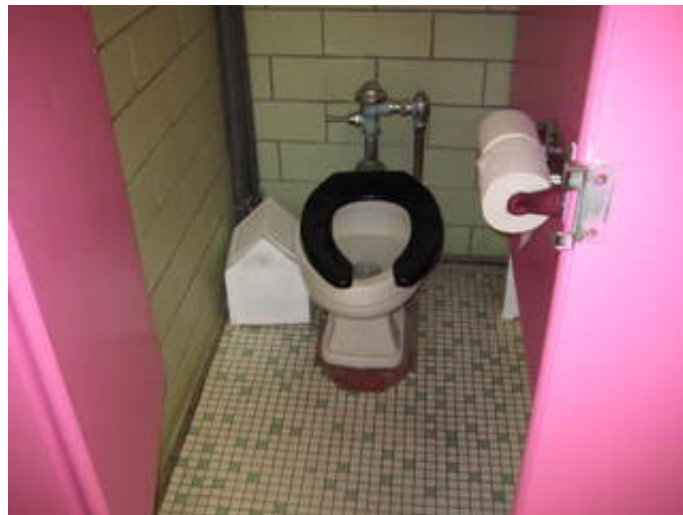
Floor Mounted Flush Valve Toilet

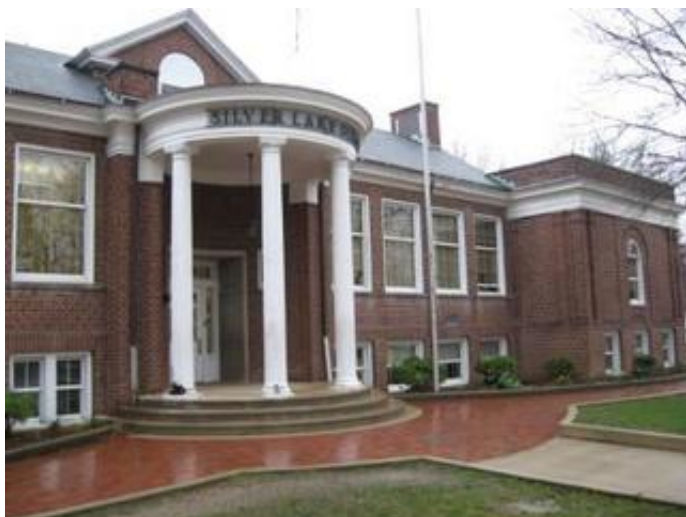
The overall facility is equipped with thermally broken aluminum frame windows with double glazed insulated glazing type window systems. The window system in the 1927 Original Construction was installed in 1982 and is good to fair condition. The window system in the 1946, 1950 and 1956 Additions was installed in 1999, and is in good condition. Window system seals are in good condition, with no air and water infiltration being experienced. Window system hardware is in good condition. The window system features surface mounted blinds and shades, which are in good to fair condition. The window system in the 1927 Original Construction is not equipped with insect screens on operable windows. The window system in the 1946, 1950 and 1956 Additions is equipped with insect screens on operable window, which are in good condition. This facility is not equipped with any curtain wall systems. This facility does not feature any glass block windows. The majority of exterior doors in the overall facility are equipped with thermally broken aluminum frame sidelights and transoms with double glazed insulated glazing, in good condition. The main entry door to the 1927 Original Construction is equipped with wood frame sidelights and transom with single pane glazing, in fair condition. The school does not contain skylights. Window security grilles are not provided for the majority of ground floor windows. Security grilles are provided for two ground floor windows in the 1946 Addition, and are in good condition. There is no Greenhouse associated with this school. 06-22-18 Assessment Update: Windows in the Original Building need replaced in order to meet LEED Energy Efficiency Requirements. Since windows will have integral blinds and operable portion with screen, line item for replacing screens, surface mounted blinds.

Typical Windows in the 1927 Original Construction

Provide insect screens for operable windows in the 1927 Original Construction. Replace defective surface mounted blinds and shades as required through the overall facility. Recaulking of perimeter joints of all exterior windows in the 1927 Original Construction is addressed in Item H. Replace single pane glazing in the 1927 Original Construction main entry sidelights and transom. 06-22-18 Assessment Update: Replace windows in Original Building and delete window screen and surface mounted blinds.

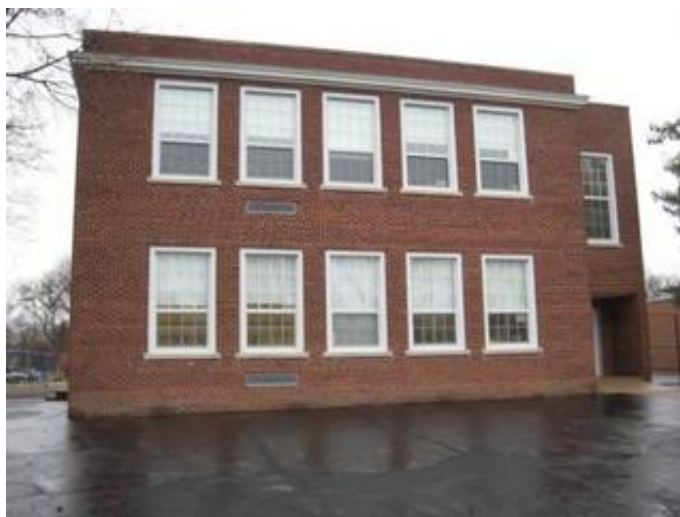
Typical Classroom Windows in the 1950 and 1956 Additions

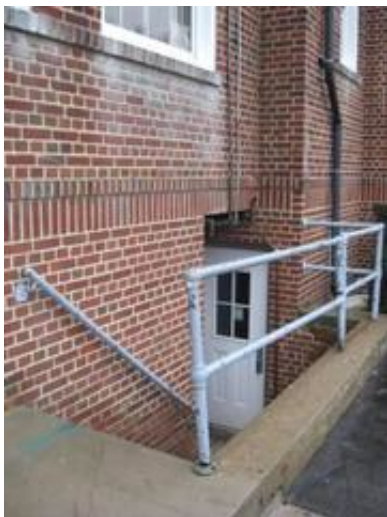
**Description:** The overall facility is equipped with masonry and concrete foundation walls on concrete footings. One area of differential settlement and cracking was observed at the southwest corner of the 1946 Addition. The foundations in the overall facility are in fair condition. The District reports that there has been past leaking at the exterior stairs next to the Boiler Room in the 1927 Original Construction. A site drainage deficiency was noted at the perimeter of the 1946 Addition that is contributing to the foundation settlement. 06-22-18 Assessment Update: Settling has occurred at the southeast classroom of the 1956 Addition. A significant floor crack spans the classroom floor (north to south) and exterior brick cracking on the exterior wall.

Location of Leaking in the 1927 Original Construction Boiler Room

**Recommendations:** Provide drainage tile system for the existing roof drains from on the west side of the 1946 Addition. Address foundation leaking issue at the exterior Boiler Room wall in the 1927 Original Construction. 10-02-14 Update: There is significant water damage and water infiltration at the foundation along the South elevation West elevation (main entry). Revise "Foundation Leaking Issue" line item quantity from 200 sf to 600 sf and cost/sf from \$50/sf to \$95/sf to excavate, provide under drains water proofing of foundation wall. 06-22-18 Assessment Update: Provide underpinning of foundation to prevent further settlement.

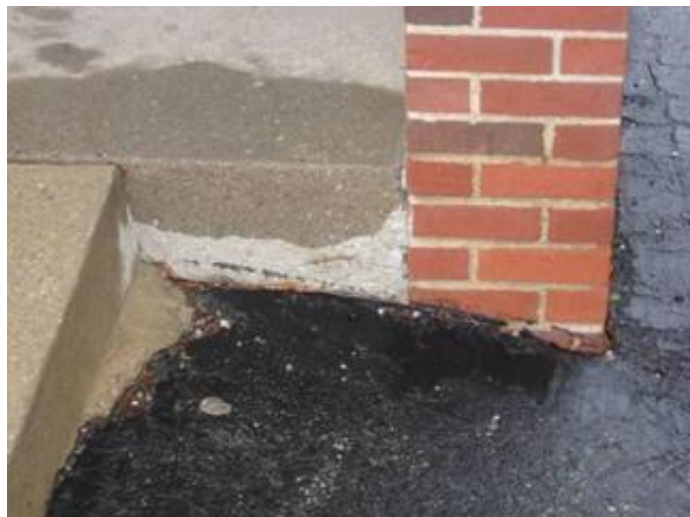
Exterior Wall at Grade

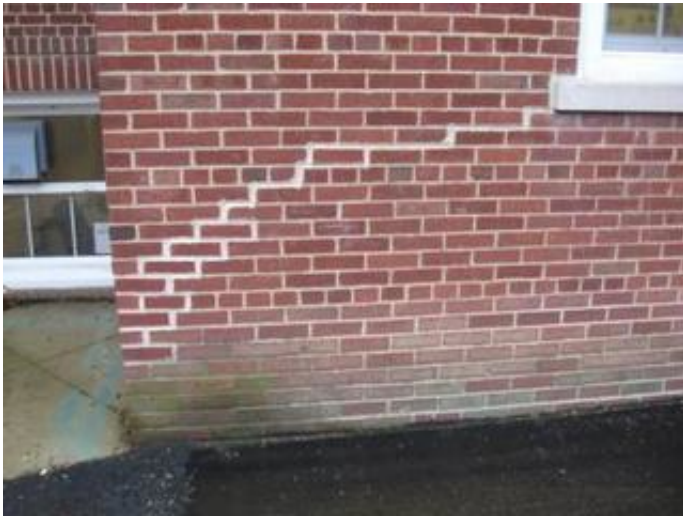
**Description:** The overall facility has a brick veneer on a masonry bearing wall system, which displayed locations of deterioration, and is in good to fair condition. The exterior masonry does not contain control joints and none are needed as there is no indication of exterior masonry cracking or separation. The school does not contain expansion joints, and none are needed as there is no indication of exterior masonry cracking or separation. The exterior masonry has not been cleaned and sealed in recent years, and shows evidence of mortar deterioration and locations of staining. Architectural exterior accent materials consist of stone and painted wood trim which are in fair condition. Interior walls are glazed block, plaster and wood paneling and are in fair condition. Interior masonry does not contain control joints, and none are needed as there is no indication of cracking or separation. The window sills in the 1927 Original Construction are brick and are in good to fair condition. The window sills in the 1946, 1950 and 1956 Additions are stone and are in good condition. The exterior lintels are steel, and are rusting and in fair condition. Chimneys are in fair condition and require masonry tuckpointing, cleaning and sealing. Canopies and soffits over entrances are plaster type construction, and are in good to fair condition. A loading dock has not been provided to facilitate unloading of trucks and receipt of product / supplies / food stuffs. The stone and clay tile copings at roof lines are in fair condition and require repointing. The wood columns at the main entry to the 1927 Original Construction are deteriorating and require replacement. 06-22-18 Assessment Update: The faux wood gutter/cornice at the West, East and North elevations of the building is in poor condition and should be replaced.

Masonry Condition in the 1948 Addition

**Recommendations:** Provide tuckpointing in all areas of mortar deterioration as required through the overall facility. Provide masonry repairs as required through the overall facility. Provide masonry cleaning, sealing and caulking as required through the overall facility. Prep and paint exposed steel lintels through the overall facility. Prep and paint wood cornices and trim in the 1927 Original Construction and the 1956 Addition. Repoint stone copings in 1927 Original Construction and the 1946 and 1956 Additions. Repoint stone window sills in the 1946, 1950 and 1956 Additions. Repoint brick window sills in the 1927 Original Construction. Replace clay tile copings as required in the 1927 Original Construction. Replace wood columns at the 1927 Original Construction main entry. Replace perimeter window sealant in the 1927 Original Construction. Provide masonry infill for unit ventilator openings in exterior walls. Prep and paint exterior plaster soffits. 10-02-14 Update: Steel Lintels rusted and deteriorated and should be replaced. Provide for lintel replacement. Wood Cornice and Facia deteriorated. Provide budget to replace wood Cornice and Facia with Fypon of same profile. Reduce "Prep and Paint Cornice and Trim" line item from 1,512 lf to 200 lf. 06-22-18 Assessment Update: Remove faux wood gutter/cornice at the West, East and North elevations of the building and replace with new Fypon Millwork.

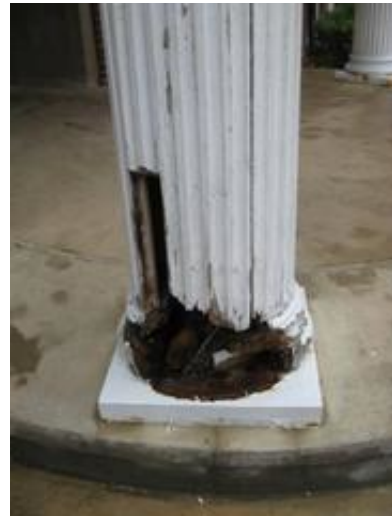
Wood Column at the 1927 Original Construction Entry

<b>Other:</b> Replace Entry Columns	\$2,500.00	each		4 Required				\$10,000.00	Replace wood columns at the 1927 Original Construction main entry.
<b>Other:</b> Replace Wood Cornice and Facia	\$35.00	ln.ft.		1,256 Required				\$43,960.00	Replace Wood Cornice and Facia with Fypon of same profile
<b>Other:</b> Replace Wood Gutter/Cornice	\$12,000.00	per unit		2 Required	1 Required	1 Required	0 Required	\$48,000.00	Remove wood gutter/cornice and replace with Fypon of same profile
<b>Other:</b> Repoint Brick Sills	\$7.50	ln.ft.		230 Required	0 Required			\$1,725.00	Repoint brick window sills in the 1927 Original Construction.
<b>Other:</b> Repoint Stone Copings	\$7.50	ln.ft.		490 Required	402 Required		420 Required	\$9,840.00	Repoint stone copings in 1927 Original Construction and the 1946 and 1956 Additions.
<b>Other:</b> Repoint Stone Window Sills	\$7.50	ln.ft.			130 Required	36 Required	60 Required	\$1,695.00	Repoint stone window sills in the 1946, 1950 and 1956 Additions.

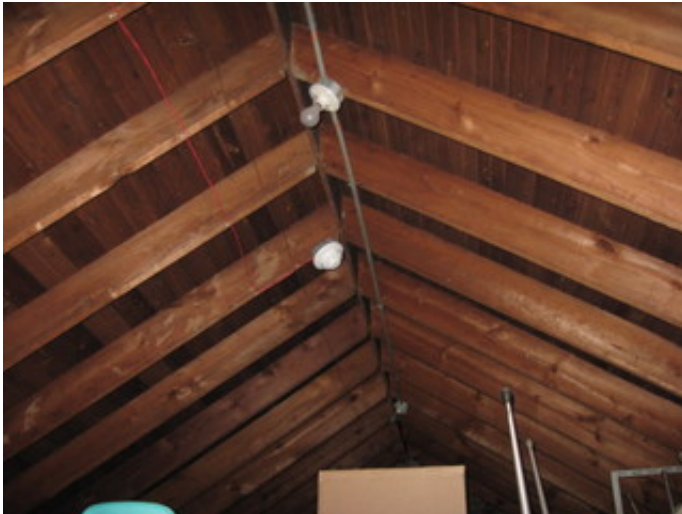
Wood Roof Structure Over the 1927 Original Construction

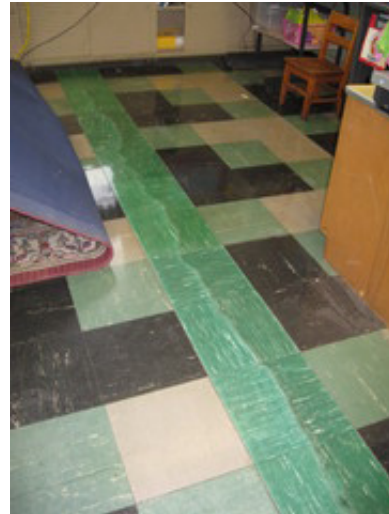
**Description:** The floor construction of the base floor of the overall facility is concrete slab-on-grade type construction, and is in fair condition due to cracking of the floor slab in the southwest corner of the 1946 Addition. There is a tunnel space located under the Corridors of the 1946 Addition with cast-in-place reinforced concrete type construction, and is in good condition. The floor construction of the first and second floors of the overall facility precast concrete planks with concrete topping type construction, and is in good to fair condition due to some cracks in the Corridors. Ceiling to structural deck spaces are sufficient to accommodate HVAC, electrical, and plumbing scopes of work in required renovations, except in the basement, where architectural soffits will be required. The roof construction of the 1927 Original Construction is wood deck on wood rafter type construction, and is in good condition. The roof construction of the 1946, 1950, and 1956 Additions is steel deck on steel joist type construction, and is in good condition.

Crack In the Floor Slab In the Southwest Classroom Of the 1946 Addition

**Recommendations:** Repair cracks in the 1927 Original Construction and 1946 Addition concrete slab. Repair cracks in the 1950 and 1956 Additions elevated floor slabs. Refer to Item U for pricing of fire suppression system for wood structures. Refer to Item A for funding of architectural soffits to accommodate HVAC, electrical, and plumbing scopes of work.

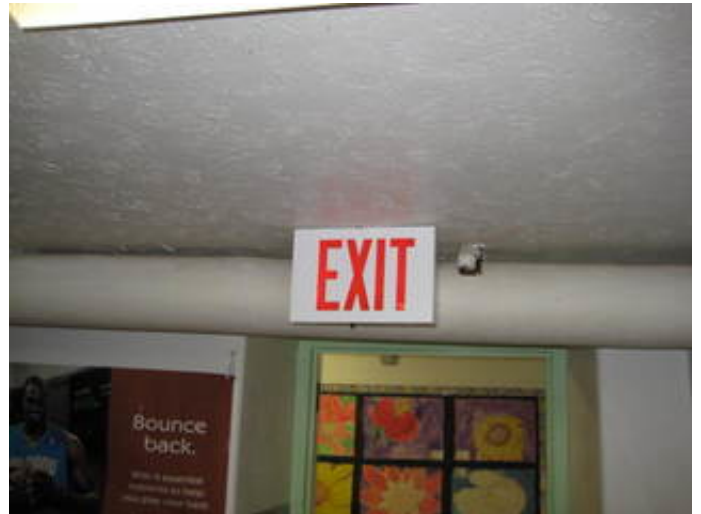
Non-compliant Illuminated Exit Sign

**Recommendations:** Provide complete replacement of emergency / egress lighting system to meet Ohio School Design Manual guidelines.

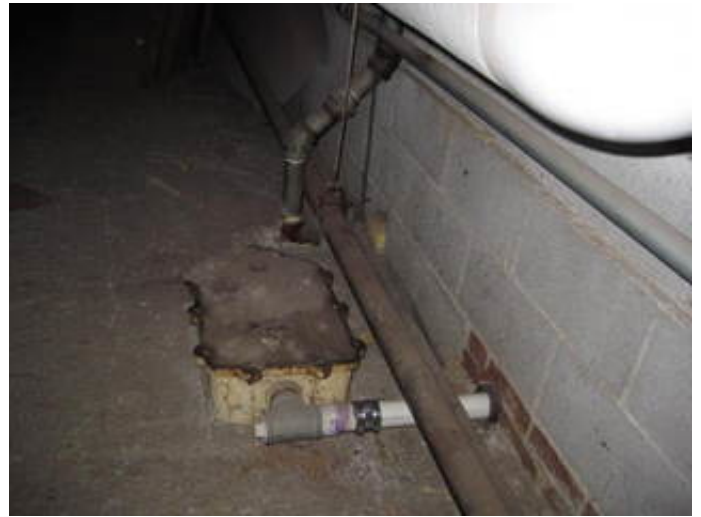
Kitchen Grease Trap Interceptor

Other: Kitchen Grease Trap	\$5,000.00	per unit		1 Required				\$5,000.00	Replace the Kitchen grease trap interceptors due to age, condition, and insufficient capacity.
Other: Kitchen Water Heater	\$5,100.00	per unit		1 Required				\$5,100.00	Provide the Kitchen with a water booster heater.
Other: Lavatory Mounted Type Drinking Fountain	\$1,500.00	per unit		3 Required	3 Required	5 Required	4 Required	\$22,500.00	To facilitate the school's compliance with OBC and OSFC requirements, provide 16 lavatory mounted type drinking fountains.
Other: Service Sink	\$500.00	per unit		1 Required	1 Required		1 Required	\$1,500.00	Replace the existing Custodial Closet service sinks due to age and condition.
Sum:			\$369,642.00	\$157,457.00	\$107,189.00	\$17,048.00	\$87,948.00

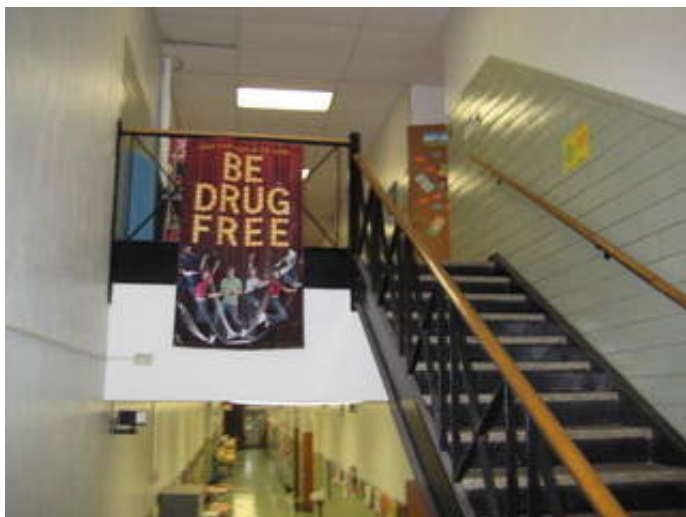
Non-compliant Guardrails

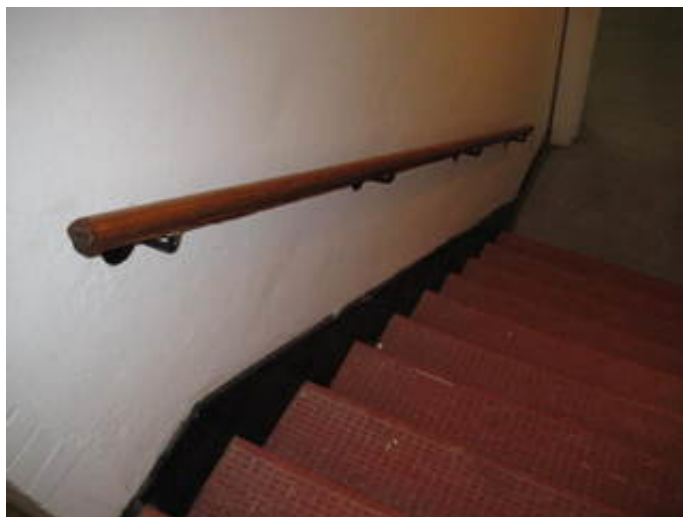
Non-compliant Handrail
