# Cuyahoga Falls City Schools

Facilities Committee Meeting #4

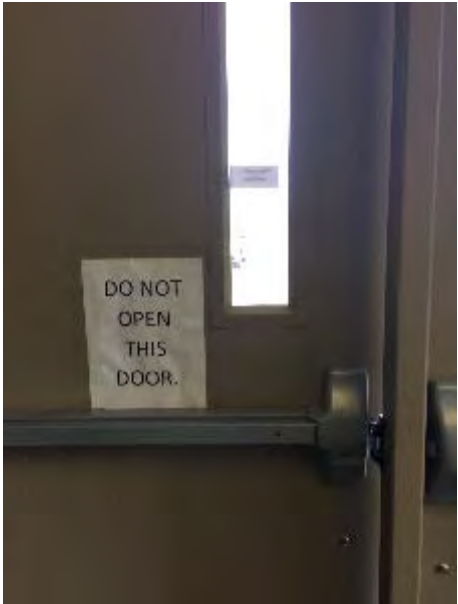
Exterior doors in Poor condition

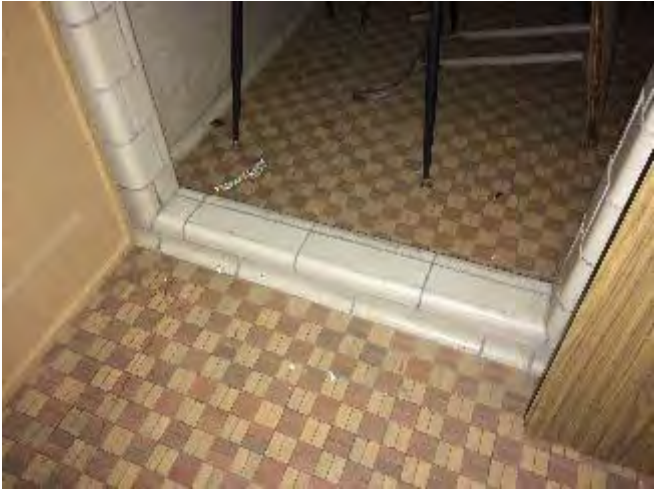
ADA barriers present

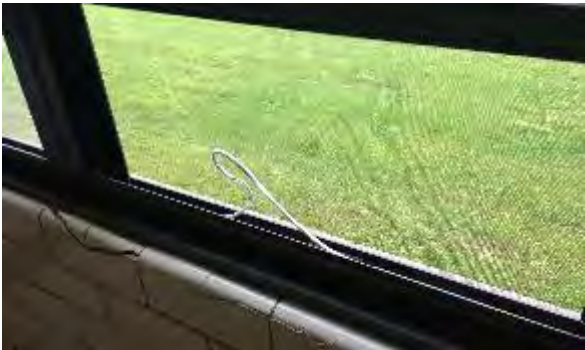
Window gaskets failing

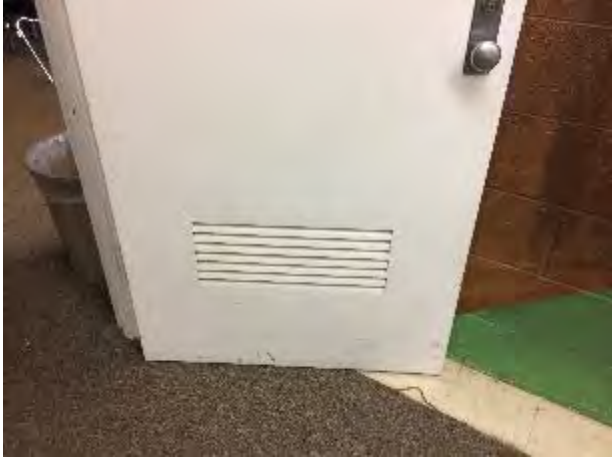
Louvered interior doors worn

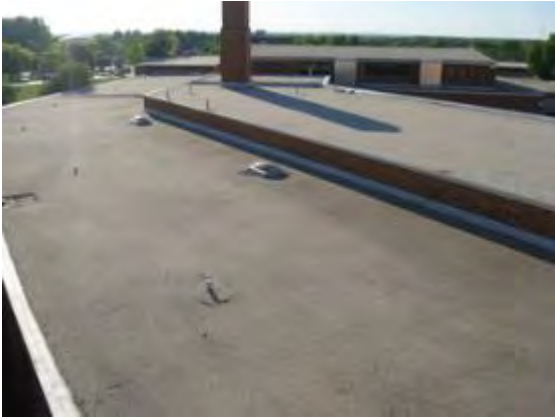
Roofs in poor condition

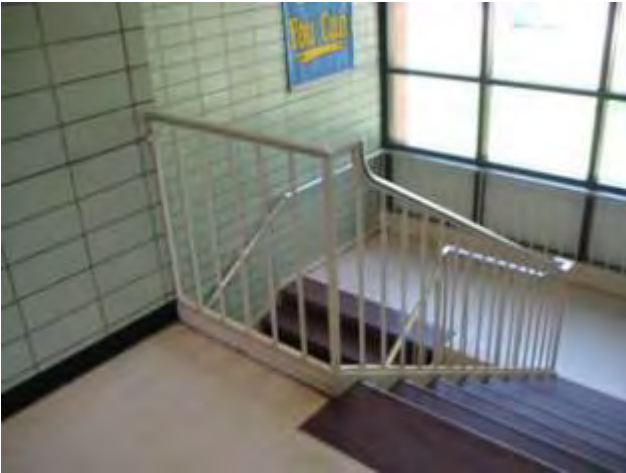
Guard/handrails not Code compliant

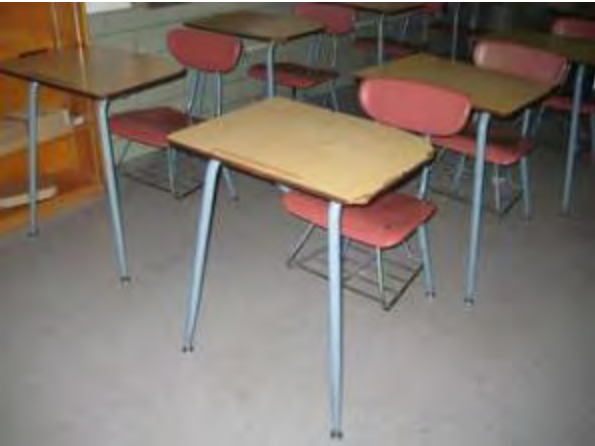
Dated & worn furniture

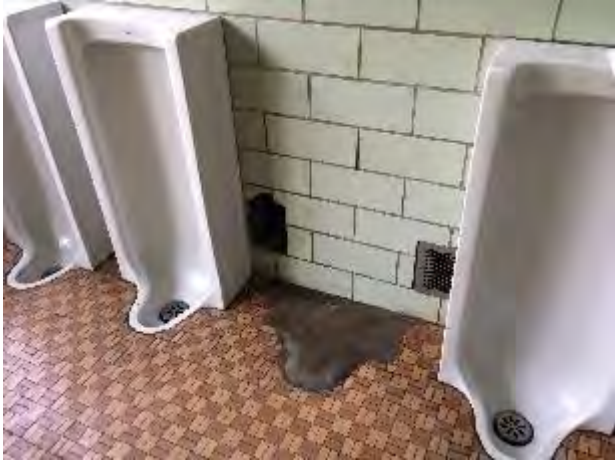
Fixtures in disrepair

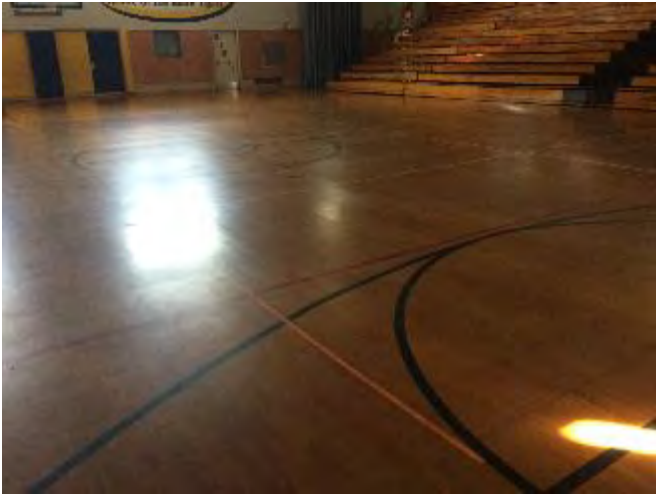
General finishes worn

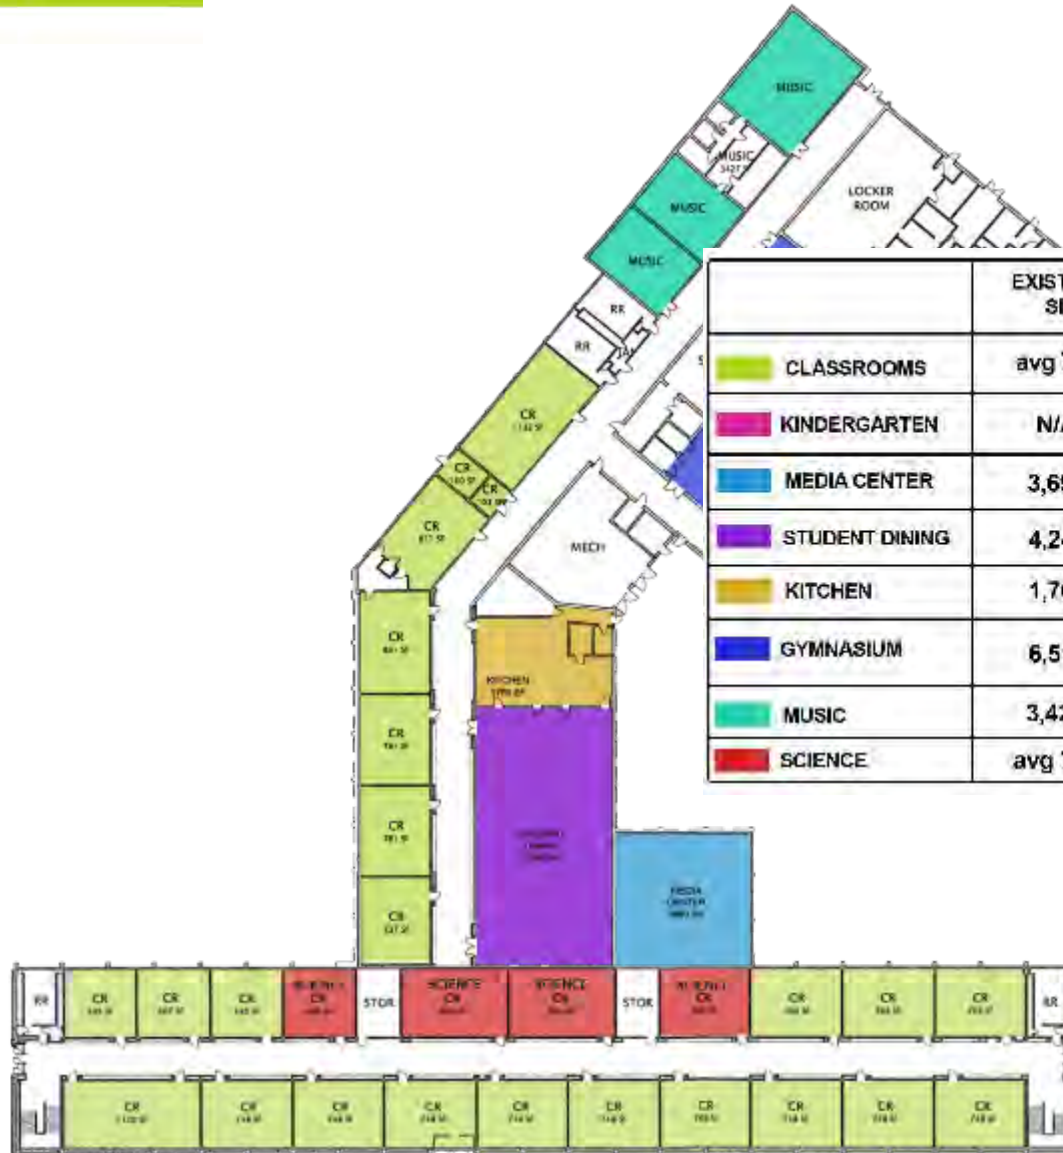
EXISTING SF	OFCC RECOMMENDED SF	DELTA
CLASSROOMS	avg 748	900	-152
KINDERGARTEN	N/A	1,200	N/A
MEDIA CENTER	3,699	1,915	+1,784
STUDENT DINING	4,248	3,000	+1,248
KITCHEN	1,769	1,915	-146
GYMNASIUM	6,513	7,500	-987
MUSIC	3,427	2,700	+727
SCIENCE	avg 784	900-1,100	-116/-316

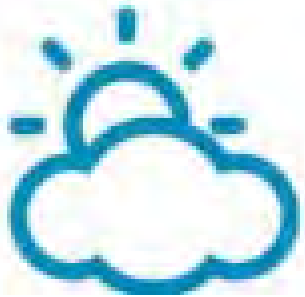
“In one school district, students with the most daylighting in their classrooms progressed 20% faster on math tests and 26% faster on reading tests when compared to students in the least daylit classrooms.”

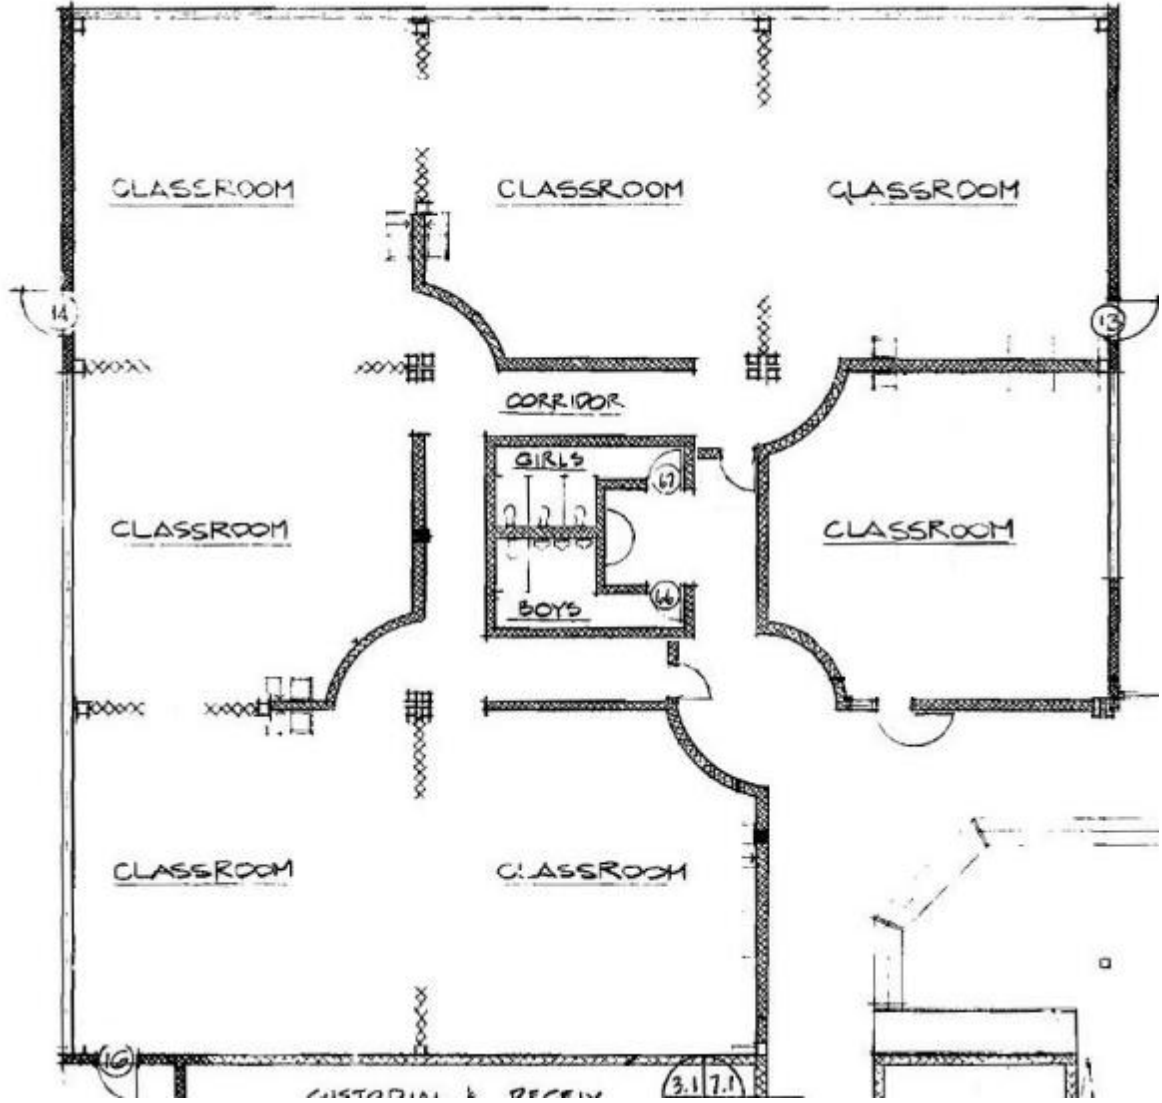
# Bolich Middle School – Summary

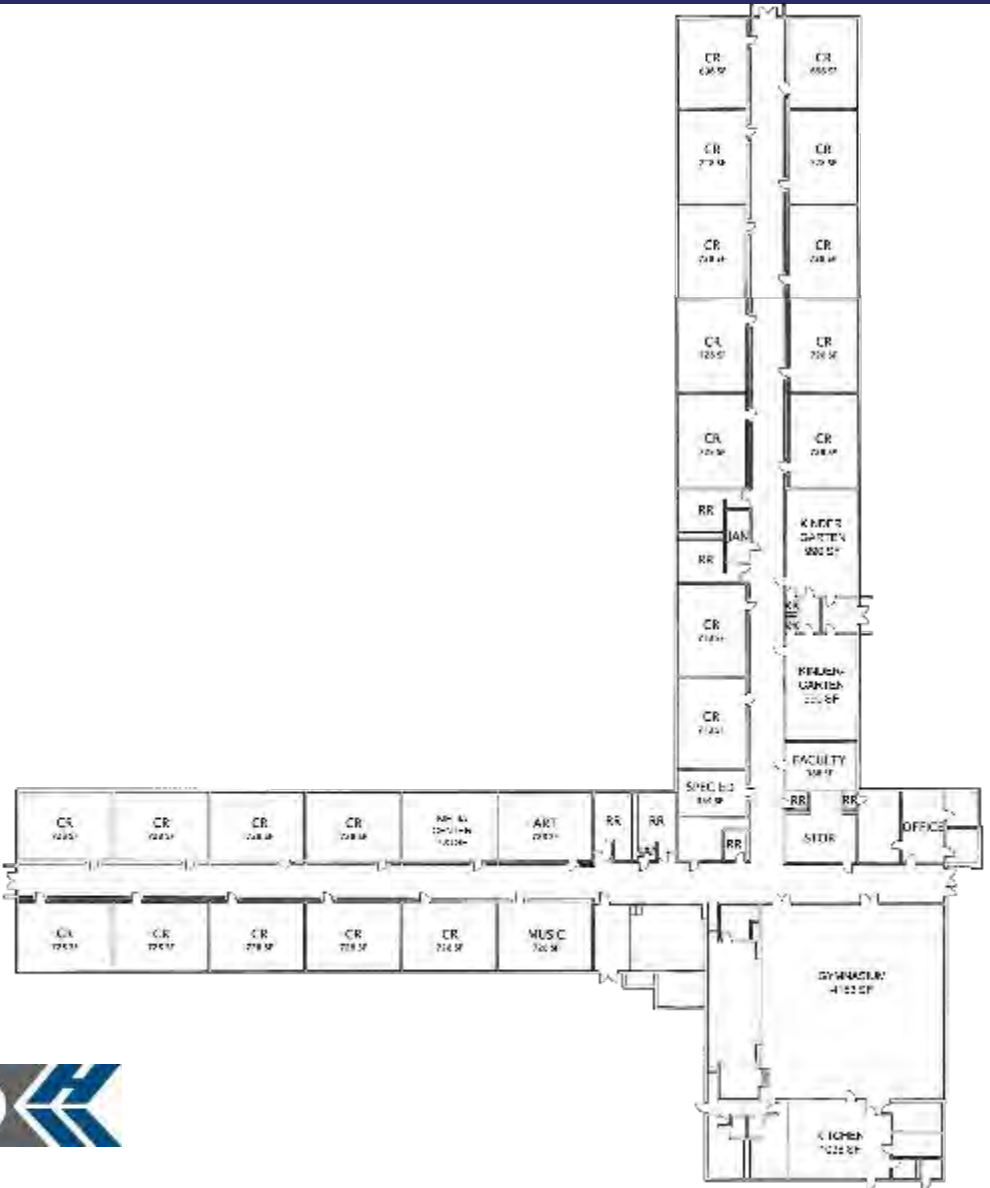
# Newberry ES – Assessment Validation

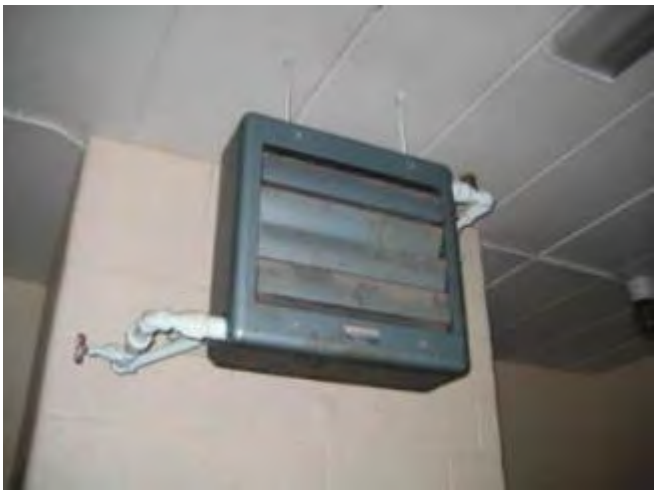
No A/C and outdated Heating / Ventilation System

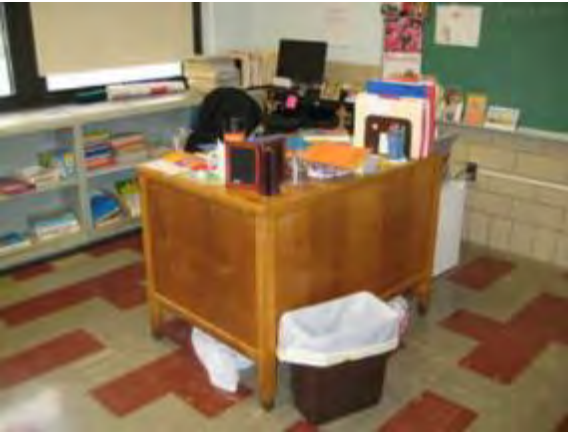
Outdated furnishings

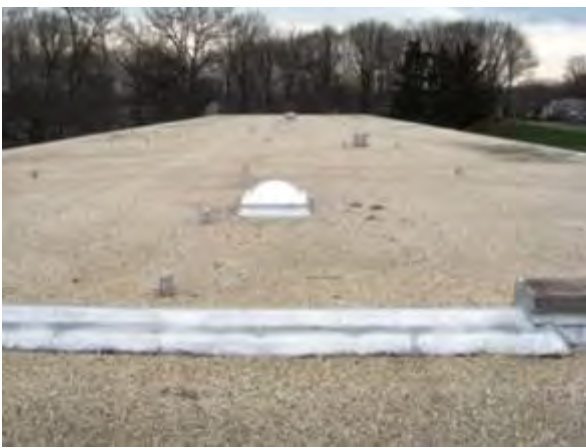
Roofs have multiple layers and some in worn condition

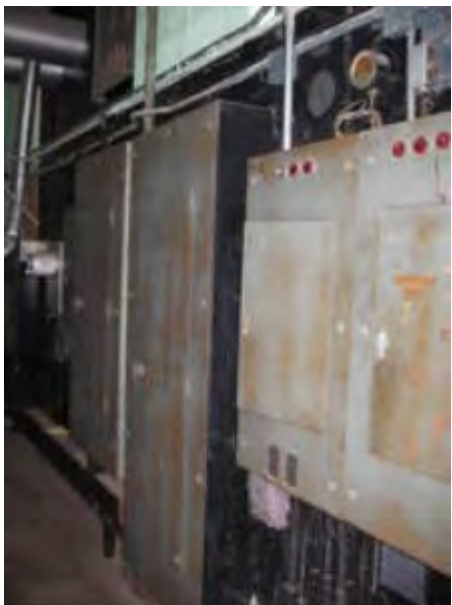
Electrical system is original and in poor condition

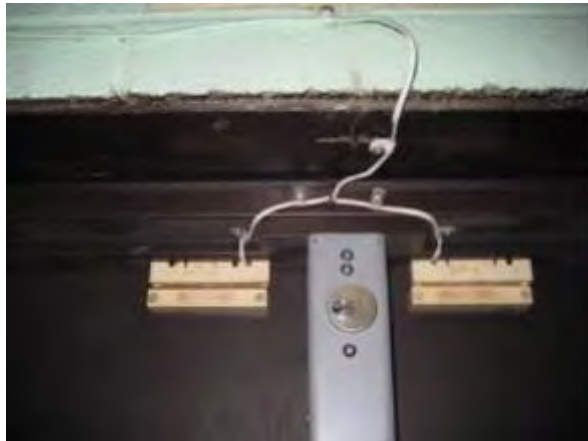
Minimal security system

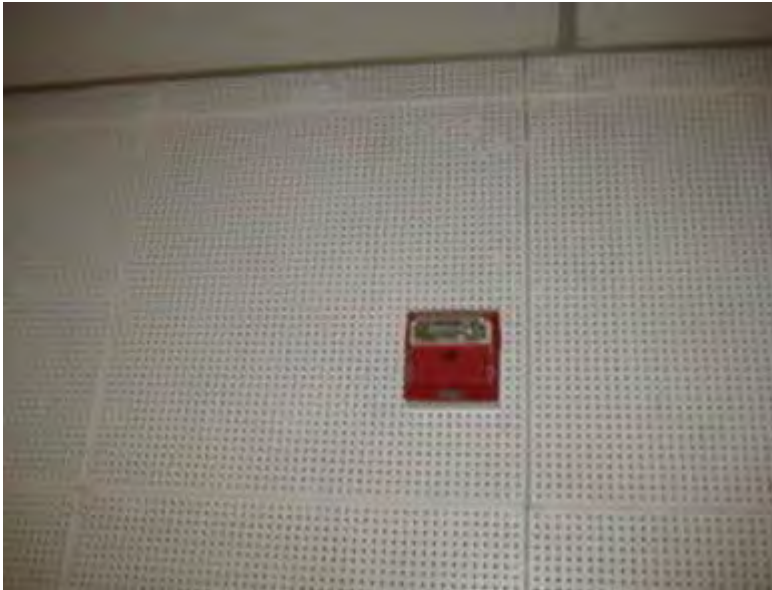
- 1) Fire alarm system does not meet OB Code, NFPA, or OSDM
- 2) Perforated wall board contains asbestos

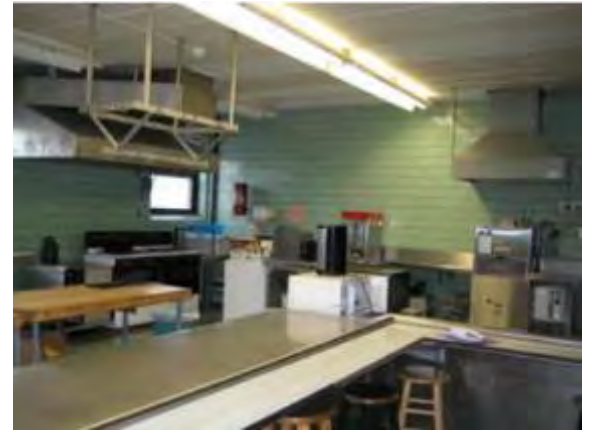
Kitchen & general finishes dated/worn

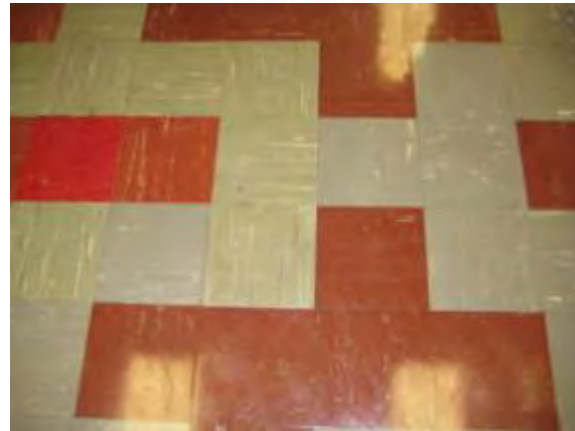
VAT flooring in CR's

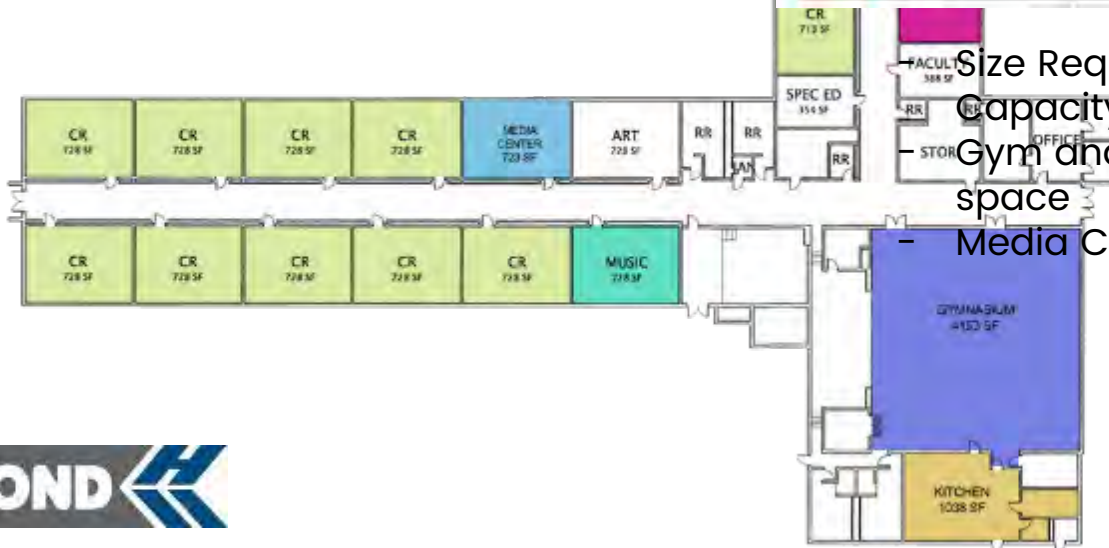
Size Requirements based on  
 Capacity enrollment of 382 students  
 Gym and student dining shared space  
 Media Center & Music in typical CR

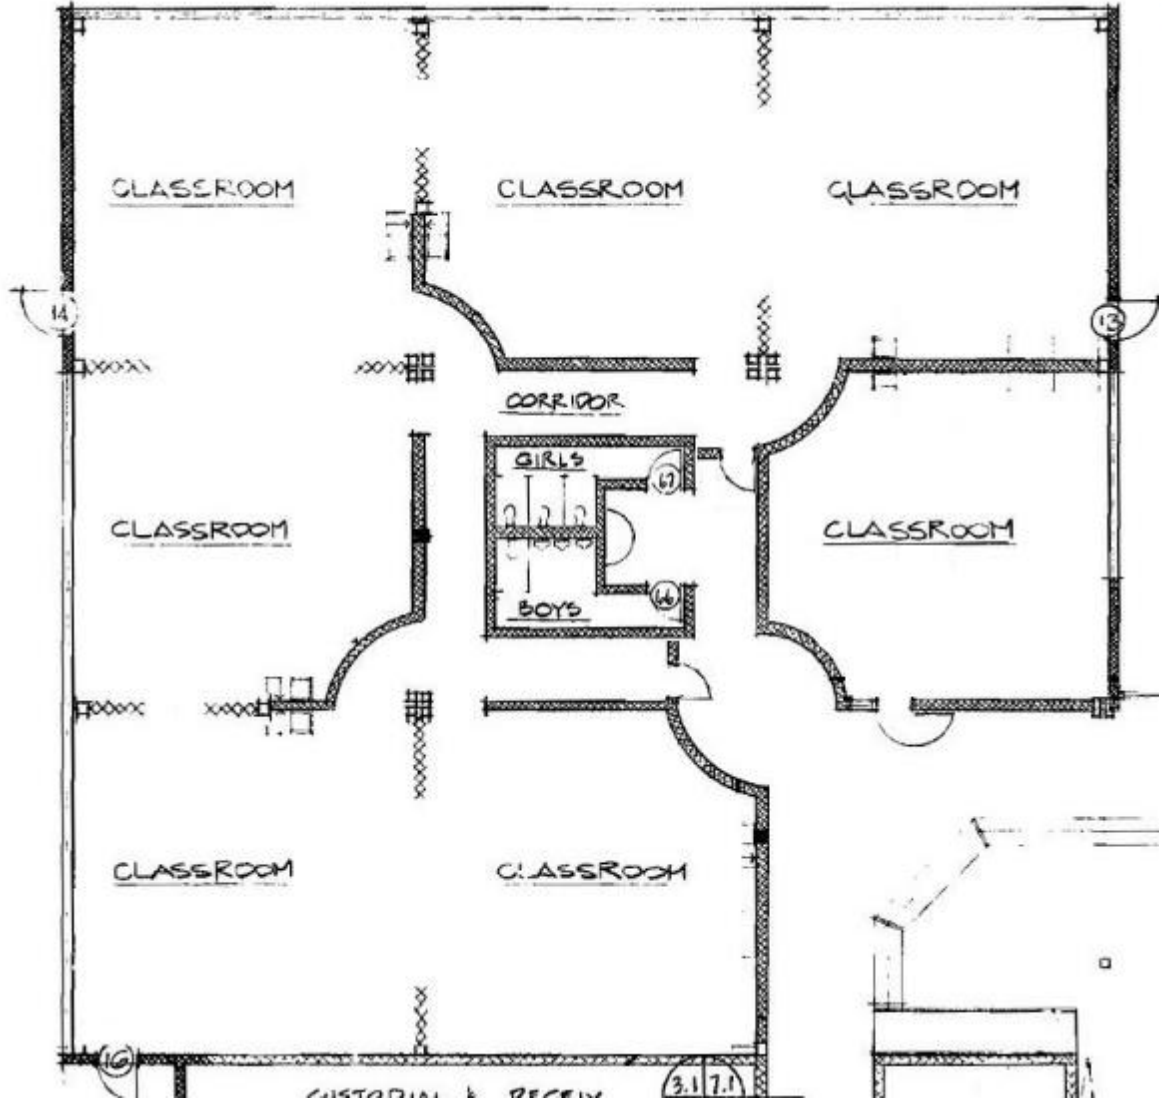
# Newberry ES – Summary
