Cuyahoga Falls City Schools

Facilities Committee Meeting #5

November 8, 2018

Roberts Middle School – Condition

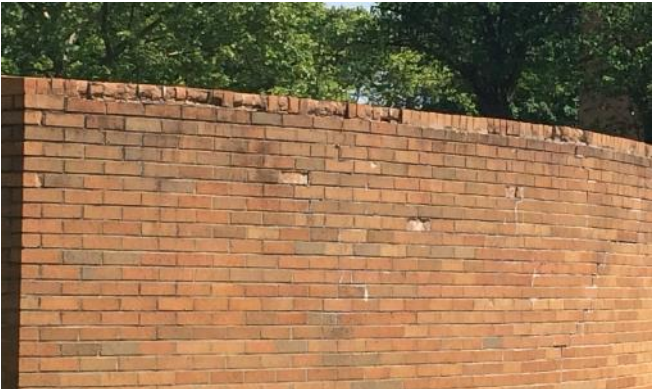
Spalling brick

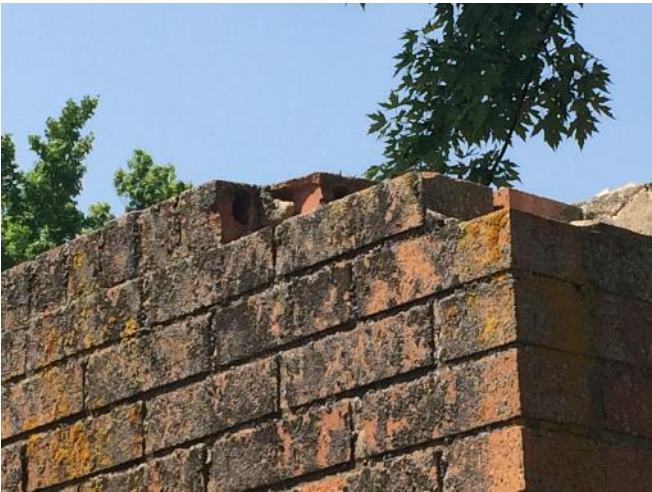
Deteriorating wall

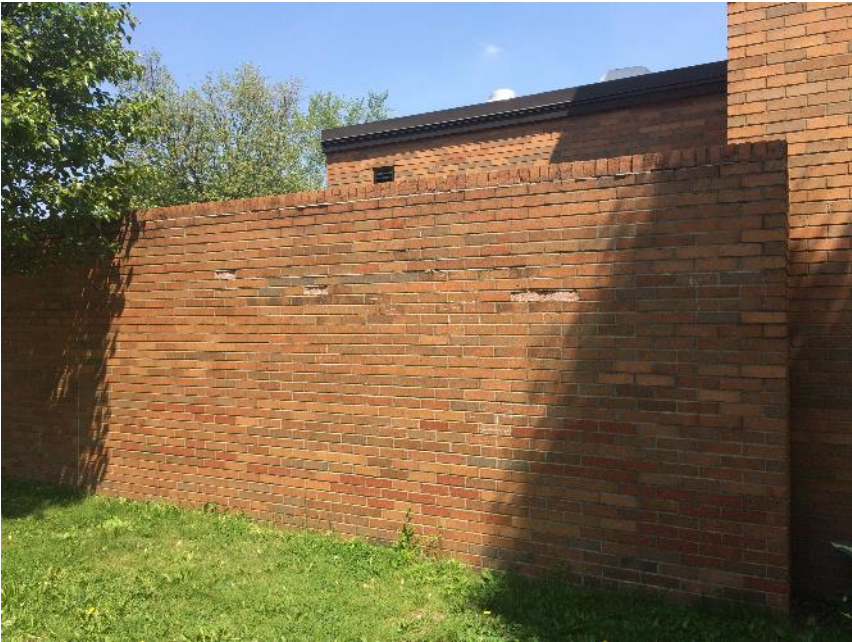
Spalling brick

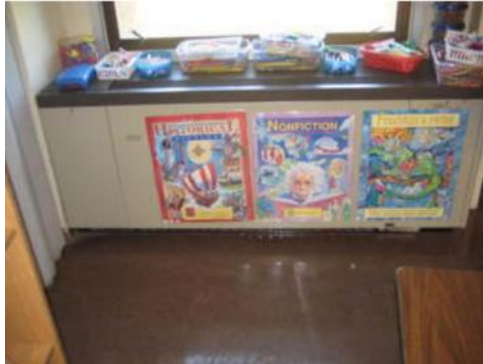
HVAC system does not provide 15 CFM fresh air per OBC

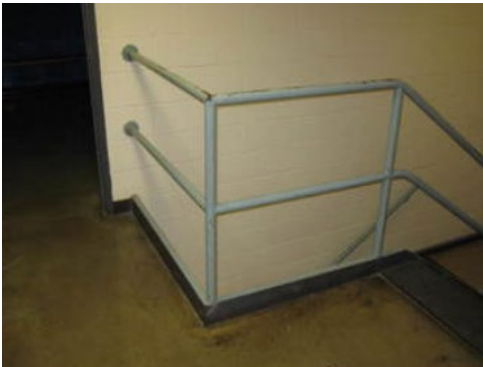
Guard/Handrail not code compliant

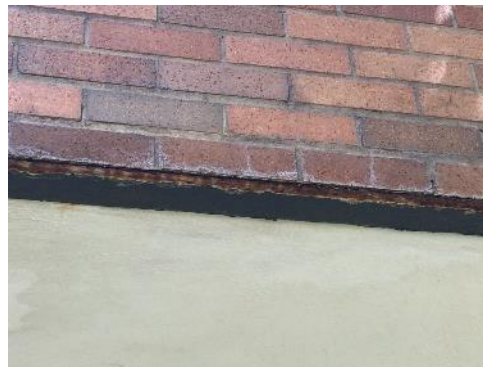
Rusted/delaminated lintel

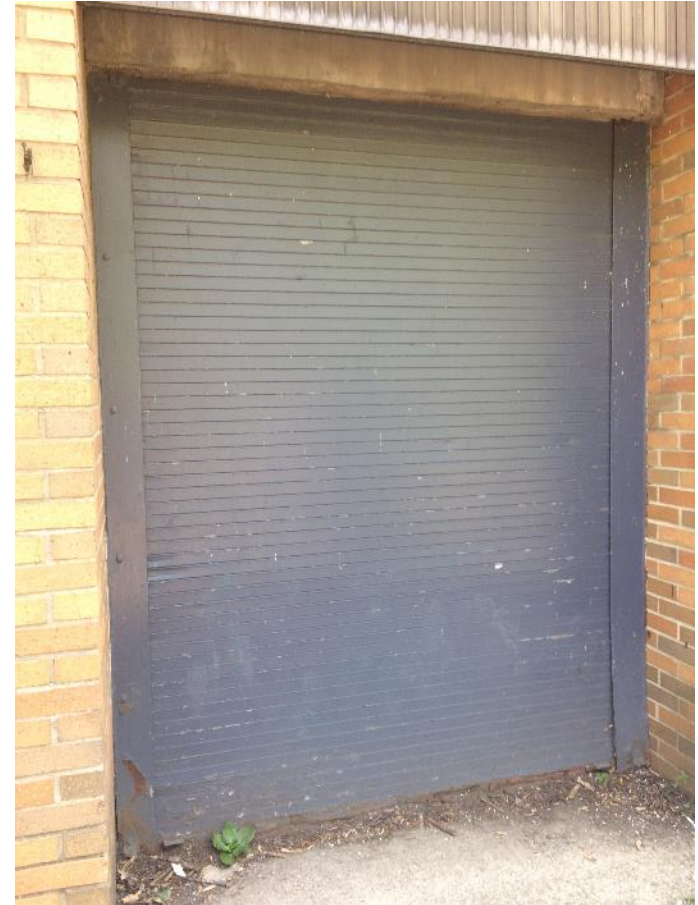
Exterior doors in poor condition

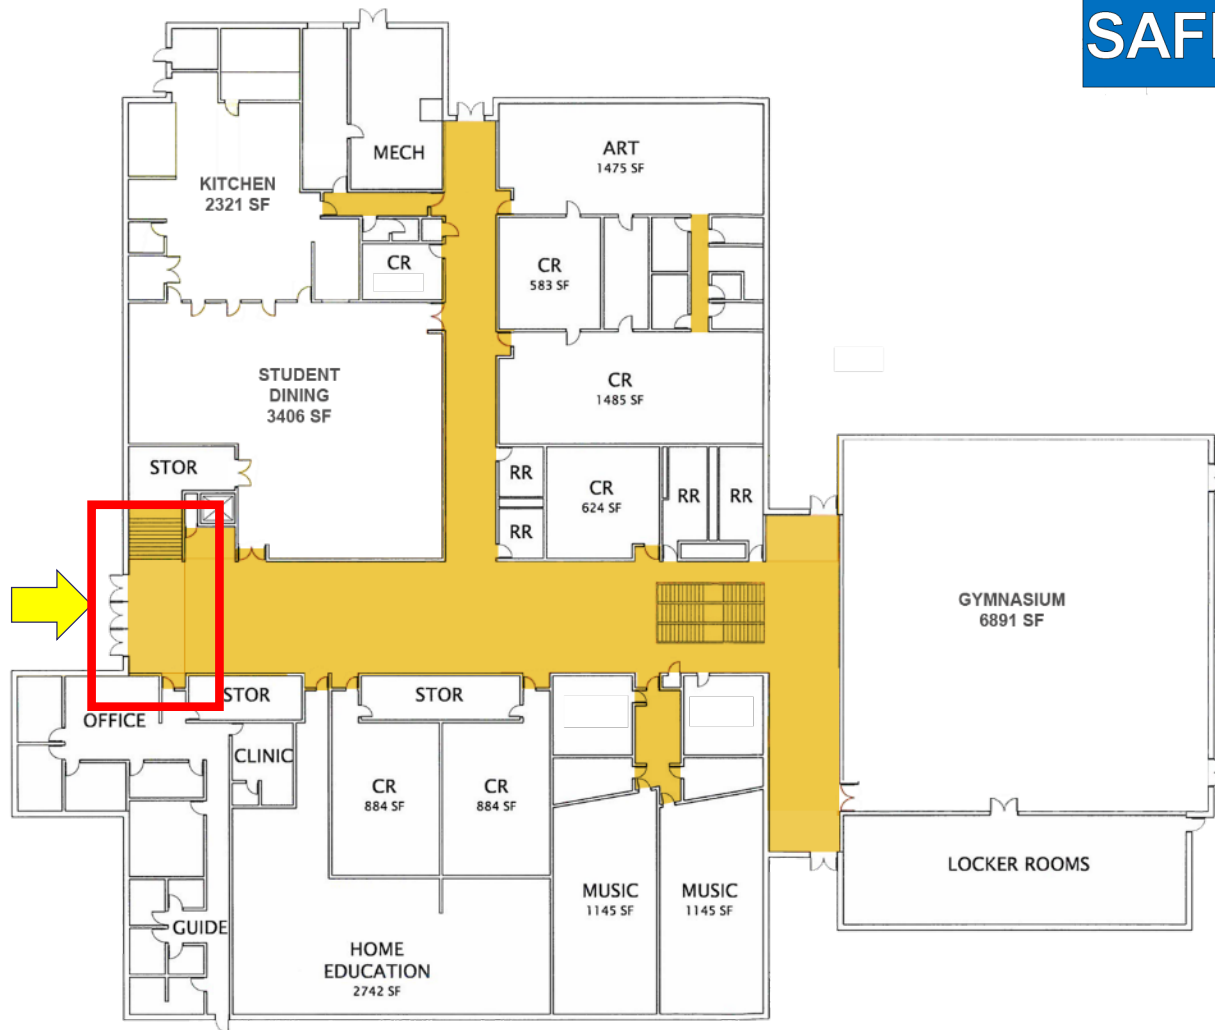
- Main office is located near to main entrance
- A secure vestibule is not present at main entrance
- Corridor generally provide good line of site, but there are a few bends limiting visual supervision
- Restroom design does not provide sinks in a common area on the outer portion of the bathrooms so adults can better supervise kids

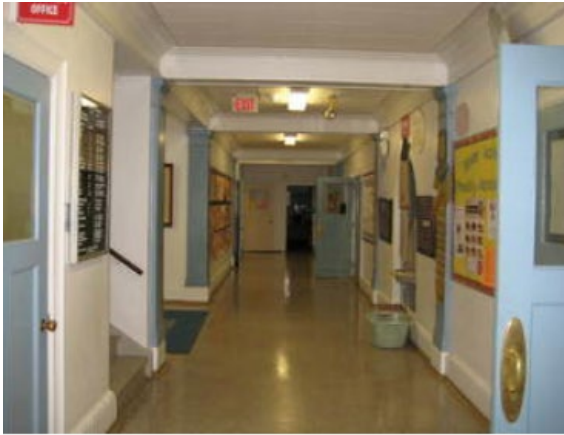
General Finishes in
Worn condition

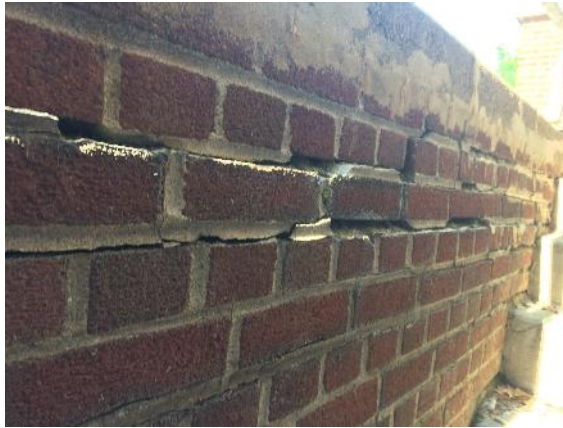
Retaining wall deteriorating

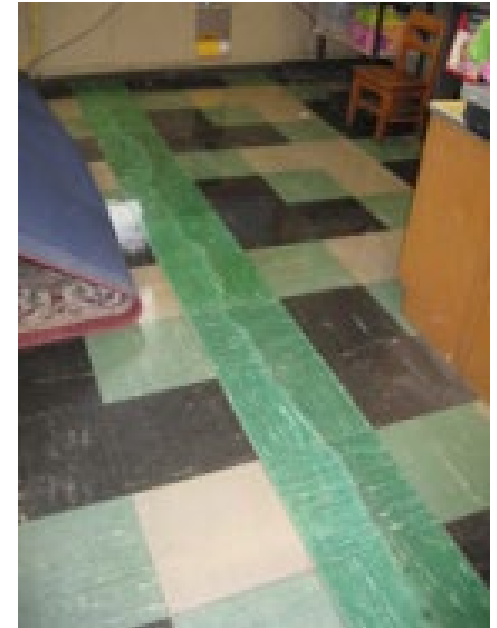
Floor crack due to
settlement

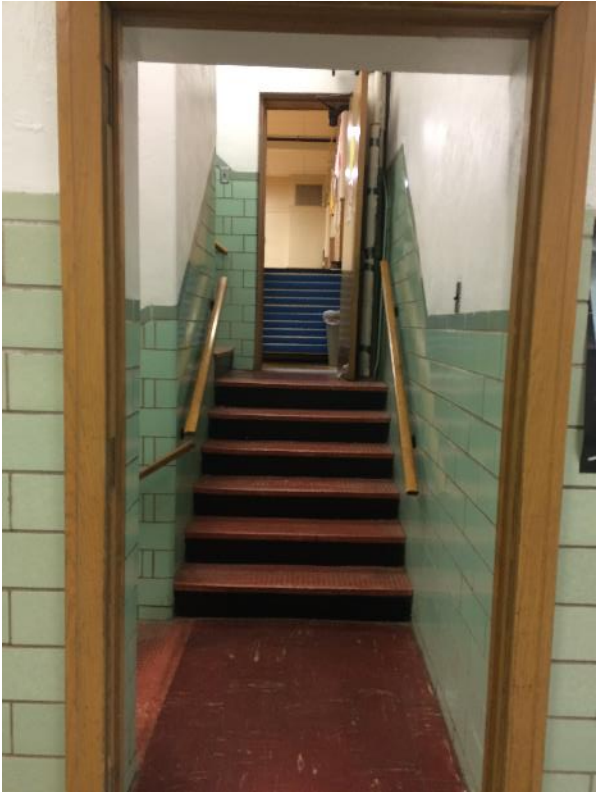
ADA barriers with multiple stories and level changes

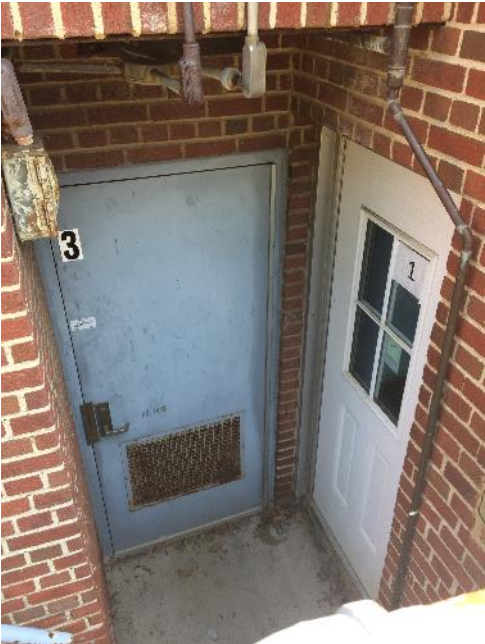
Exterior doors in worn out condition

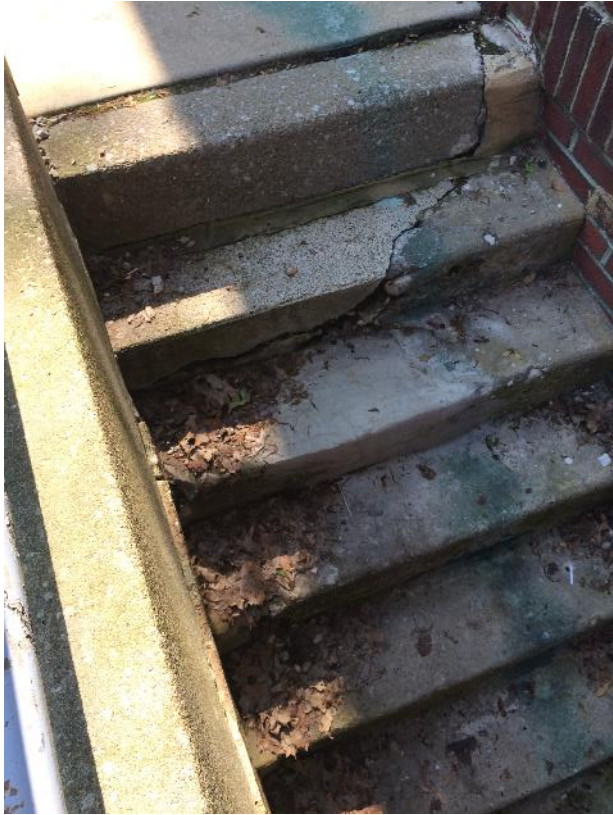
Concrete steps deteriorating

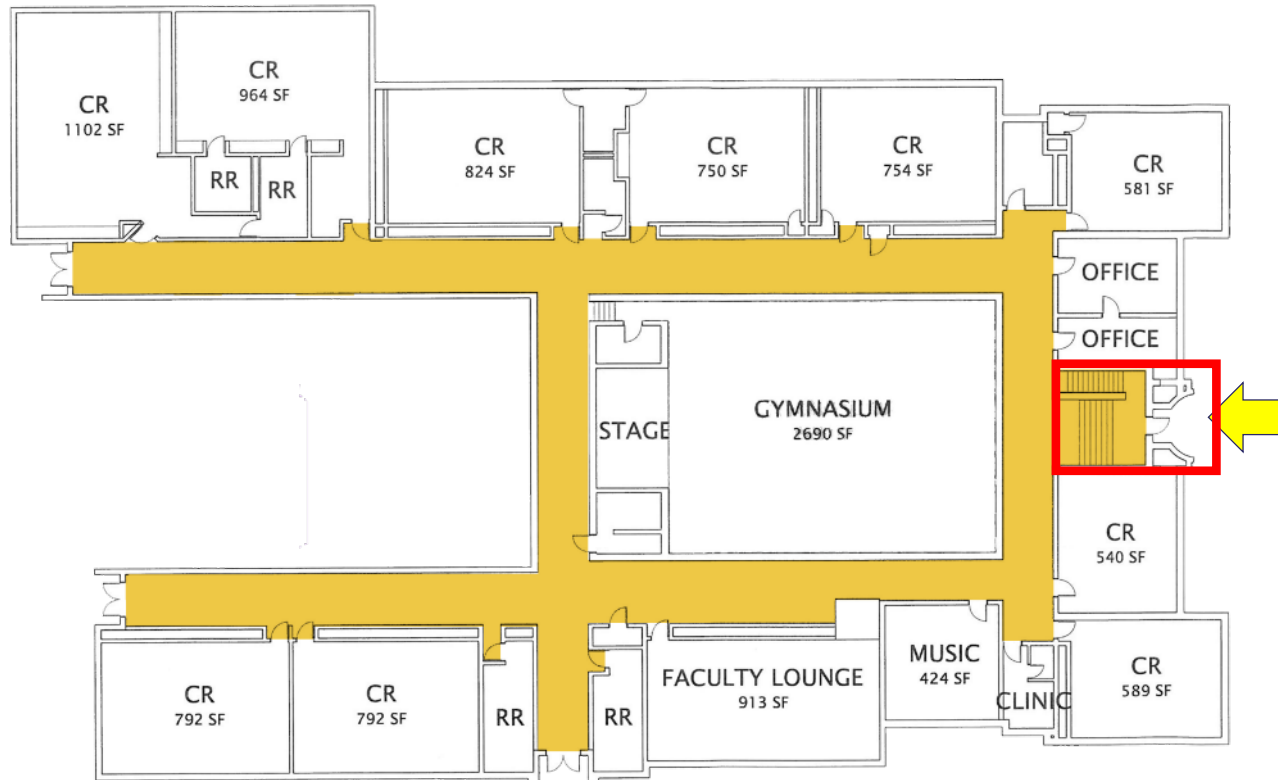
- Main office is located a half level above main entrance
- A secure vestibule is not present at main entrance
- Corridors provide generally a good line of sight for supervision
- Restroom design does not provide sinks in a common area on the outer portion of the bathrooms so adults can better supervise kids
