Cuyahoga Falls City Schools

Facilities Committee Meeting #6

November 29, 2018

Lincoln Elementary School– General Information

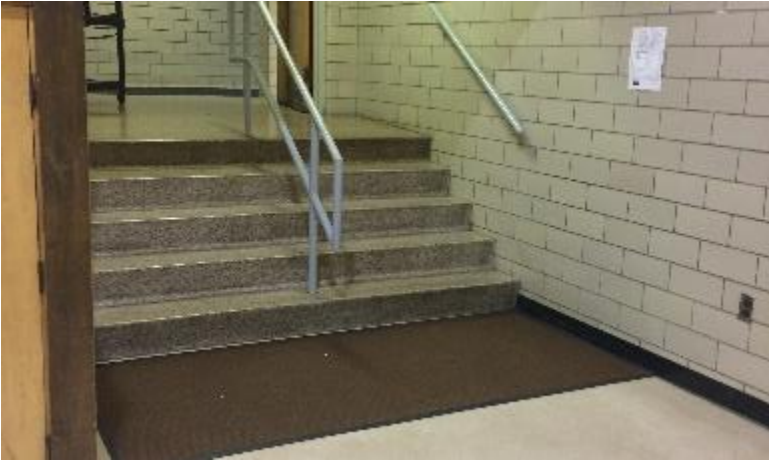
ADA barriers

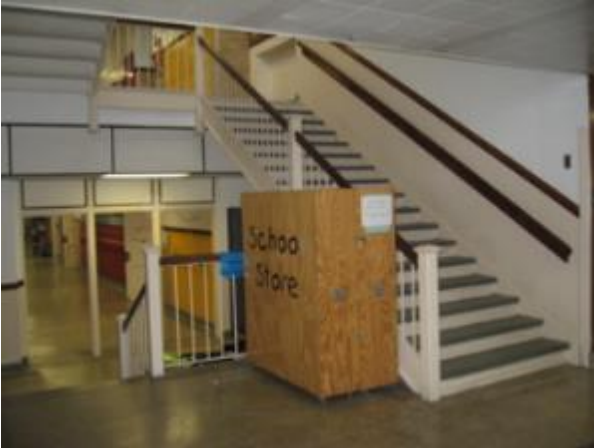
ADA barriers

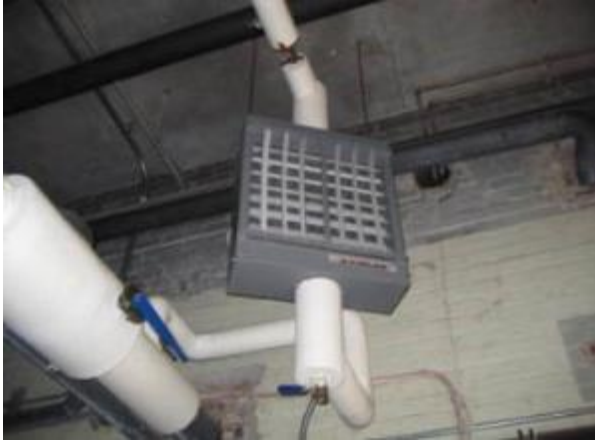
Heating water unit heater

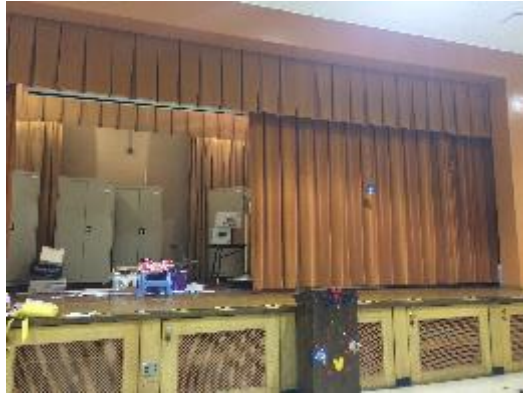
Dated worn out finishes

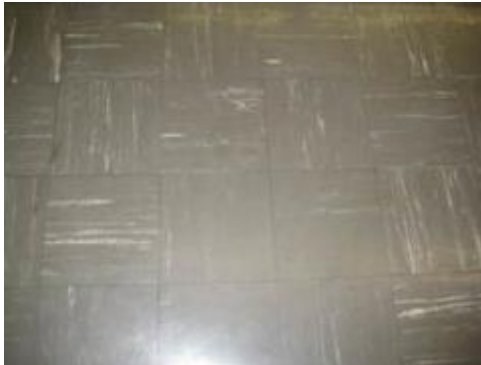
VAT – asbestos flooring

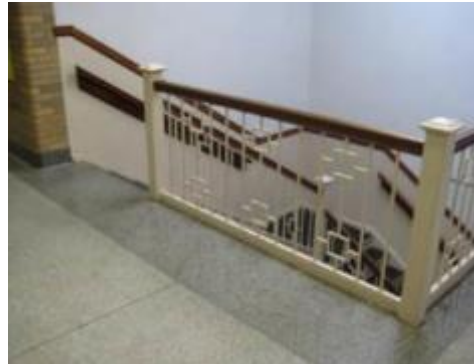
Non-Code compliant
hand/guardrails

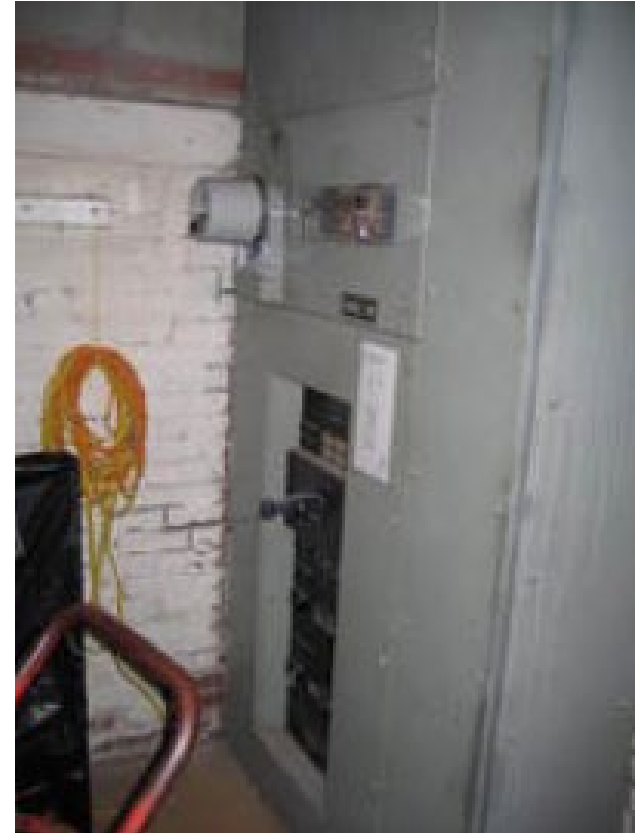
Main Electrical Distribution panel –
system cannot be expanded to
accommodate A/C

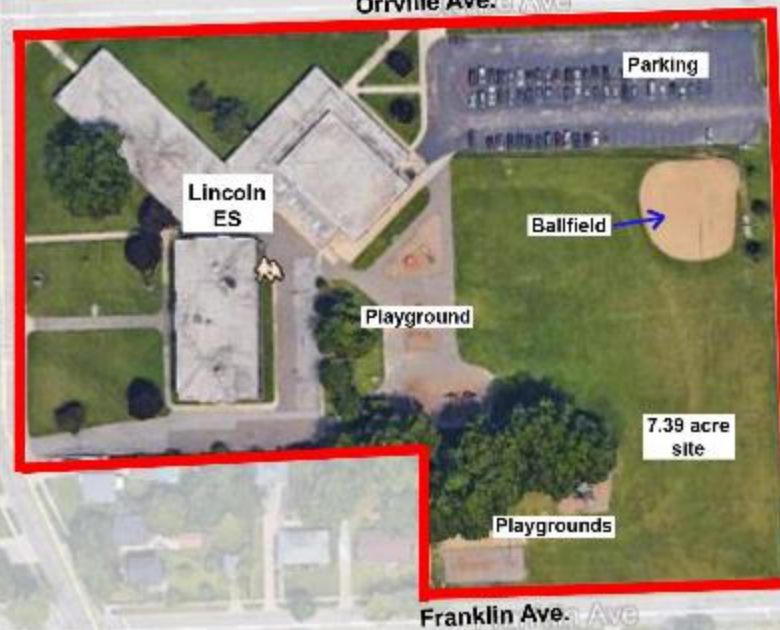
Lincoln Elementary School Site:

- Does not have a one-way Bus Loop - streetside pick-up/drop off
- Site is open, relatively flat and park-like setting
- Greenspace available - about 2.5 acres on the east end
- Site is embedded within residential neighborhood

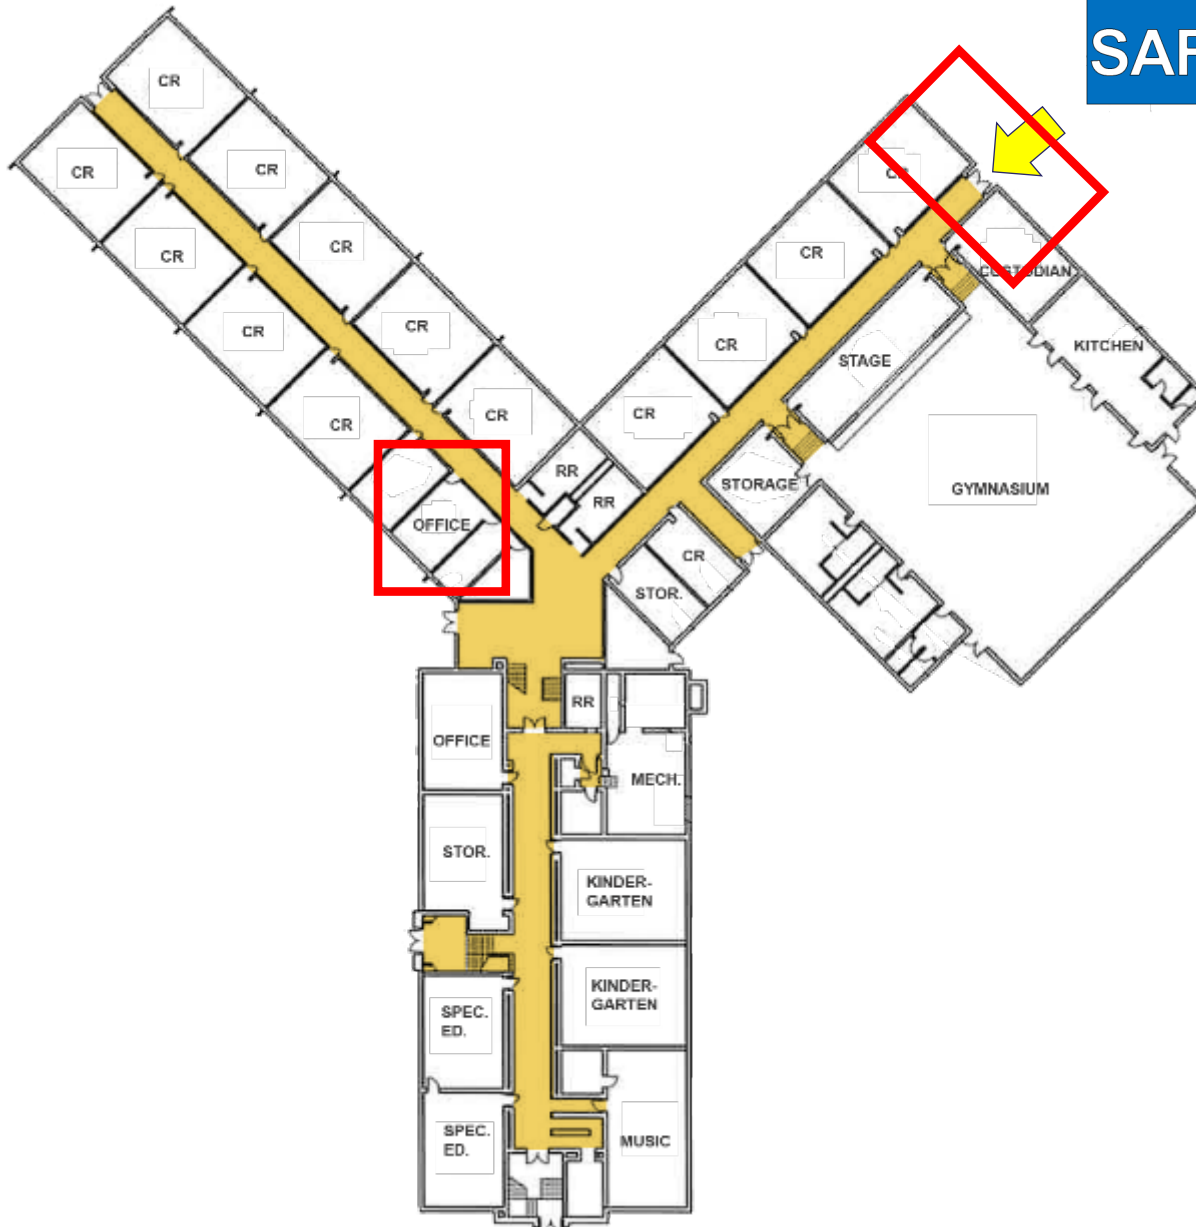
- Main office is very distant from the main entrance
- A secure vestibule is not present at main entrance
- Corridor generally provide good line of site, but there are some turns and bends and level changes limiting visual supervision
- Restroom design does not provide sinks in a common area on the outer portion of the bathrooms so adults can better supervise kids

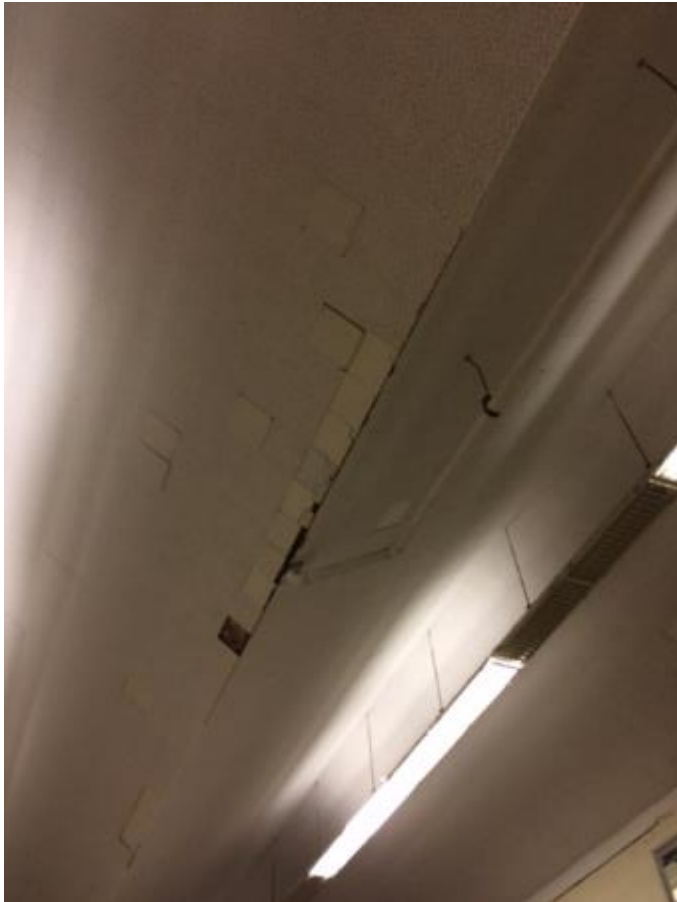
Gym roof tiles deteriorating from roof leaks

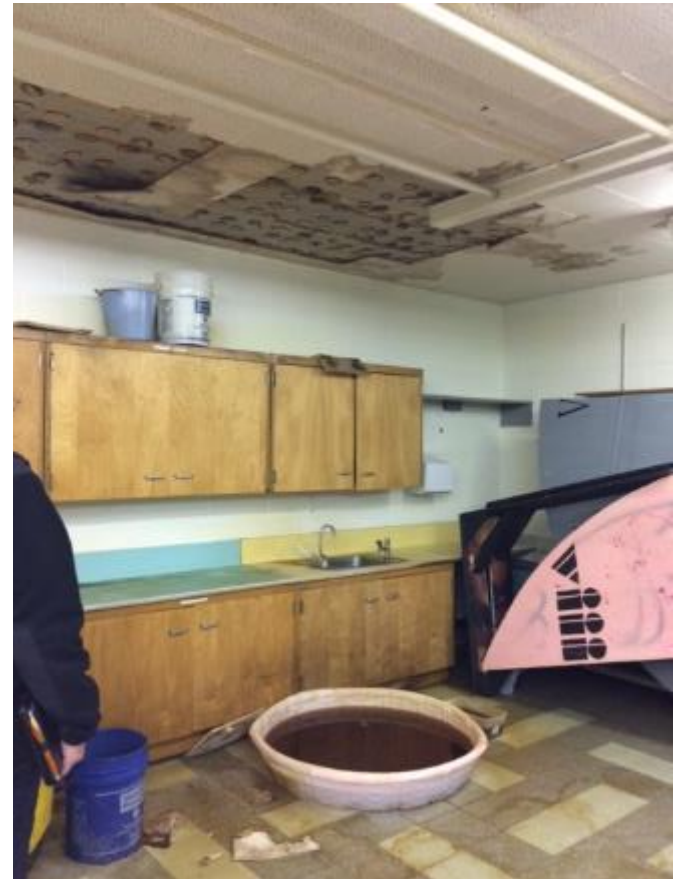
Significant Roof leaks and damage

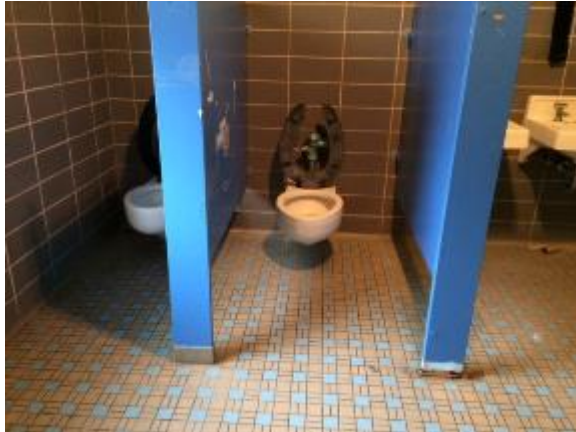
General finishes and fixtures worn

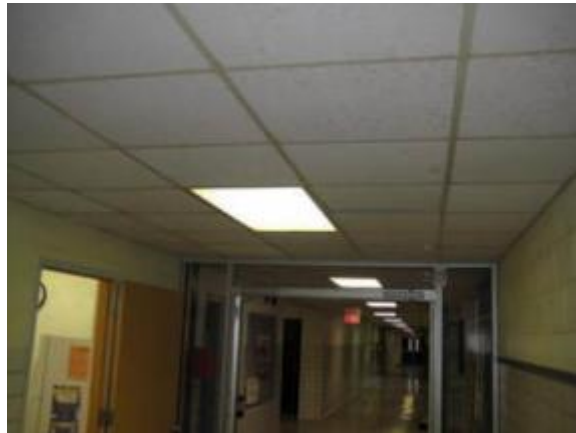
Light levels low compared to State recommendations

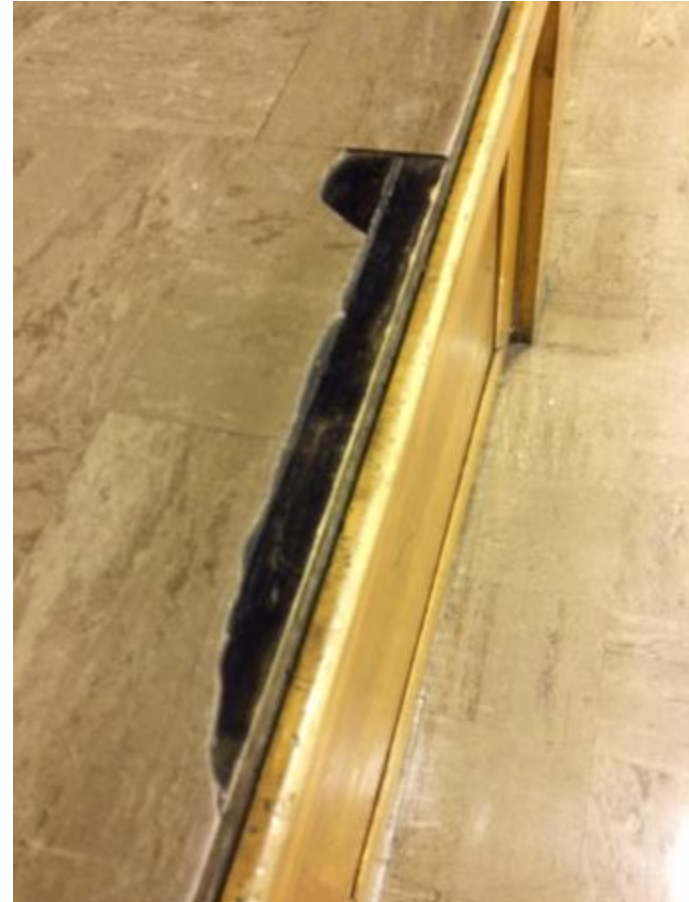
Damaged VAT (asbestos flooring)

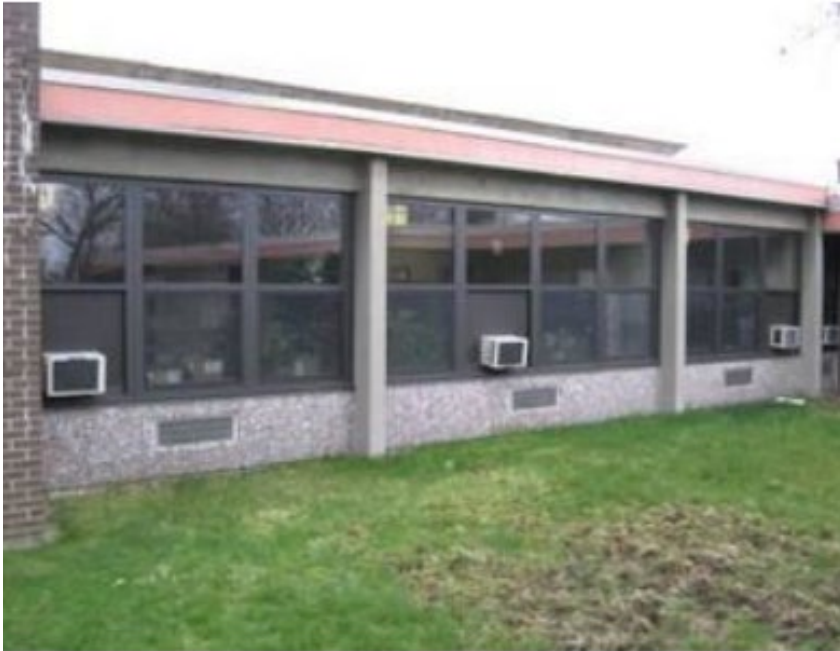
Insulated windows installed in 2003 and are in good condition

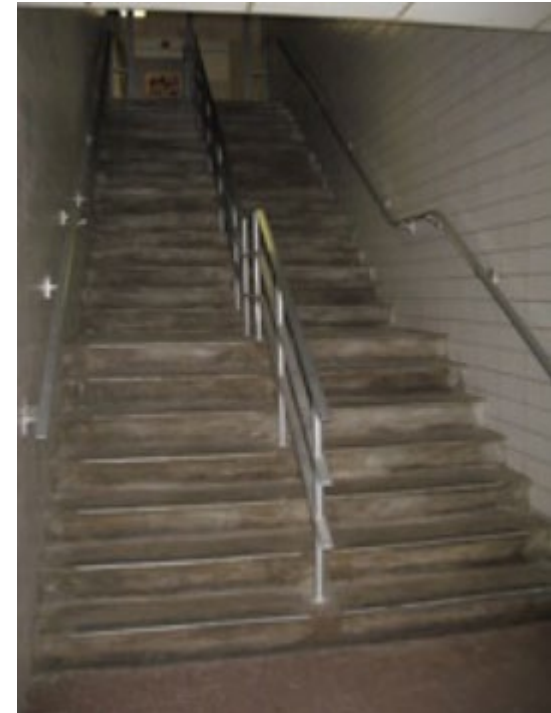
Stair handrails to lower level not code compliant

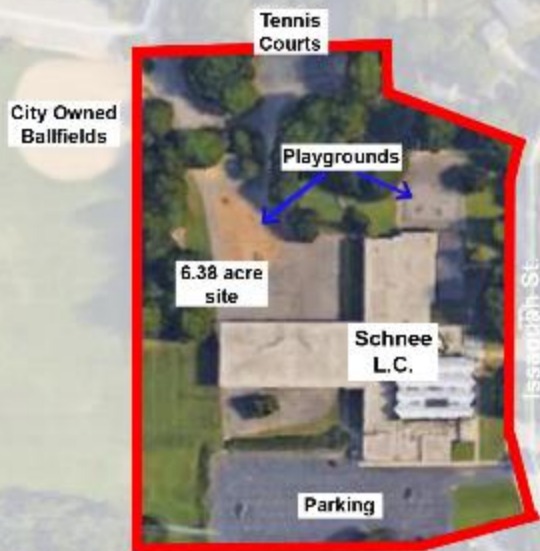
Schnee Learning Center Site:

- Does not have any Bus or Car Loop
- Site has significant slopes. Limited greenspace available.
- Adjacent ballfields on City property
- Only one entrance in and out of parking lot inhibits good good circulation patterns

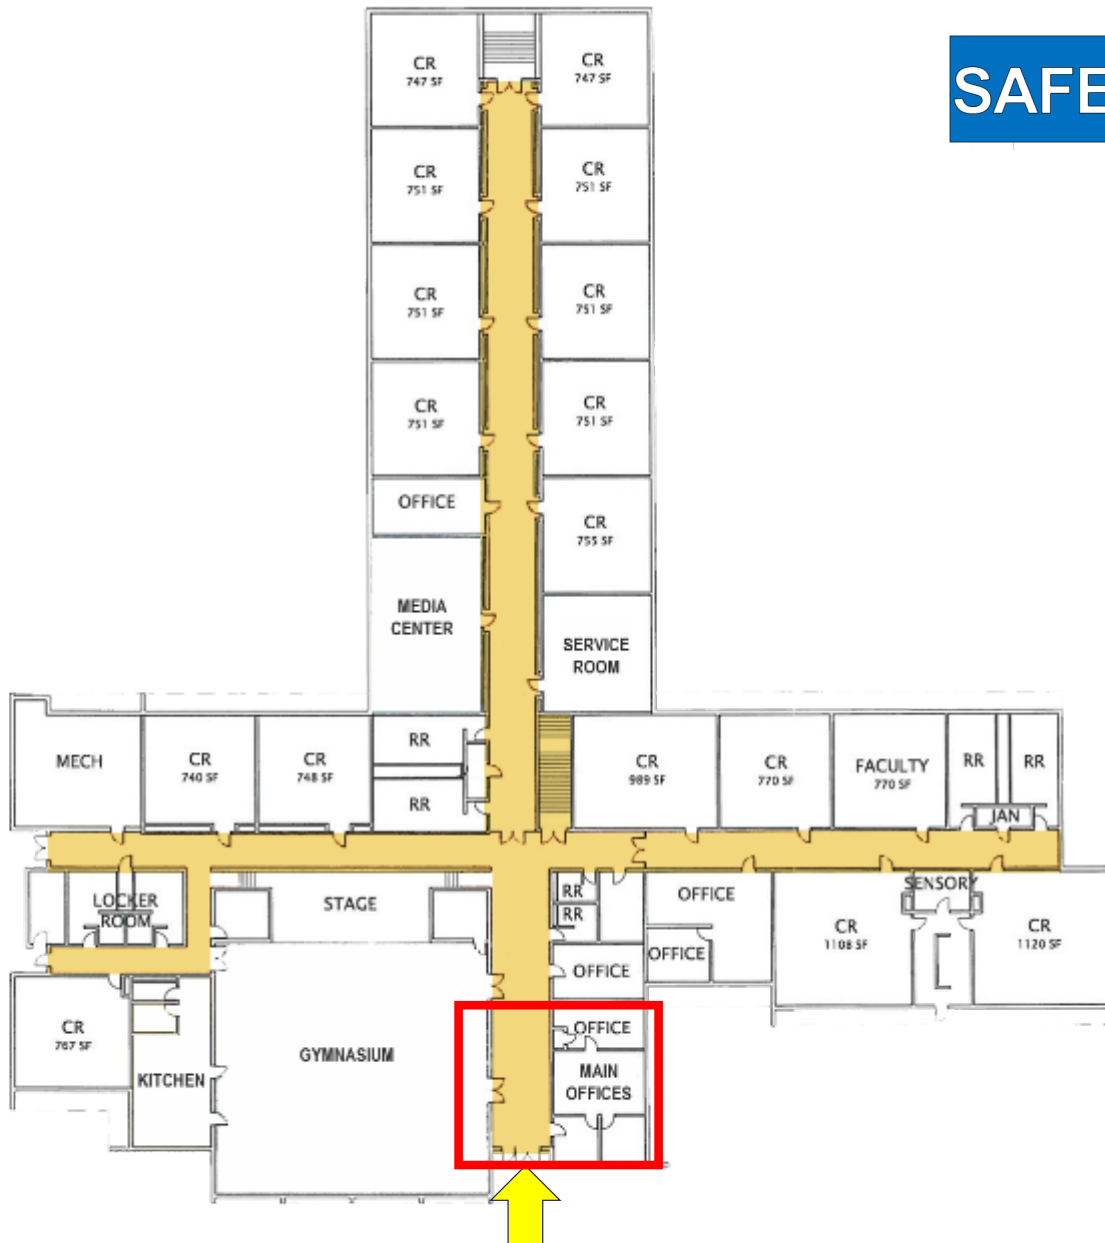
- Main office is directly adjacent to main entrance
- A secure vestibule is not present at main entrance
- Corridor design provides a great line of site sight for supervision
- Restroom design does not provide sinks in a common area on the outer portion of the bathrooms so adults can better supervise kids
