Cuyahoga Falls City Schools

Facilities Committee Meeting #8

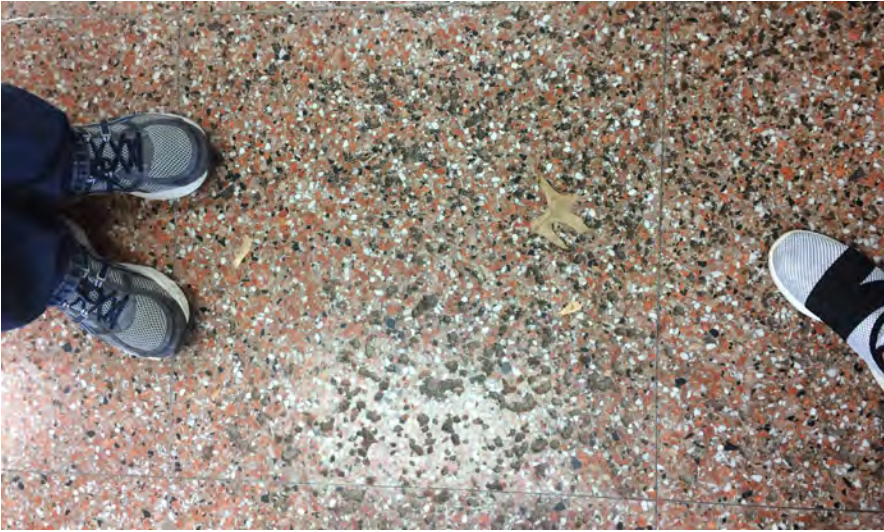
Preston Elementary School – Condition

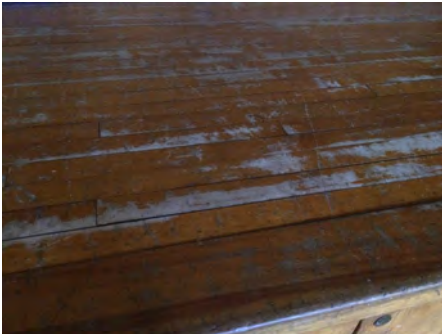
Wood floor in worn condition

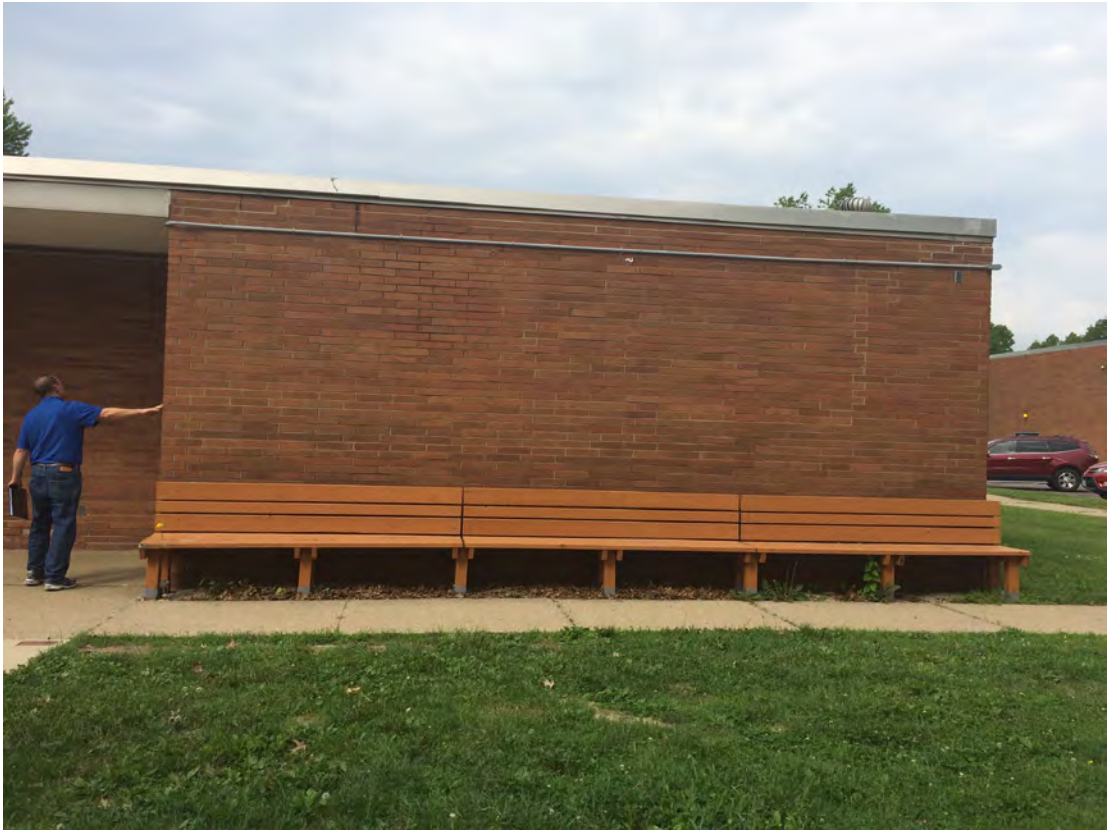
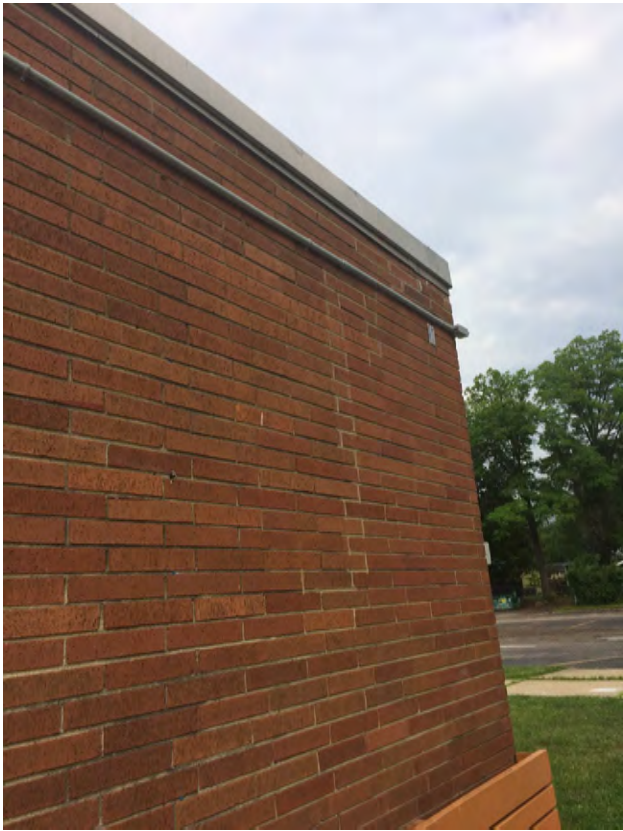
Preston Elementary School Site:

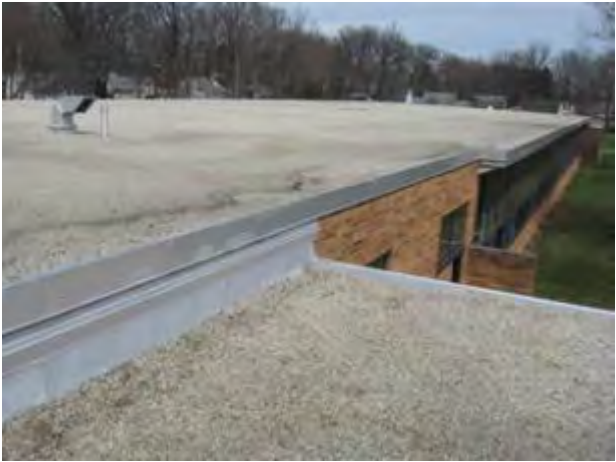
Built-up roofs need replacement

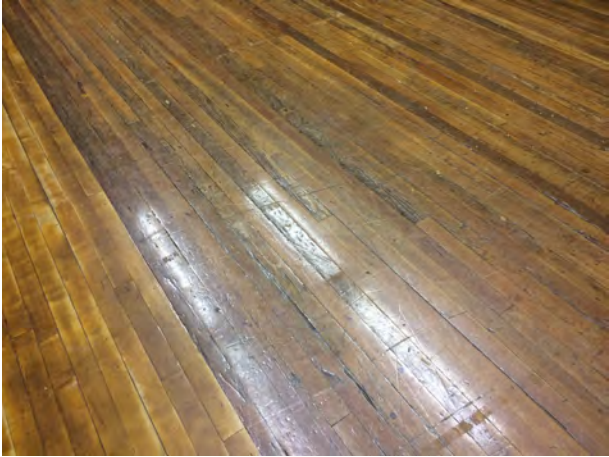
Wood flooring in poor condition

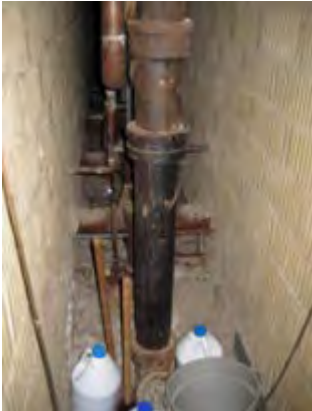
Main sanitary sewer recently had section collapse

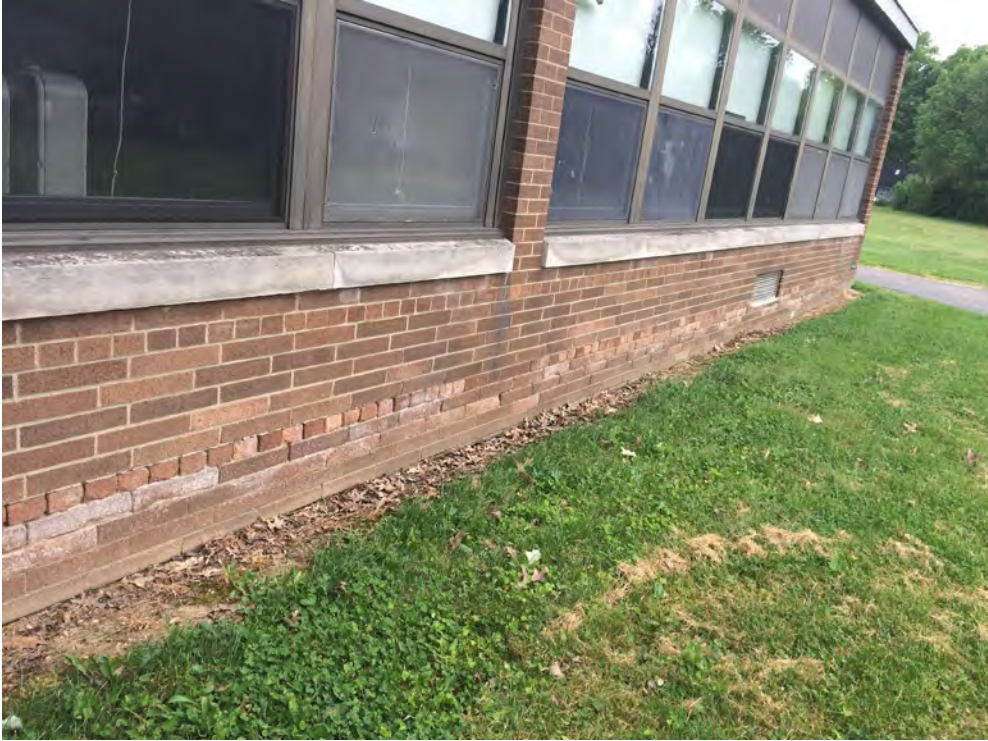
Masonry and mortar deterioration

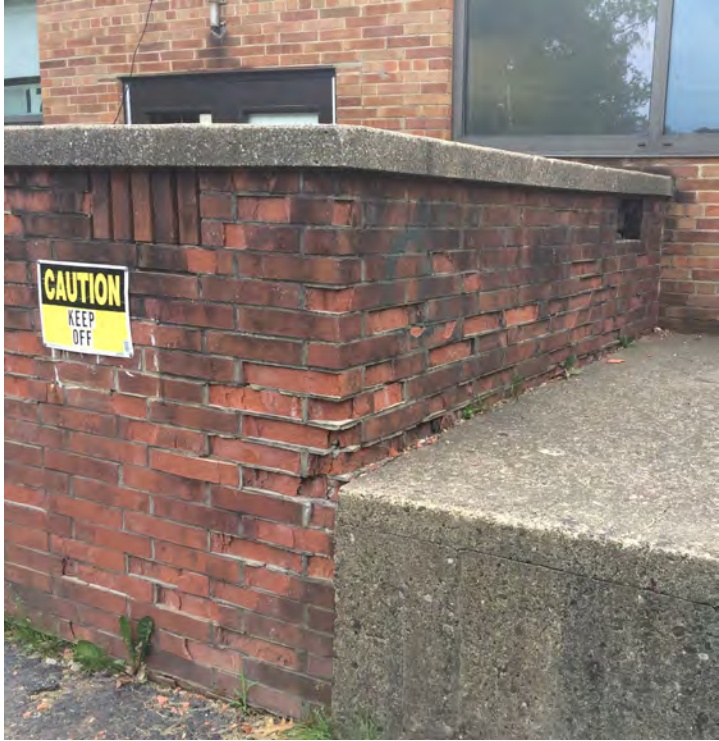
Spalling brick in poor condition
