Building Information - Cuyahoga Falls City (43836) - Elizabeth Price Elementary

Building Construction Information - Cuyahoga Falls City (43836) - Elizabeth Price Elementary (10215)

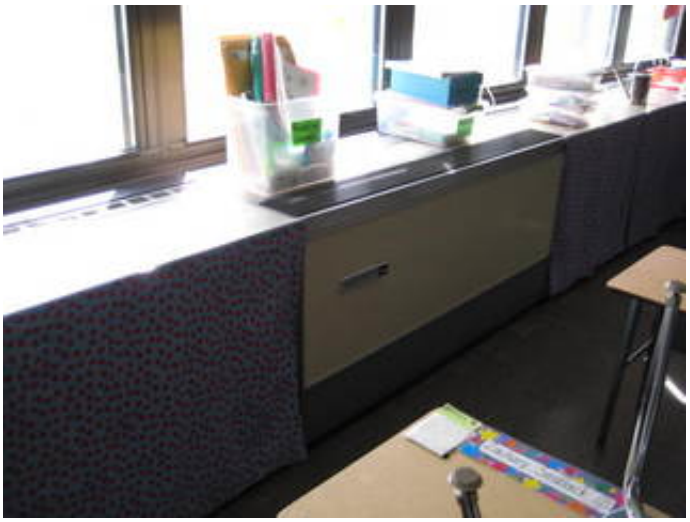
Description: The existing system for the 1953 Original Construction is a natural gas fired heated water boiler type system, installed in 1953, and is in fair to poor condition. The system in the 1963 Addition is an extension of that found in the 1953 Original Construction. 2-pipe vs. 4-pipe designations are not applicable in this facility, as no central air conditioning is provided. The two (2) cast iron boilers, manufactured by American-Standard, were installed in 1953 and are in poor condition. Heating water is distributed to terminal units consisting of unit ventilators, cabinet heaters, unit heaters, air handlers, and fin tubes. The terminal equipment is original to each addition and is in fair to poor condition. The system does not comply with the 15 CFM per person fresh air requirements of the Ohio Building Code mechanical code and Ohio School Design Manual. The pneumatic type system temperature controls are original to each addition, with upgrades in 1999, and are in fair condition. The system does not feature individual temperature controls in all spaces required by the OSDM. The overall system does not feature any central energy recovery systems. The facility is not equipped with louvered interior doors to facilitate Corridor utilization as return air plenums. The existing system is not ducted, except for the Multi-Purpose Room (Student Dining / Gymnasium), and floor to structural deck heights in the 1953 Original Construction will not accommodate the installation of properly sized ductwork for a future Ohio School Design Manual approved system. Floor to structural deck heights in the 1964 Addition and the remainder of the 1953 Original Construction will accommodate the installation of properly sized ductwork for a future Ohio School Design Manual approved system. The existing system in the Multi-Purpose Room (Student Dining / Gymnasium) is ducted, but the ductwork cannot be integrated into a possible future system due to arrangement, air volume, and routing of existing ductwork. The overall heating system is evaluated as not being in safe and efficient working order, and long term life expectancy of the existing system is not anticipated. The structure is not equipped with a central air conditioning system. The site does not contain underground fuel tanks.

Rating: 3 Needs Replacement

Natural Gas Fired Heated Water Boilers

Unit Ventilator

Recommendations: Provide new overall heating, ventilating, and air conditioning system to achieve compliance with Ohio Building Code and Ohio School Design Manual standards. Convert the overall facility, except for the Multi-Purpose Room (Student Dining / Gymnasium) to a ducted system to facilitate efficient exchange of conditioned air. Replace existing ductwork in the Multi-Purpose Room (Student Dining / Gymnasium) to facilitate efficient exchange of conditioned air with pricing included in conversion to ducted system replacement. Provide architectural soffits in the 1953 Original Construction Corridors to accommodate the installation of ductwork, with funding provided in conversion to ducted system replacement.

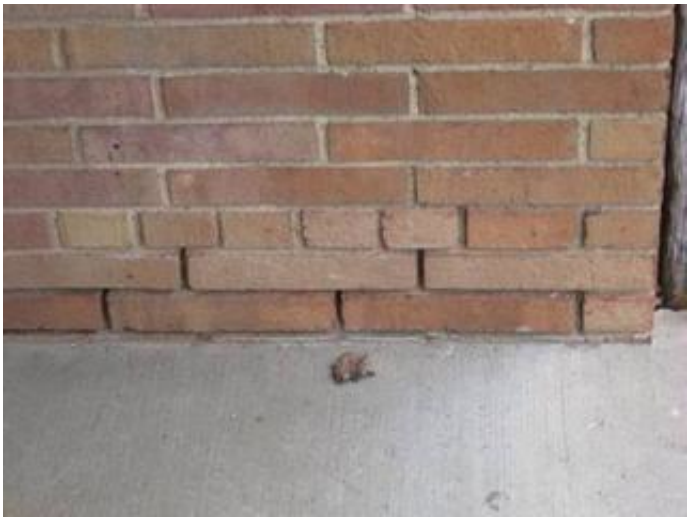
Description: The overall facility is equipped with concrete masonry unit foundation walls on concrete footings, which displayed no locations of significant differential settlement, cracking, or leaking, and are in good condition. The District reports that there has been no past leaking. No grading or site drainage deficiencies were noted around the perimeter of the structure that are contributing or could contribute to foundation / wall structural deterioration. 06-22-18 Assessment Update: School district personnel reported, and it was observed, there is storm water infiltration along the North elevation (running east and west) of the classroom wing of 1953 Original Building.

Rating: 2 Needs Repair

Condition of Exterior Wall at Sidewalk

Typical Condition of Exterior Wall at Grade

Recommendations: Existing conditions require no renovation or replacement at the present time. 06-22-18 Assessment Update: School district personnel reported, and it was observed, there is storm water infiltration along the North elevation (running east and west) of the classroom wing of 1953 Original Building.

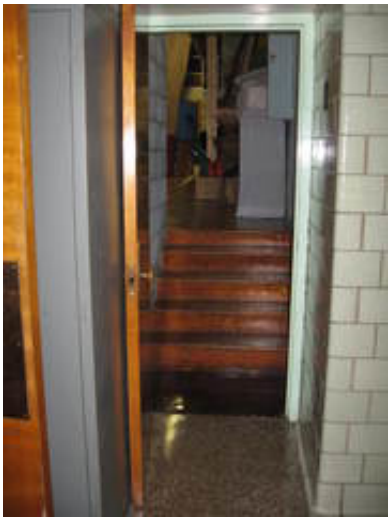
Rating: 2 Needs Repair

Narrow Opening and Steps At the Stage

Drinking Fountain and Staff Toilet

Recommendations: Provide an ADA-compliant power assist door opener, 1 chair lift, 1 electric water cooler, 6 toilets, 6 sinks, 1 urinal, 6 toilet accessories, 27 doors and frames in the overall facility to facilitate the school's meeting of ADA requirements. Add new ADA compliant handrails at steps to the Stage. Provide funding for removal of existing glazed block screen walls in both Student Locker Restrooms. Enlarge and reconfigure 4 new single ADA Toilet Rooms for the Kitchen, Health Clinic, Staff, and Kindergarten, including 4 toilets, 4 sinks and 4 sets of ADA accessories. Add 1 new single ADA Toilet Room for the Special Education Classroom, including 1 toilet, 1 sink, and 1 set of ADA accessories. Toilet partitions issues are corrected in Item J. ADA compliant sink base casework in the Classrooms are corrected in Item J. For interior doors that are not being replaced under this Item, door hardware to be replaced with funding provided in Item J. 10-02-14 Update: Change handicapped restroom conversion allowance from $10,000 for each restroom to $16,761.00 for each restroom. Add Allowance of $25,707.00 for converting space to handicapped accessible Family Restroom.06-22-18 Assessment Update: Replace ADA signage with new

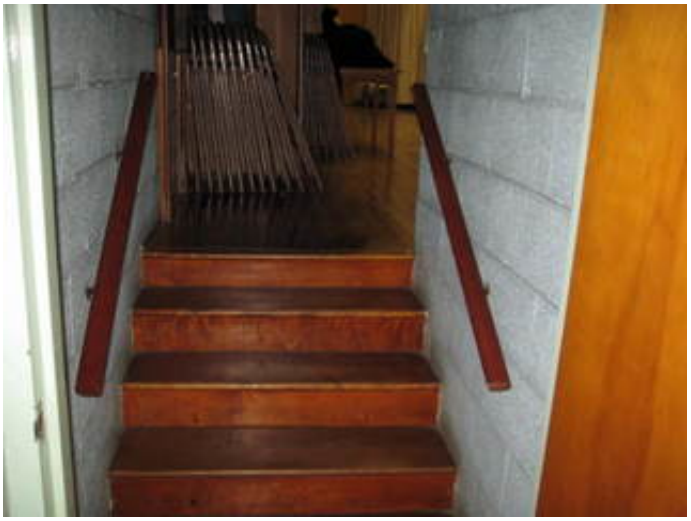
Rating: 3 Needs Replacement

Stage Non-compliant Handrails

Wall Cabinet and Fire Extinguisher

Recommendations: Provide new automated fire suppression system to meet Ohio School Design Manual guidelines. Provide increased water service of a capacity sufficient to support the fire suppression system, with funding included in fire suppression funding. Provide new emergency generator, with funding provided via complete replacement of electrical system in Item D. Provide new handrails to meet the requirements of the Ohio Building Code. Provide new guardrails to meet the requirements of the Ohio Building Code. Provide additional wall cabinets and fire extinguishers. Provide the new Kitchen hood with a UL 300 compliant wet chemical fire suppression system, with funding provided in Item J. Provide the interlock to de-energize cooking equipment upon discharge of the Kitchen hood fire suppression system, with funding provided in Item J. 10-02-14 Update: Existing 3'' water service not sufficient to support sprinkler system. Provide new water service for fire protection. Water meter is 1-12'' and will need to be increased in size to meet fire protection flow requirements. Replace water meter. 06-22-18 Assessment Update: Delete water meter. Add a backflow preventer to support new fire line service for fire suppression system. Revise handrail quantity from 1 to 2 to provide handrail at stage stairs.
