Building Information - Cuyahoga Falls City (43836) - Bolich Middle

Program Type	Classroom Facilities Assistance Program (CFAP) - Regular
Setting	Suburban
Assessment Name	Bolich_Middle_June_2009_Jan_2015_EEA_June_2018_Desktop_Update
Assessment Date (on-site; non-EEA)	2015-01-06
Kitchen Type	Full Kitchen
Cost Set:	2018
Building Name	Bolich Middle
Building IRN	3103
Building Address	2630 13th Street
Building City	Cuyahoga Falls
Building Zipcode	44223
Building Phone	(330) 926-3801
Acreage	35.00
Current Grades:	6-8
Teaching Stations	48
Number of Floors	2
Student Capacity	640
Current Enrollment	629
Enrollment Date	2009-05-19
Enrollment Date is the date in which the current enrollment was taken.	
Number of Classrooms	46
Historical Register	NO
Building's Principal	Mr. Michael Miller
Building Type	Middle

Harvey Bolich Middle School, which is not on the National Register of Historic Buildings, and originally constructed in 1953, is a 2 story, 96,768 square foot brick school building located in a suburban residential and commercial setting. The existing facility features a conventionally partitioned design, and does not utilize modular buildings. The structure of the overall facility contain

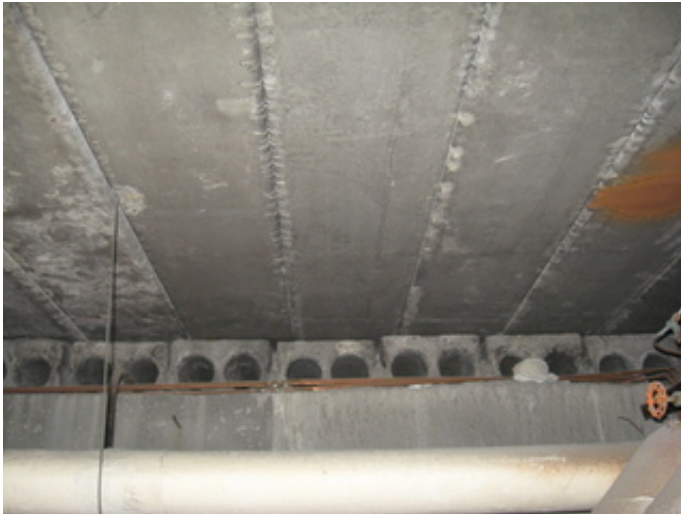
Floor Structure Of The Overall Facility

Recommendations: Existing conditions require no renovation or replacement at the present time.
