Building Information - Cuyahoga Falls City (43836) - Newberry Elementary

Program Type	Classroom Facilities Assistance Program (CFAP) - Regular
Setting	Suburban
Assessment Name	Newberry_ES_June_2009_Jan_2015_EEA_June_2018_Desktop_Update
Assessment Date (on-site; non-EEA)	2015-01-06
Kitchen Type	Full Kitchen
Cost Set:	2018
Building Name	Newberry Elementary
Building IRN	27029
Building Address	2800 13th Street
Building City	Cuyahoga Falls
Building Zipcode	44223
Building Phone	(330) 920-3621
Acreage	10.00
Current Grades:	PK-8
Teaching Stations	25
Number of Floors	1
Student Capacity	342
Current Enrollment	144
Enrollment Date	2009-04-14
Enrollment Date is the date in which the current enrollment was taken.	
Number of Classrooms	23
Historical Register	NO
Building's Principal	Mr. Walter Davis
Building Type	Elementary

Building Construction Information - Cuyahoga Falls City (43836) - Newberry Elementary (27029)

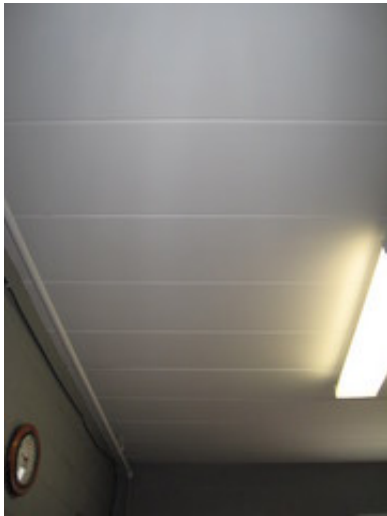
Typical Reinforced Precast Concrete Plank Roof Structure For the Overall Facility

Recommendations: Existing conditions require no renovation or replacement at the present time.

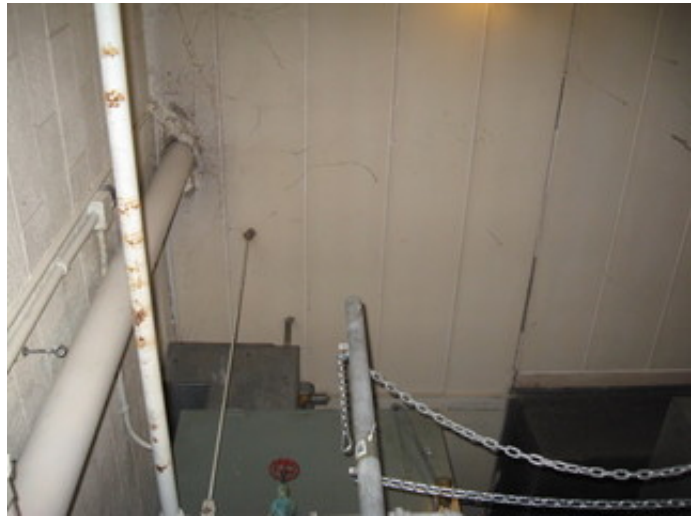
Reinforced Precast Concrete Plank Roof Structure Over the Stage

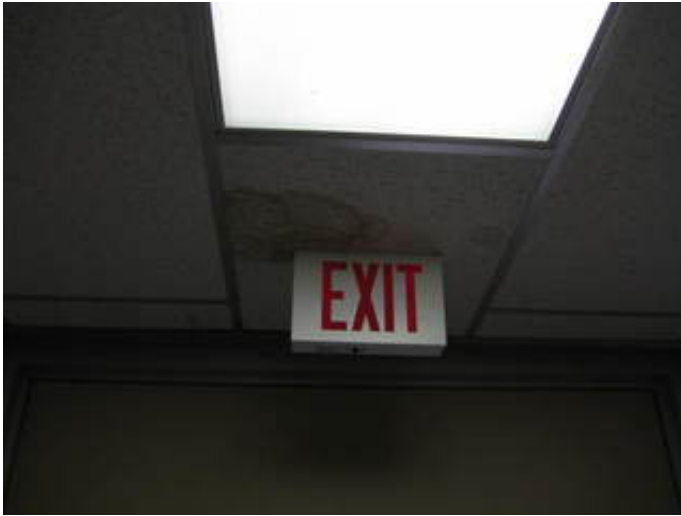
Compliant Illuminated Exit Sign

Recommendations: Provide complete replacement of emergency / egress lighting system to meet Ohio School Design Manual guidelines.

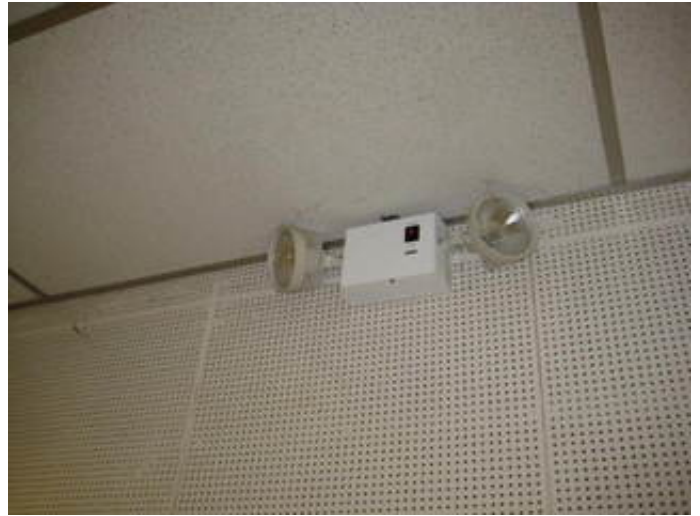
Emergency Egress Light Fixture

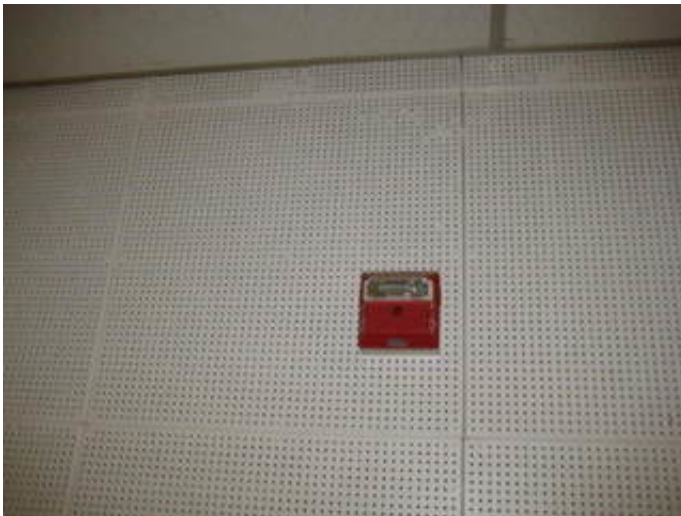
Fire Alarm System Horn and Strobe Indicating Device

Recommendations: Provide complete replacement of fire alarm system to meet OBC, NFPA, and Ohio School Design Manual guidelines.

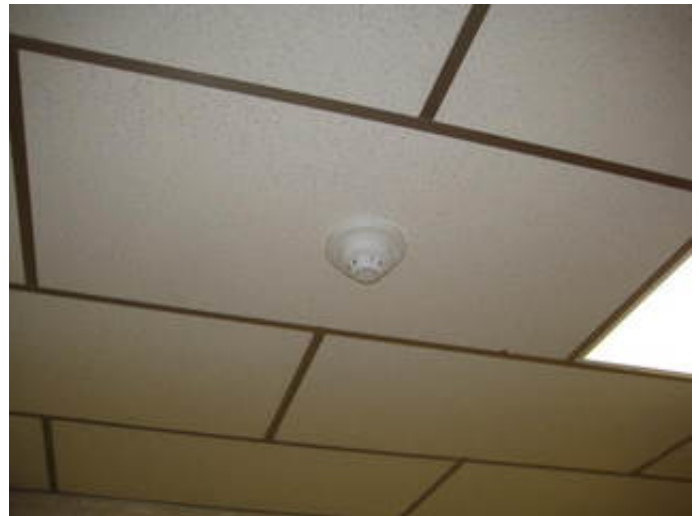
Fire Alarm System Smoke Detection Device

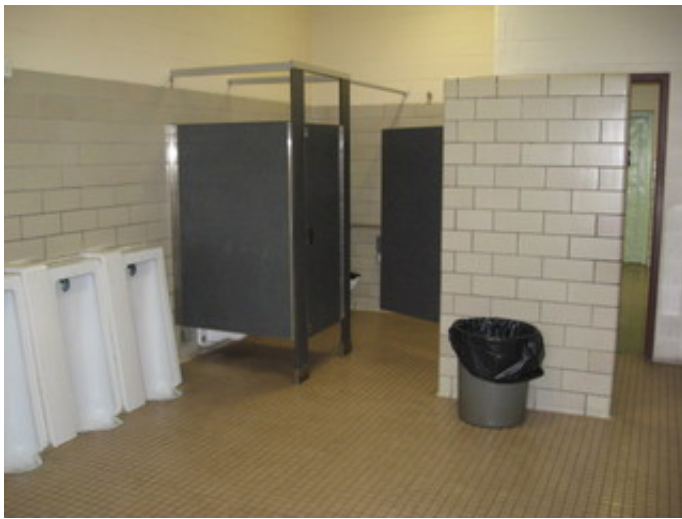
ADA Boy's Group Restroom

Other: Enlarge existing Restroom to meet ADA requirements	\$16,761.00	each		6 Required	2 Required	\$134,088.00	Enlarge existing Restroom to meet ADA requirements
Other: Replace Handrails	\$20.00	in.ft.		32 Required		\$640.00	Replace handrails at steps for ADA compliance.
Sum:			\$340,909.80	\$276,186.20	\$64,723.60

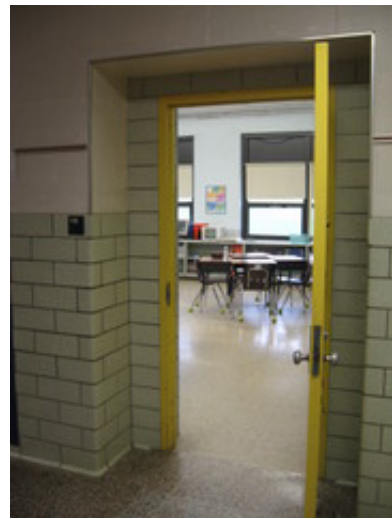
Typical Classroom Door

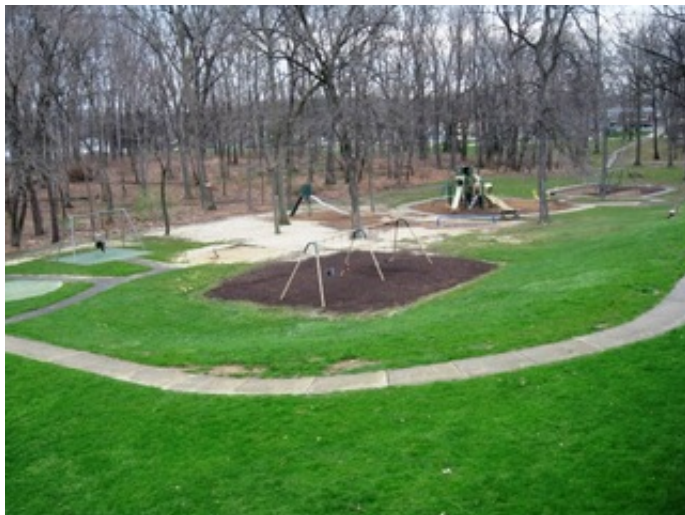
Playground Equipment

Provide Concrete Dumpster Pad:	\$2,400.00	each		1 Required		\$2,400.00	(for two dumpsters)
Base Sitework Allowance for Unforeseen Circumstances	\$50,000.00	allowance		Required		\$50,000.00	Include this and one of the next two. (Applies for whole building, so only one addition should have this item)
Sitework Allowance for Unforeseen Circumstances for buildings between 0 SF and 100,000 SF	\$1.50	sq.ft. (of entire building addition)		Required	Required	\$64,161.00	Include this one or the next. (Each addition should have this item)
Other: Replace Basketball Goals	\$1,200.00	each		2 Required		\$2,400.00	Replace basketball goals at the hard surface play area due to condition.
Sum:			\$295,800.36	\$263,467.32	\$32,333.04

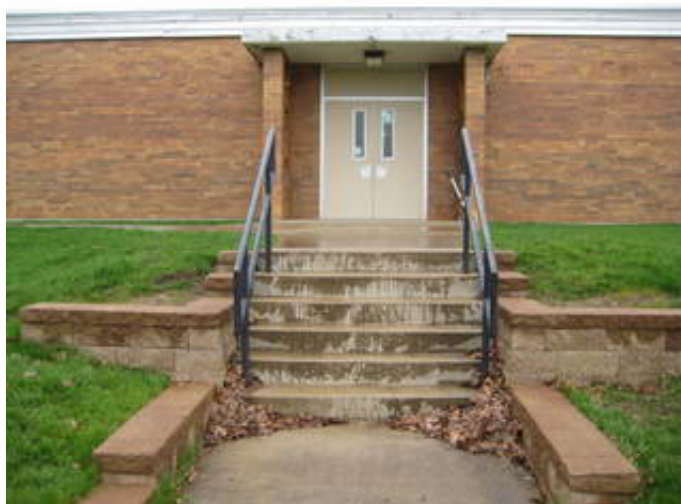
Exterior Stairs and Handrails

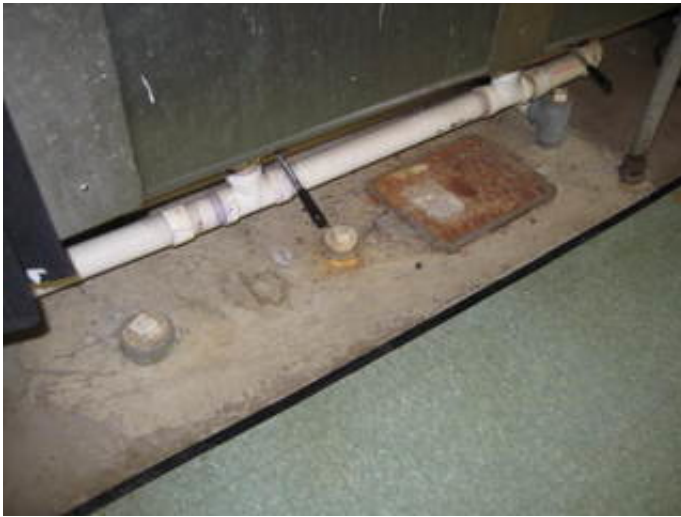
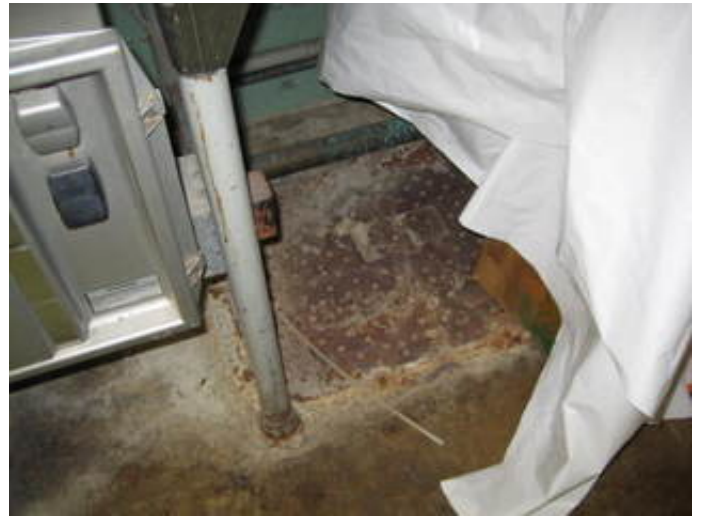
Kitchen Grease Trap Interceptor

Recommendations: Existing conditions require no renovation or replacement at the present time.

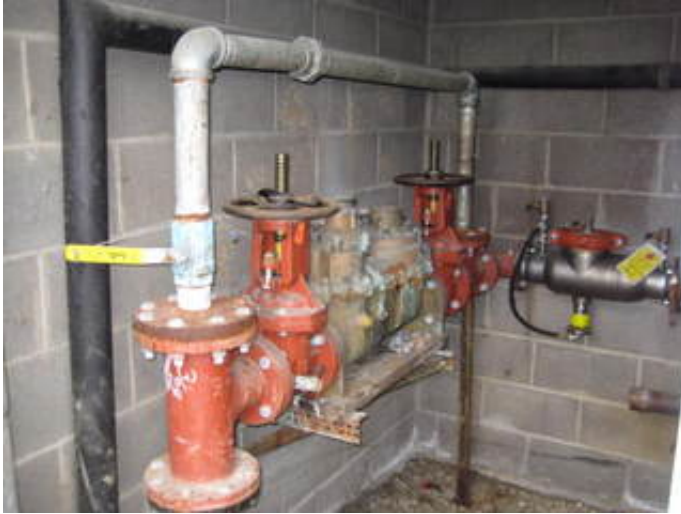
Incoming Domestic Water Service Line

Recommendations: Provide a new city water supply line of adequate capacity to support the existing needs of the facility, as well as a future automated fire suppression system. Funding provided in Item U.

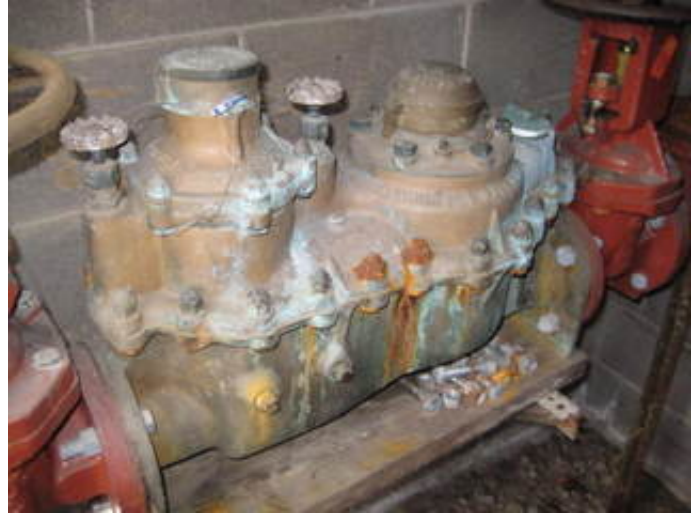
Incoming Domestic Water Service Meter

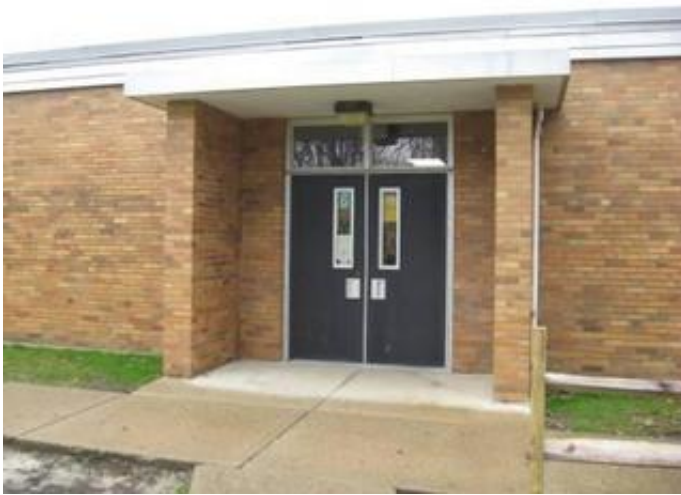
Typical Exterior Entry Door

Recommendations: Replace all hollow metal exterior doors and frames due to condition. Replace fire door identified in Item T. Replacement of single glazed exterior door vision panels is addressed in Item F.

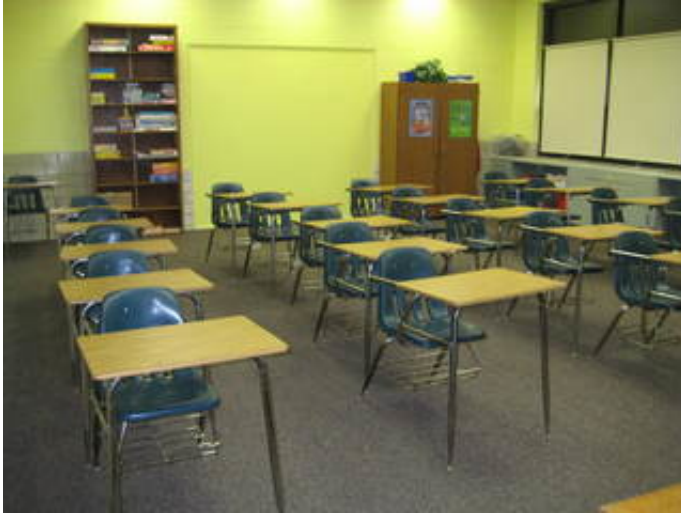
Typical Student Desk

Recommendations: Provide for replacement of outdated or inadequate furnishings.

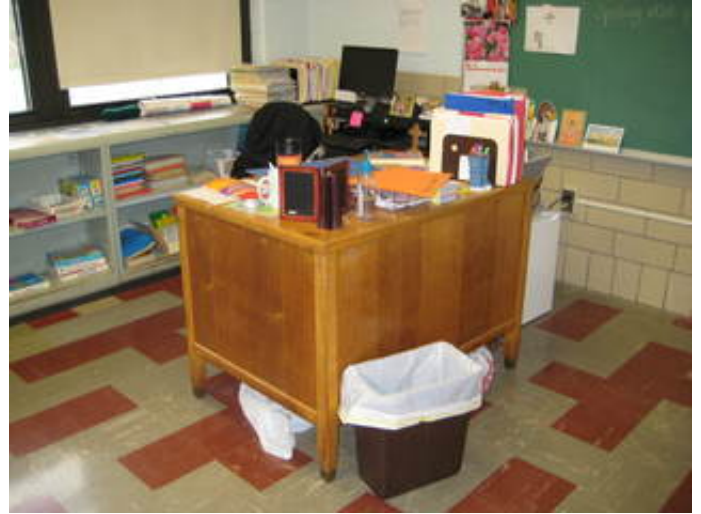
Typical Teacher Desk

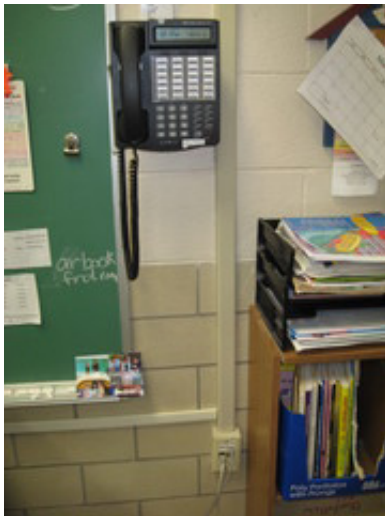
Typical Classroom Technology

Recommendations: Provide complete replacement of technology systems to meet Ohio School Design Manual requirements.
